Kempsey - Armidale Road Restoration

Arborist Report

Tree Assessment Report (Part A)

Kempsey to Armidale Road Recovery Program

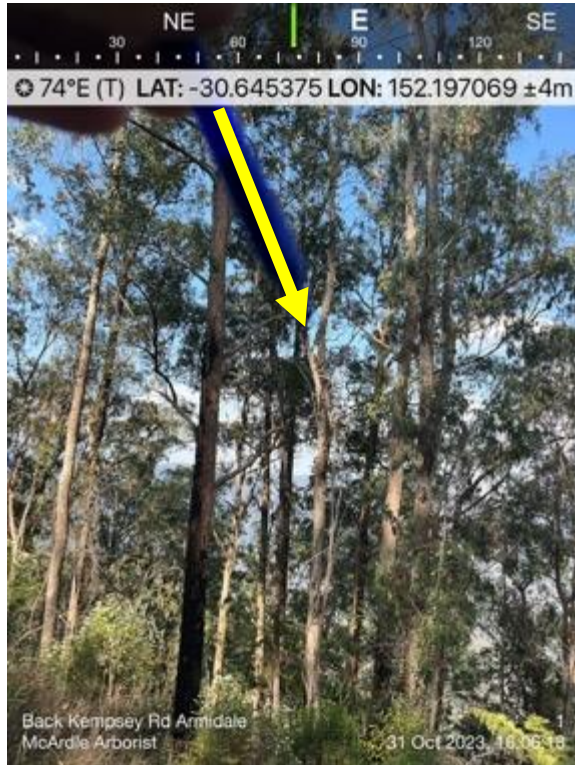
Plate 1: Tree 1, dead stag, remove. Yellow arrow.

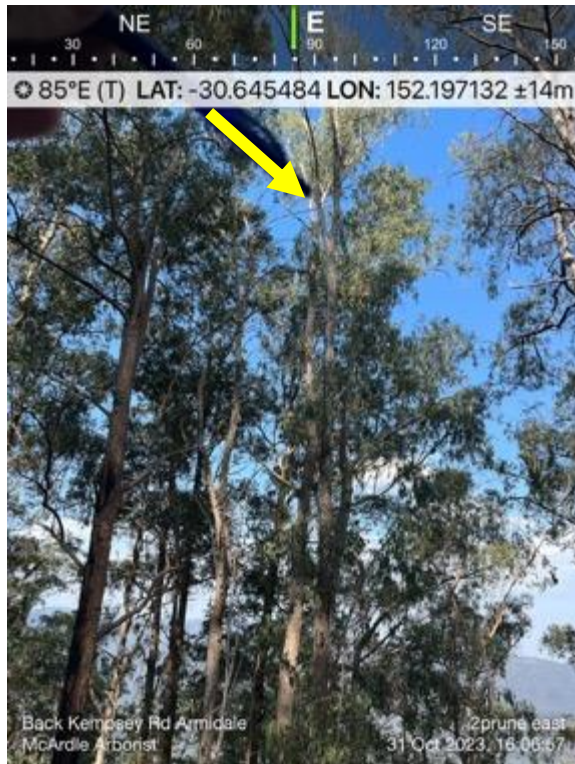
4.3.3 Six (6) trees numbered 2, 18, 64, 404, 409 and 432 have a **3a** TULE. These are trees that appear to be retainable for 5-15 years with a medium to high level of hazard. Trees that may only live for between 5 and 15 more years.

Plate 3: Tree 2, *Eucalyptus netriens*, Prune dead wood at 2 meters. Yellow arrow.

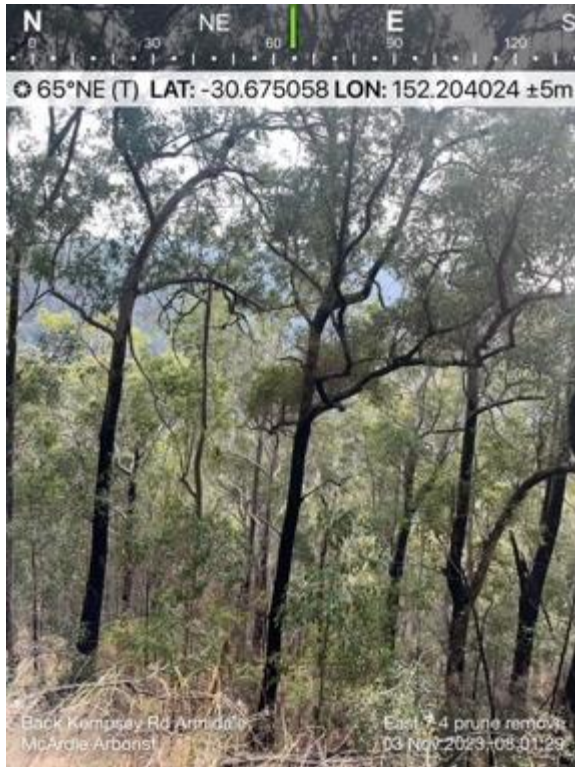
Plate 9: Tree 7, *Eucalyptus caliginosa*. Remove.

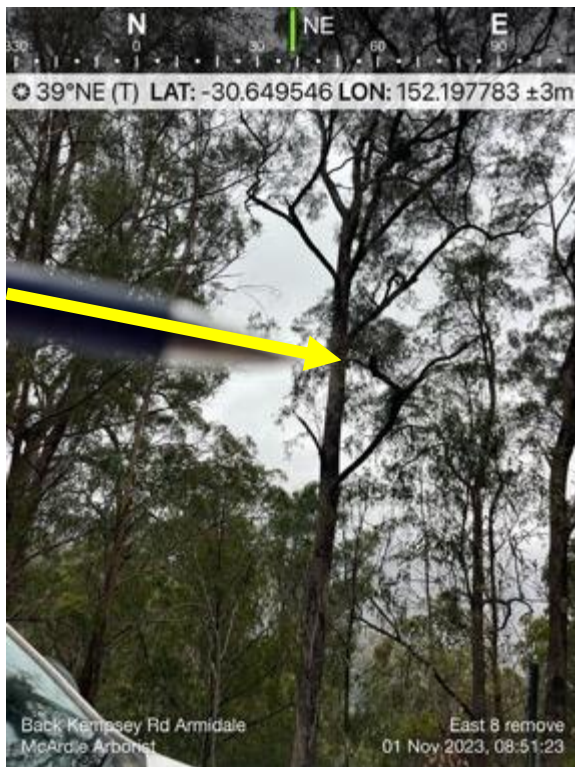
Plate 11: Tree 8, *Eucalyptus caliginosa*. Remove. Yellow arrow.

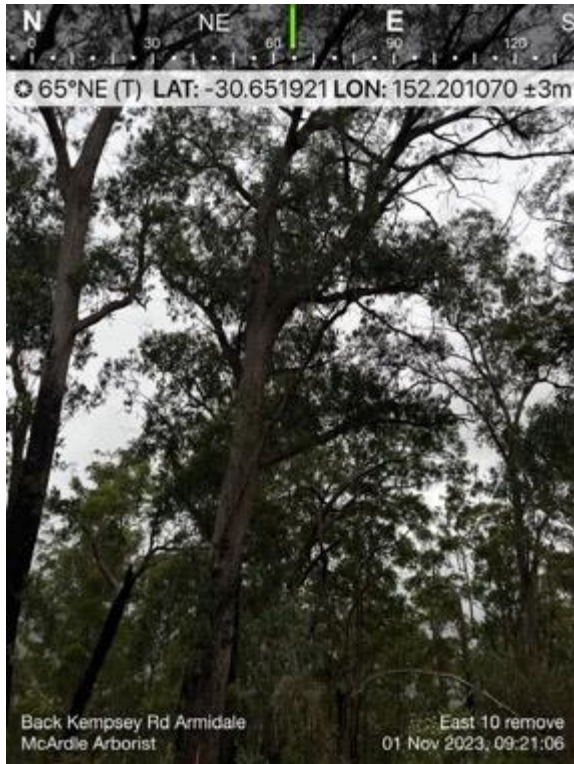
Plate 13: Tree 10, *Eucalyptus caliginosa*. Remove.

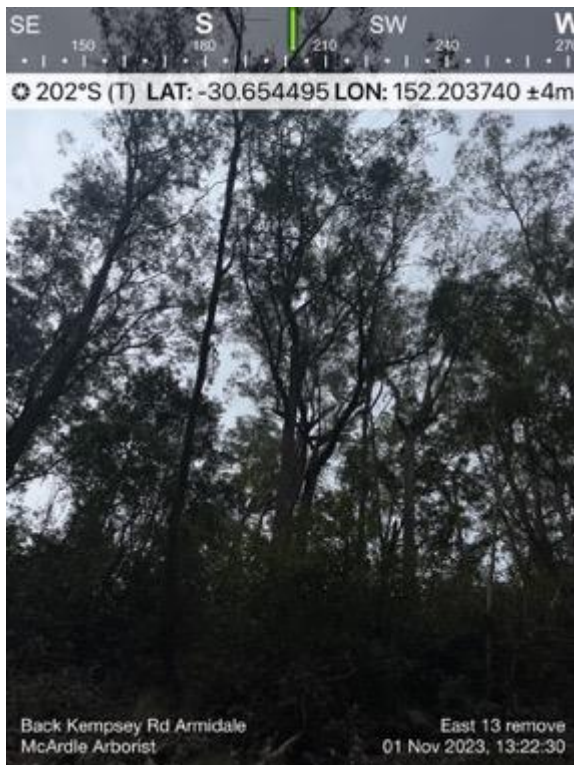
Plate 15: Tree 13, *Eucalyptus caliginosa*. Remove.

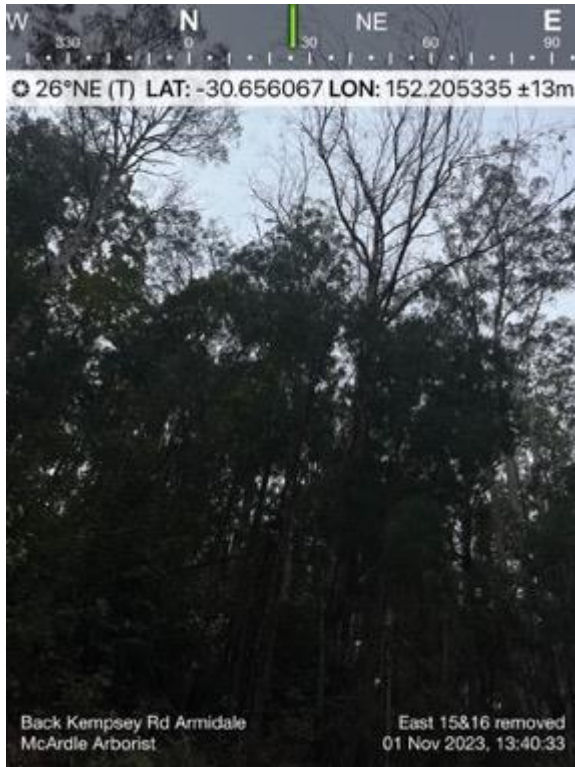
Plate 17: Tree 15, *Eucalyptus microcorys*, Remove.
Tree 16, *Eucalyptus microcorys*, Remove.

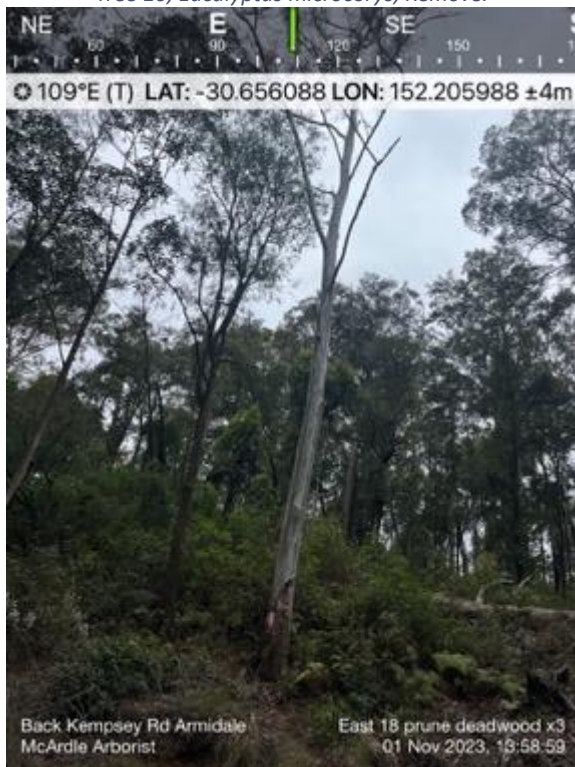
18 X3	-30.656161, 152.206176035 106182	<i>Eucalyptus dalrympleana</i> Mountain White Gum	42	65	18	Semi mature, minor dead wood.	Culvert & clearing	High1	3a	Prune dead wood over work area.
19	-30.65660801, 152.205887027 084827	<i>Syncarpia glomulifera</i> Turpentine	33	70	16	Mature, cavity at base is greater than 70% decay, lean to the North.20 meters off edge	Clearing	High1	4c	Remove.
20	-30.65750202, 152.206053994 596004	<i>Eucalyptus caliginosa</i> New England Stringy	26	75	4	Immature, dying, epicormic growth, decay on base.		High1	4c	Remove.
21	-30.657541, 152.206145022 064447	Dead stag	10	10	-	Dead, small, no hollow.	Clearing	High1	4a	Remove.
22	-30.65754603, 152.206220962 107182	Dead stag	10	10	-	Immature, good condition.		High1	4a	Remove.
23	-30.65767402, 152.206404022 872448	Dead stag	18	20	-	Dead.	Clearing	High1	4a	Remove.
24	-30.65768802, 152.206454984 843731	Dead stag	28	35	-	Dead.	Culvert	High1	4a	Remove.

Plate 19: Tree 18, *Eucalyptus saligna*, Prune dead wood over work area.

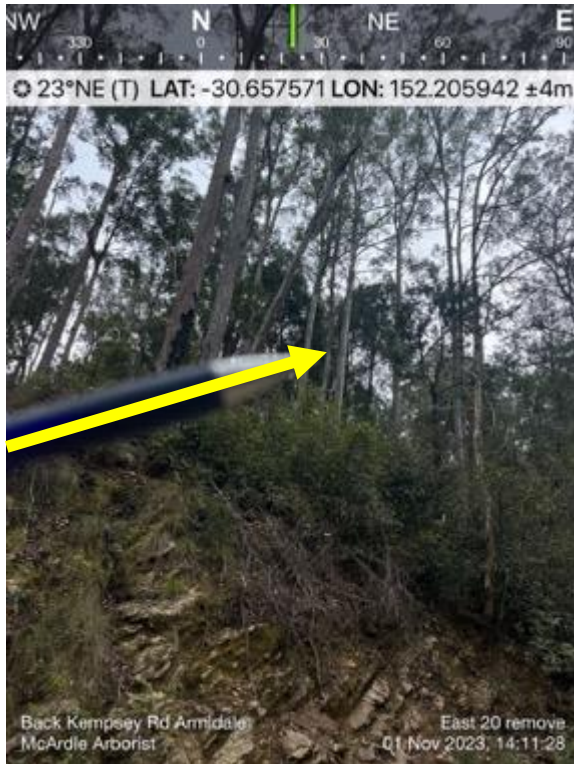
Plate 21: Tree 20, *Eucalyptus caliginosa*. Remove Yellow arrow.

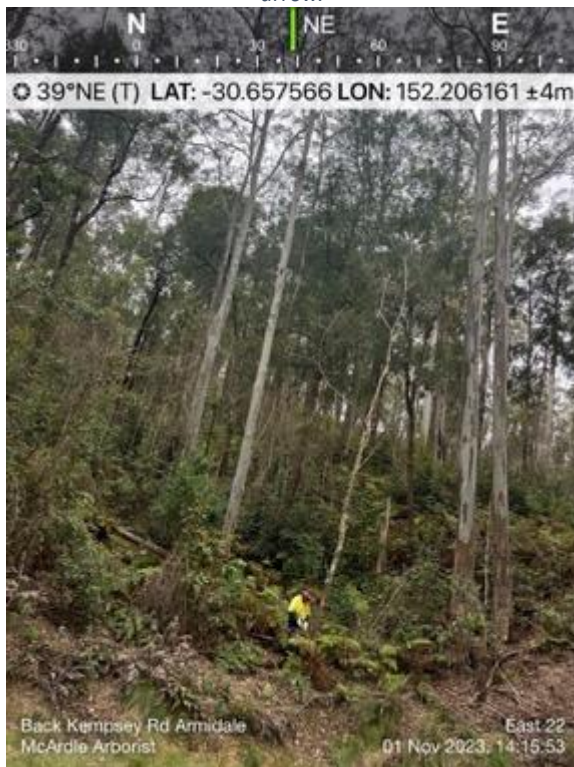
Plate 23: Tree 22, Dead stag, Remove.

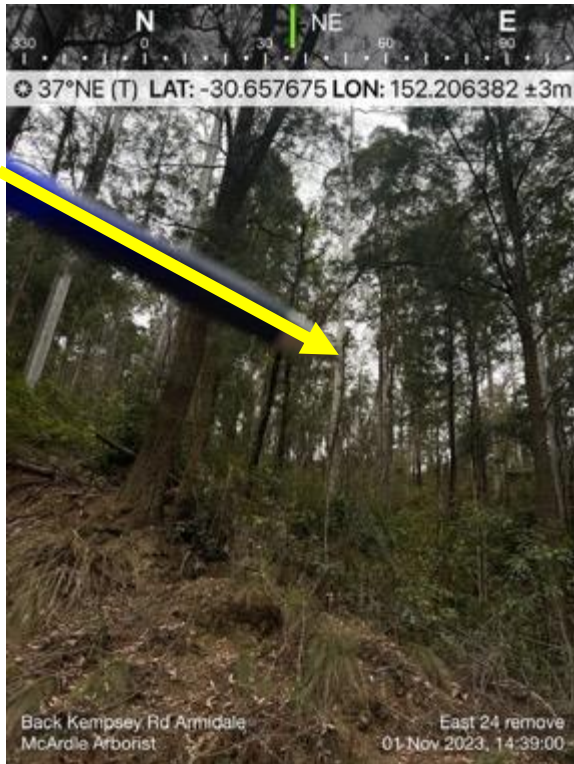
Plate 25: Tree 24, Dead stag, Remove. Yellow arrow.

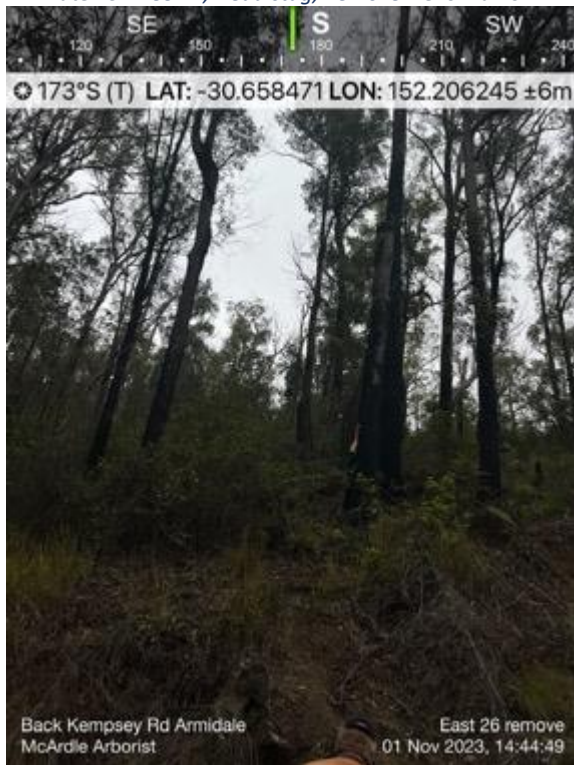
Plate 27: Tree 26, Dead stag, Remove.

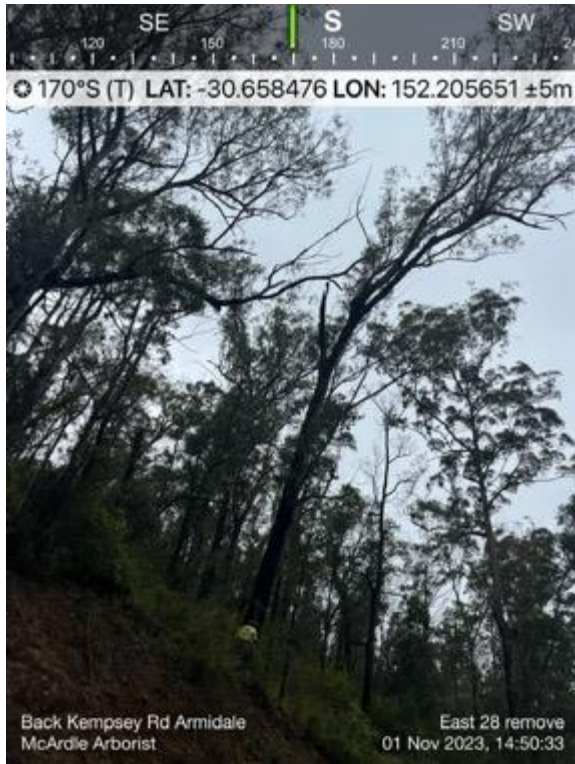
Plate 29: Tree 28, *Eucalyptus caliginosa*. Remove.

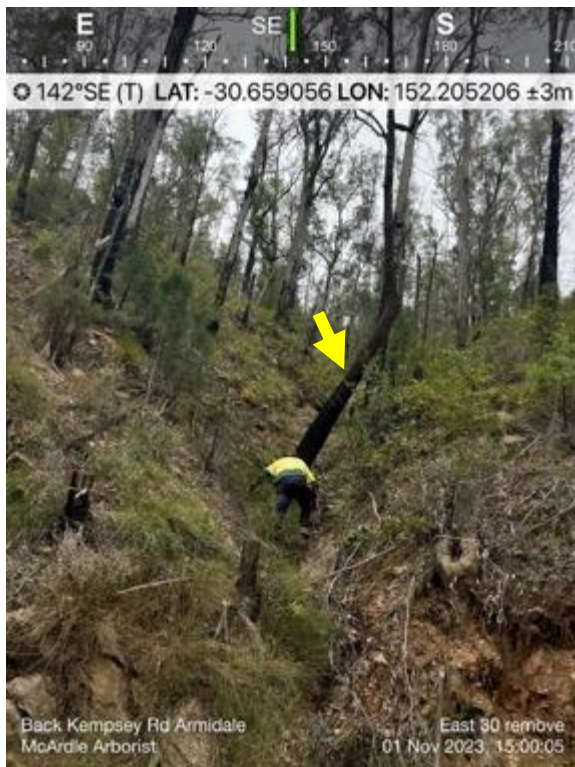
Plate 31: Tree 30, *Casuarina* species, Remove.

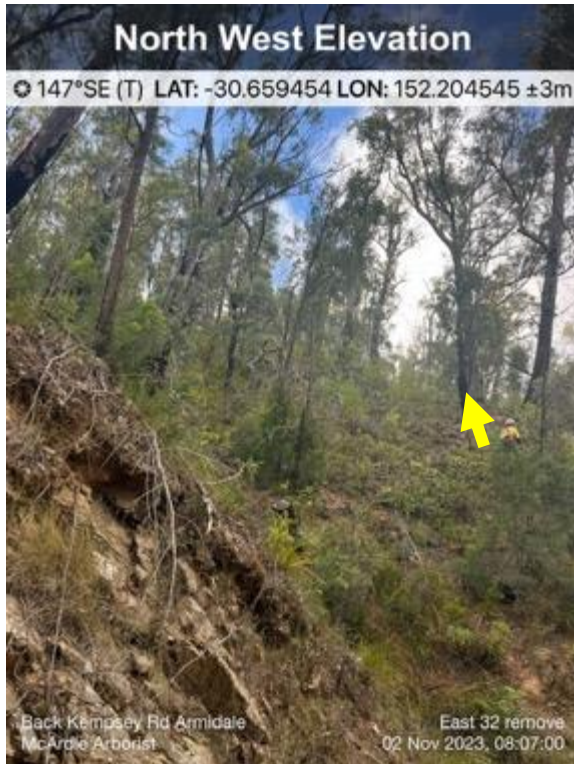
32	-30.65952097, 152.204475011 67655	<i>Casuarina species</i>	12	15	40	Immature, split on Eastern stem.	Culvert	High1	4c	Remove.
33	-30.65988902, 152.204030016 437173	<i>Eucalyptus caliginosa</i> New England Stringy	18	30	90	Immature, cavity, poor condition.	Clearing	High1	4c	Remove.
34	-30.65999597, 152.203754000 365734	<i>Eucalyptus caliginosa</i> New England Stringy	30	70	18	Semi mature, poor condition, hollow, cavity.	Clearing	High1	4c	Prune to reduce by 50%.
35	-30.66046896, 152.203414030 373096	<i>Syncarpia glomulifera</i> Turpentine	18	40	8	Immature, damage to roots, fire damage, cavity.	Culvert	High1	4c	Remove.
36	-30.66059796, 152.203406989 574432	Dead stag	-	40	-	Dead, has fallen over. Fallen tree on south side	Slip	High1	4c	Remove.
37	-30.66131503, 152.203230969 60783	<i>Eucalyptus caliginosa</i> New England Stringy	25	50	16	Semi mature, decay, moderate condition, roots on surface. On bank	Culvert	High1	4c	Remove. On bank.

Plate 33: Tree 32, *Casuarina species*, Remove.

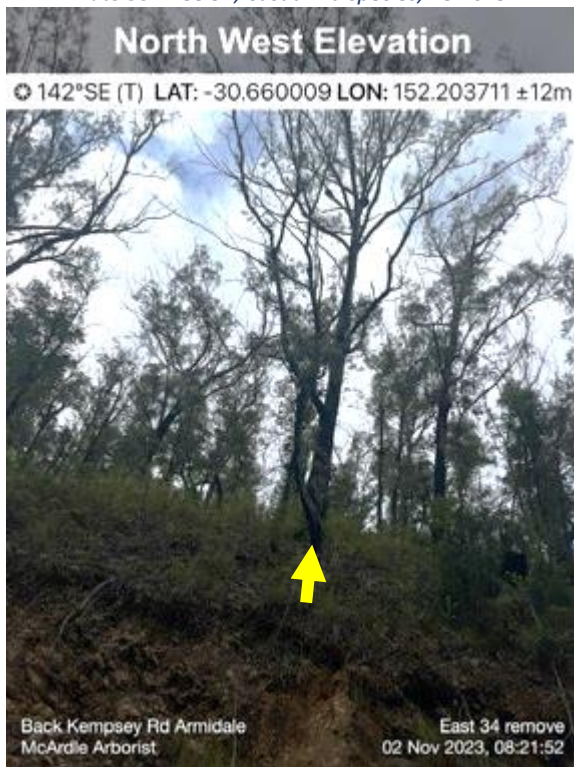
Plate 35: Tree 34, *Eucalyptus caliginosa*. Prune to reduce by 50%.

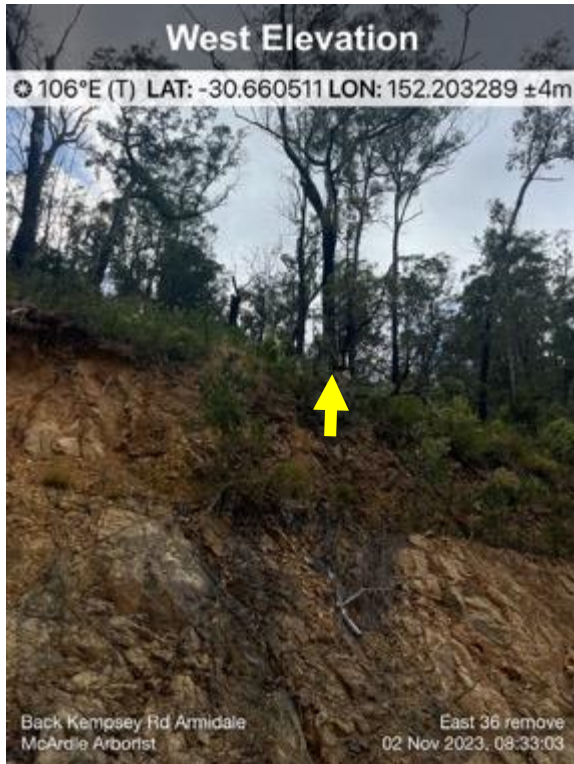
Plate 37: Tree 36, Dead stag, Remove.

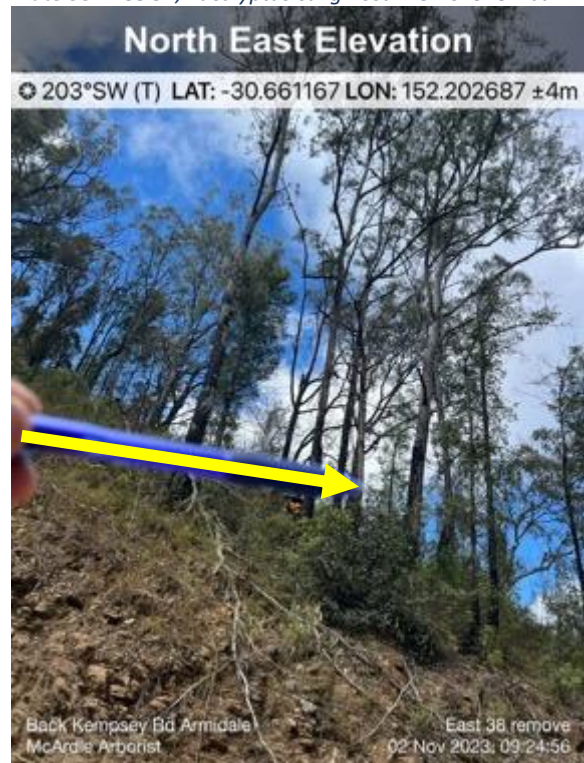
38	-30.661208, 152.202711040 154099	Dead stag	9	20	-	Dead. On cliff	Clearing	High1	4a	Remove.
39	-30.66120397, 152.202577013 522387	<i>Eucalyptus caliginosa</i> New England Stringy	25	40	12	Immature, damage to roots, damaged, poor condition.	Culvert	High1	4c	Remove to stump.

Plate 40: Tree 38, Dead stag, remove. Yellow arrow.

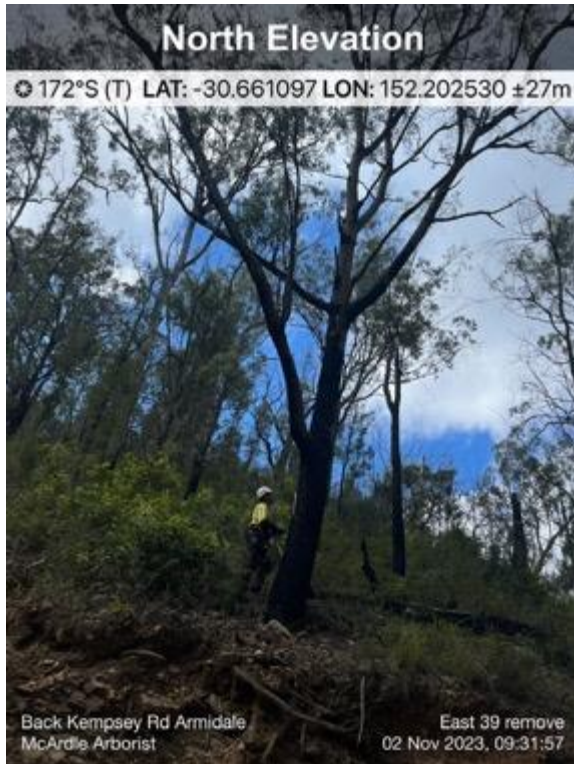
Plate 41: Tree 39, *Eucalyptus caliginosa*. Remove to stump.

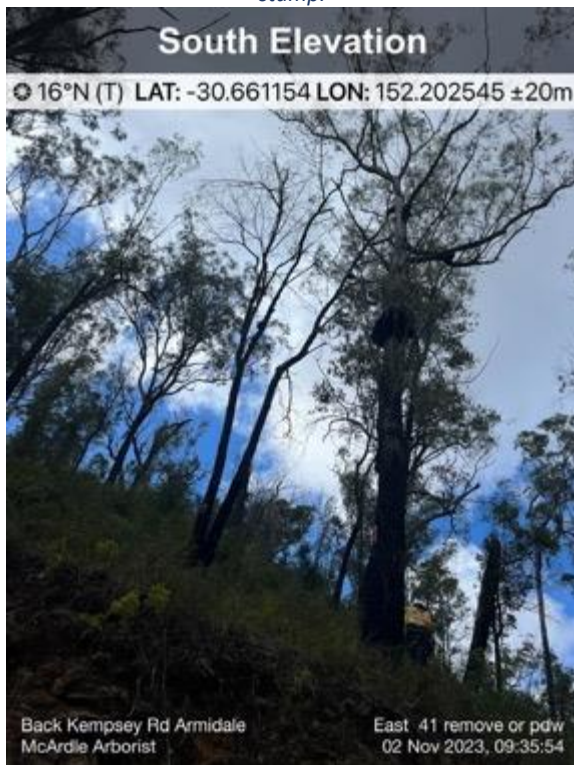
Plate 43: Tree 41, *Eucalyptus caliginosa*. Prune dead wood over road.

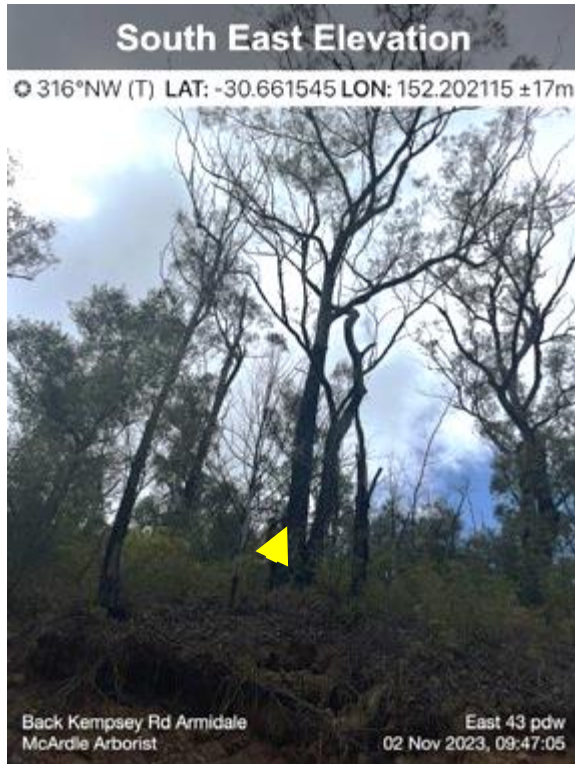
Plate 45: Tree 43, *Eucalyptus caliginosa*. Prune dead wood over bank.

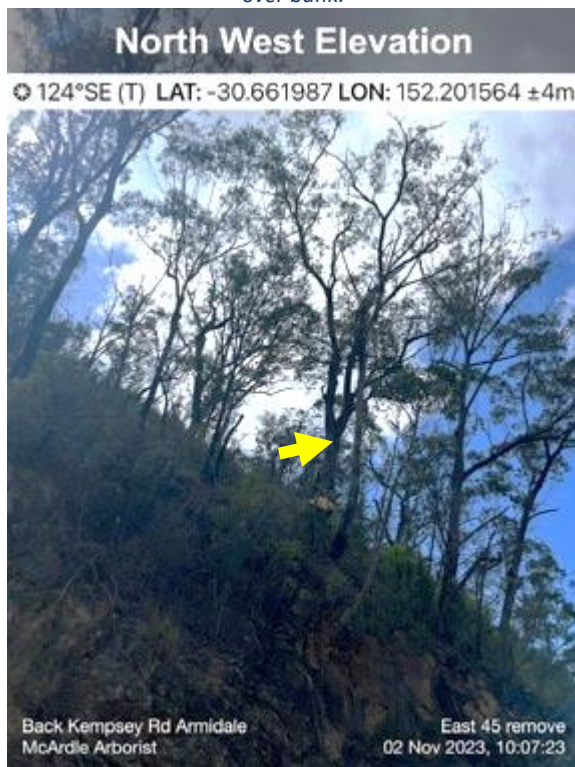
Plate 47: Tree 45, *Eucalyptus caliginosa* Remove.

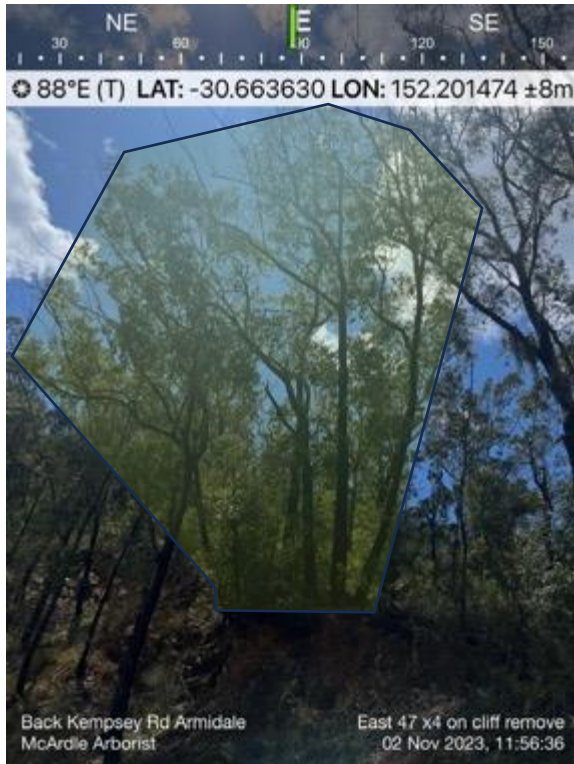
Plate 49: Tree 47, *Eucalyptus caliginosa* Remove in hatch.

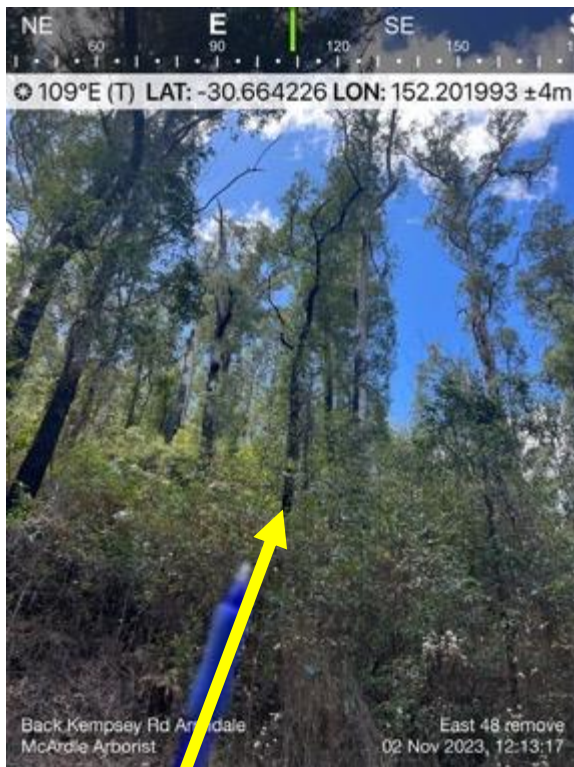
Plate 51: Tree 48, *Syncarpia glomulifera*, Remove. Yellow arrow.

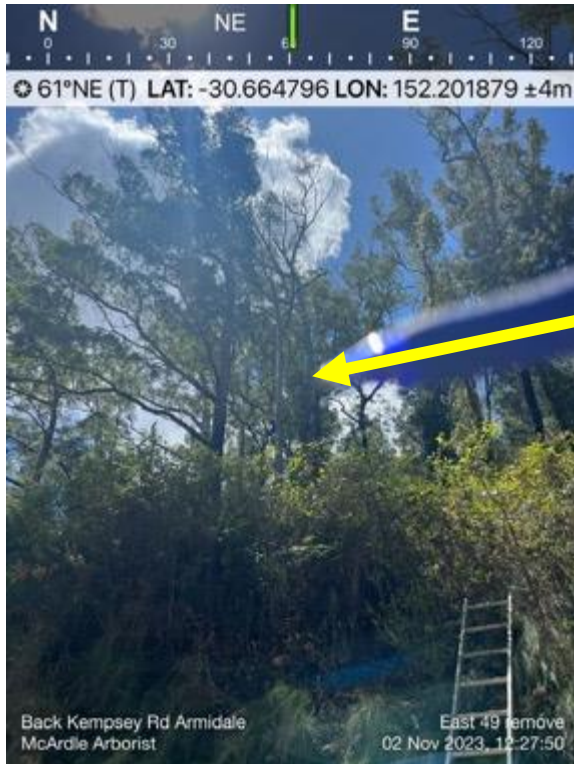
Plate 53: Tree 49, Dead stag, Remove. Yellow arrow.

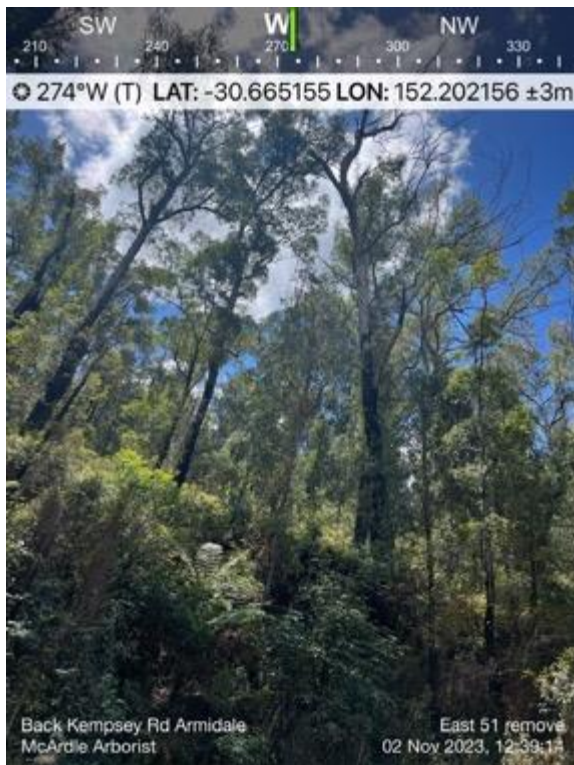
Plate 55: Tree 51, Dead stag, Remove.

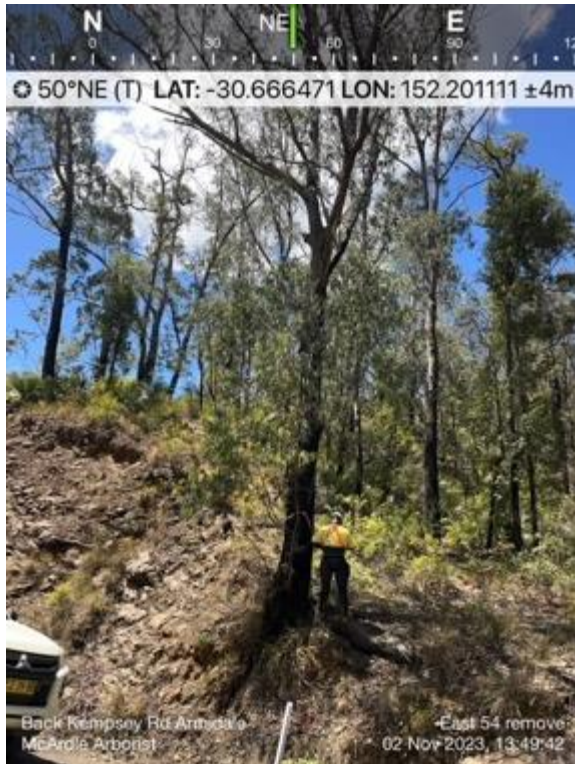
Plate 57: Tree 54, *Eucalyptus caliginosa* Remove.

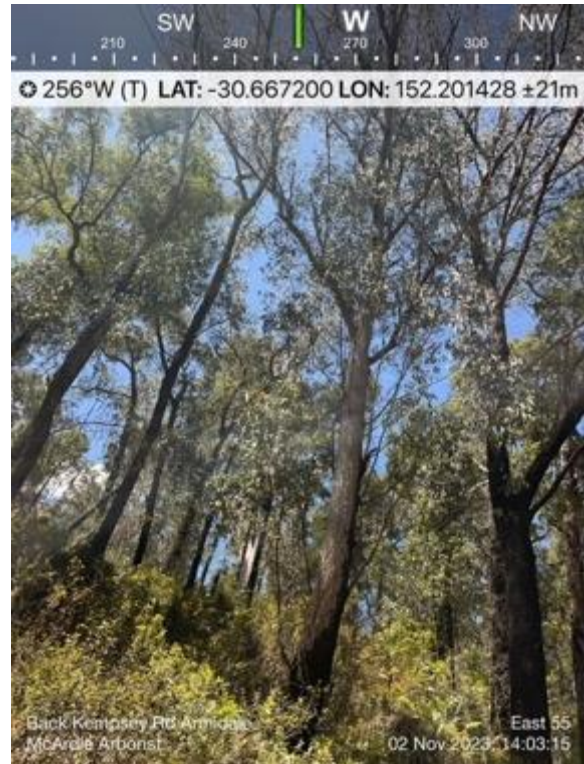
Plate 58: Tree 55, *Eucalyptus caliginosa* Prune dead wood over road.

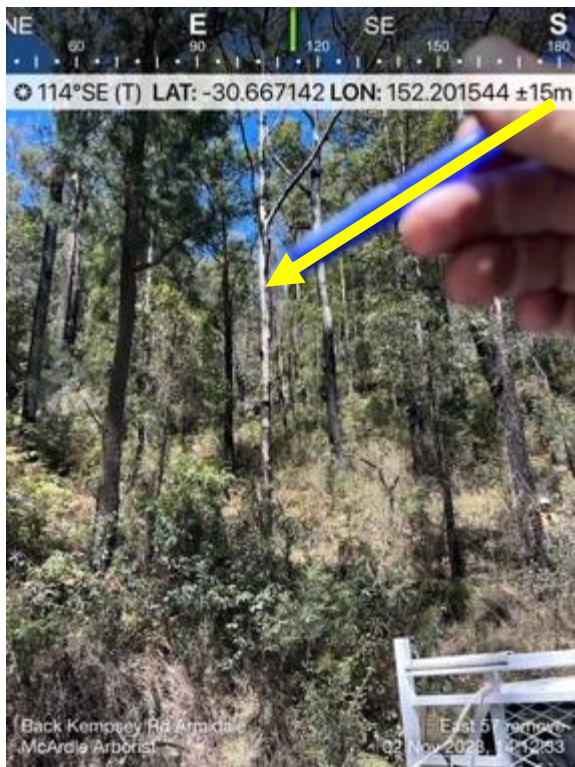
Plate 59: Tree 57, Dead stag, Remove. Yellow arrow.

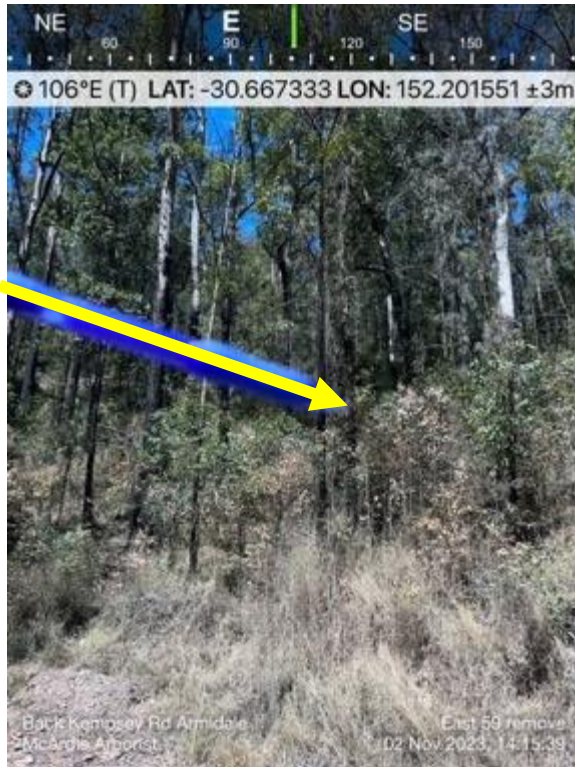
Plate 61: Tree 59, Dead stag, Remove. Yellow arrow.

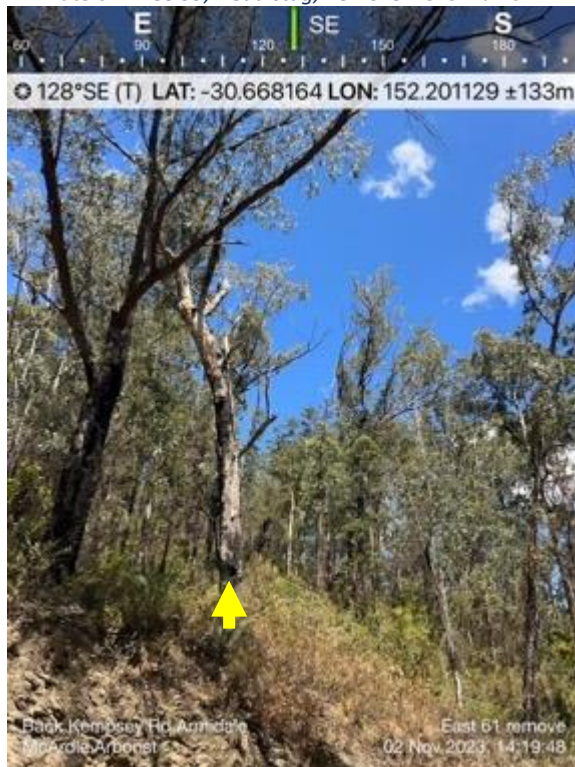
Plate 63: Tree 61, Dead stag, Remove.

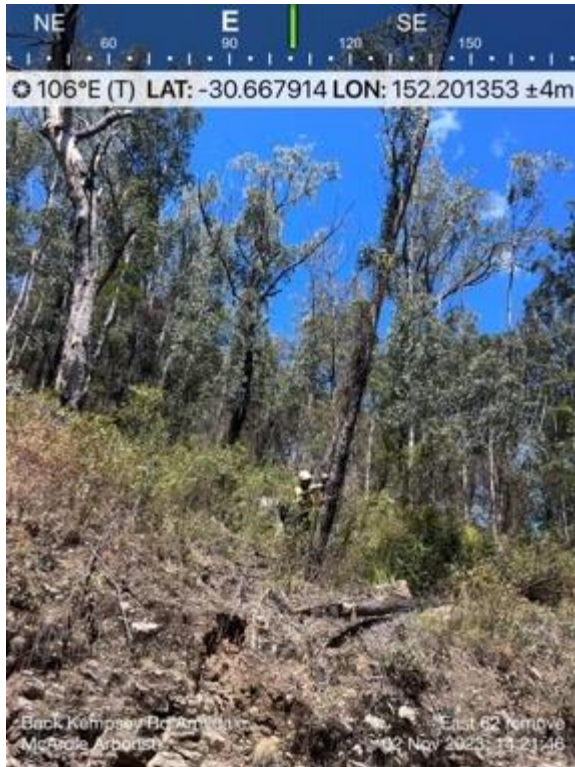
Plate 65: Tree 62, *Eucalyptus caliginosa* Remove.

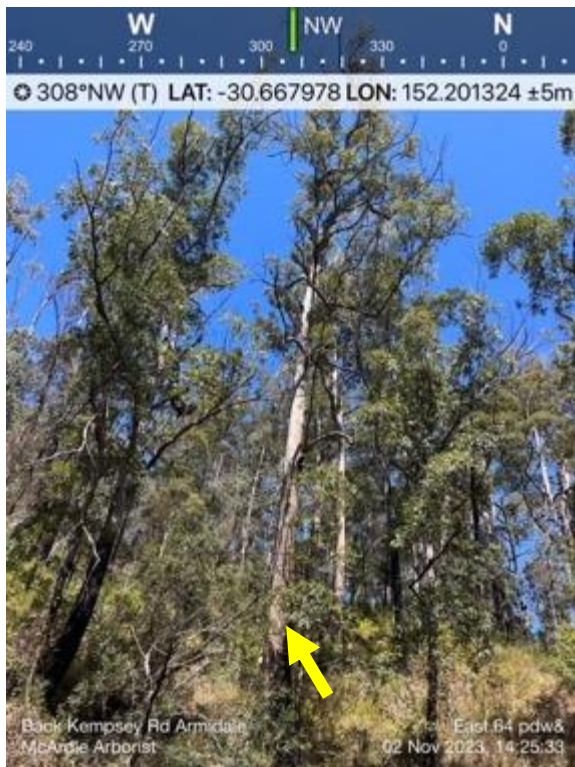
Plate 67: Tree 64, *Eucalyptus caliginosa* Prune dead wood over target.

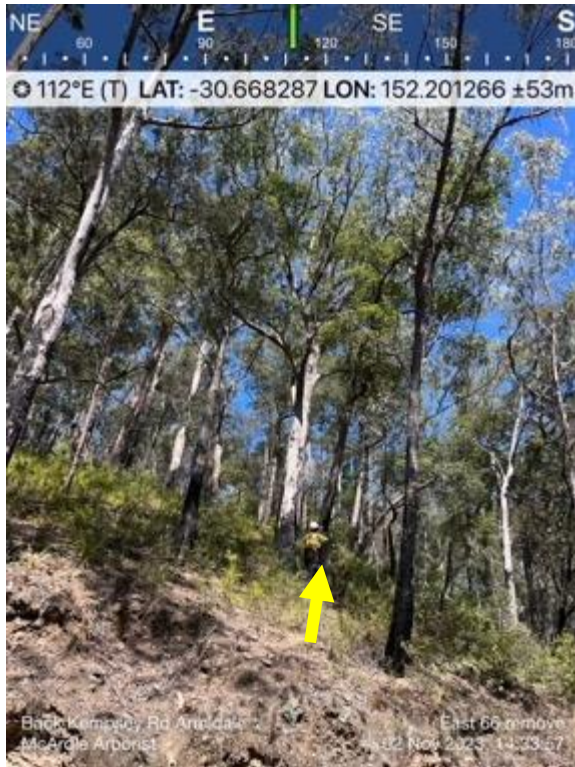
Plate 69: Tree 66, *Eucalyptus caliginosa* Remove.

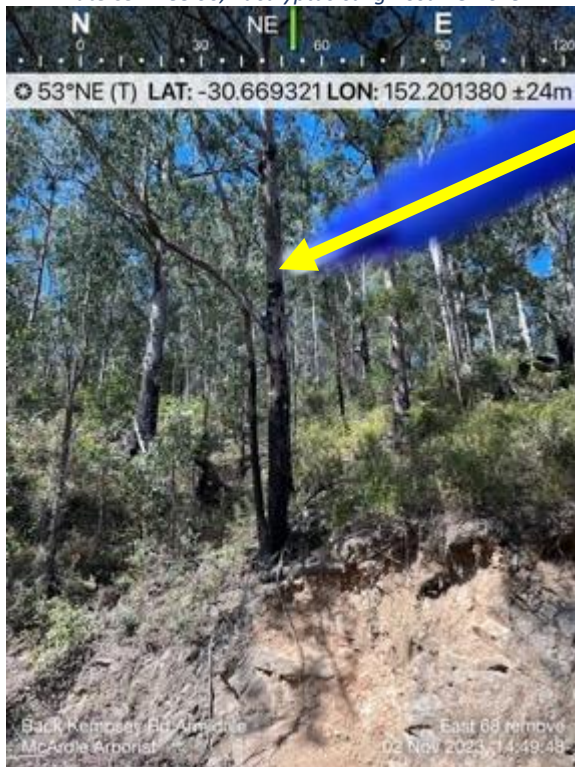
Plate 71: Tree 68, *Eucalyptus caliginosa* , Remove. Yellow arrow.

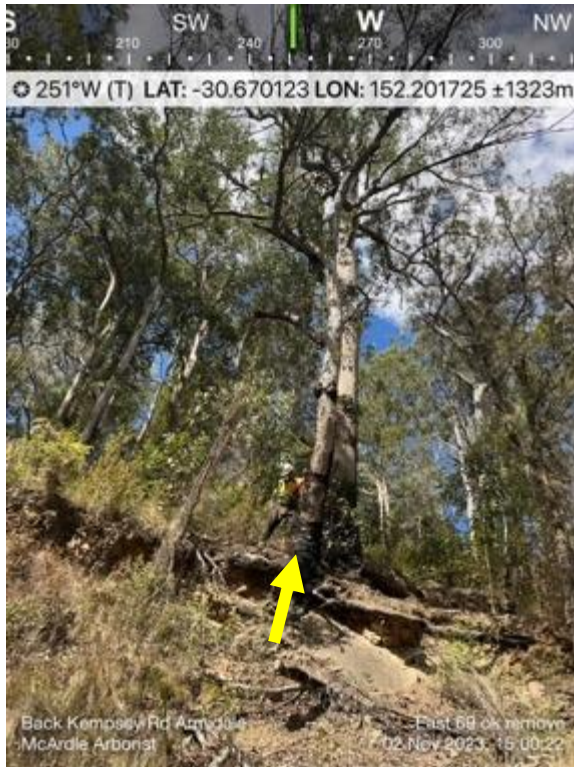
Plate 73: Tree 69, *Eucalyptus caliginosa*, Remove to stump.

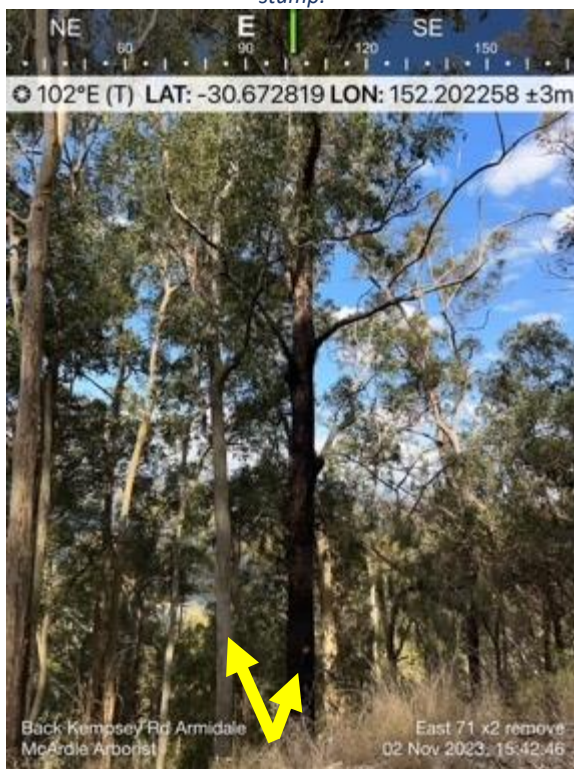
Plate 75: Tree 71, *Eucalyptus microcorys*, Remove two trees.

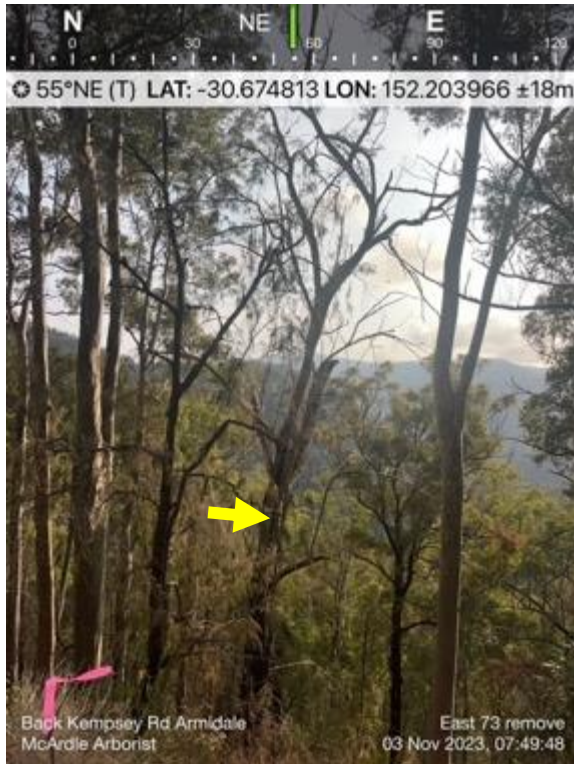
Plate 77: Tree 73, Dead stag, Remove.

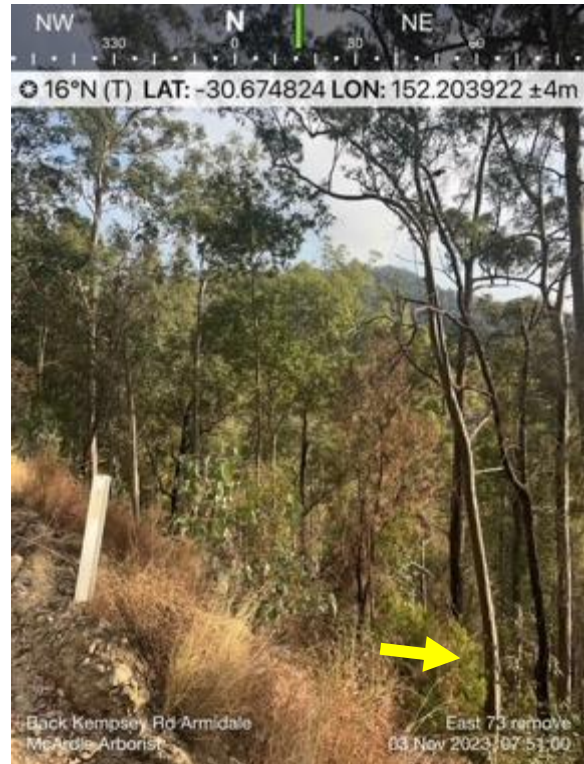
Plate 78: Tree 73, Dead stag, Remove.

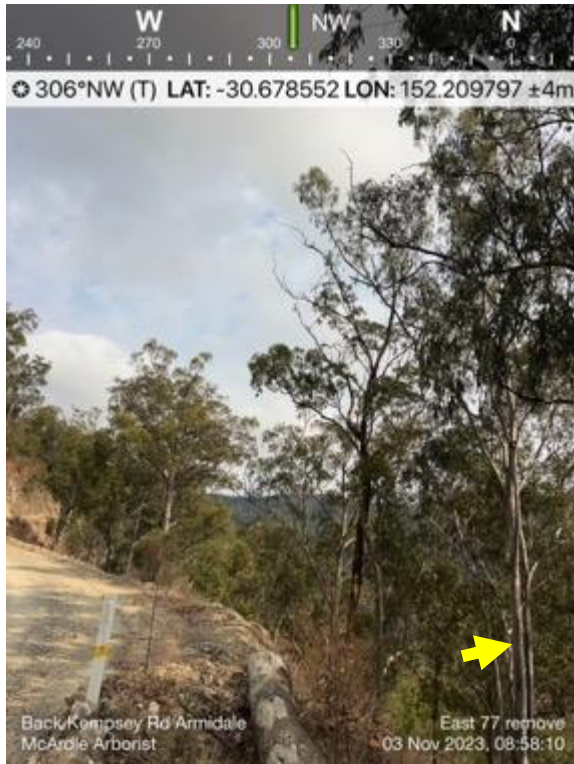
Plate 81: Tree 77, Dead stag, Remove.

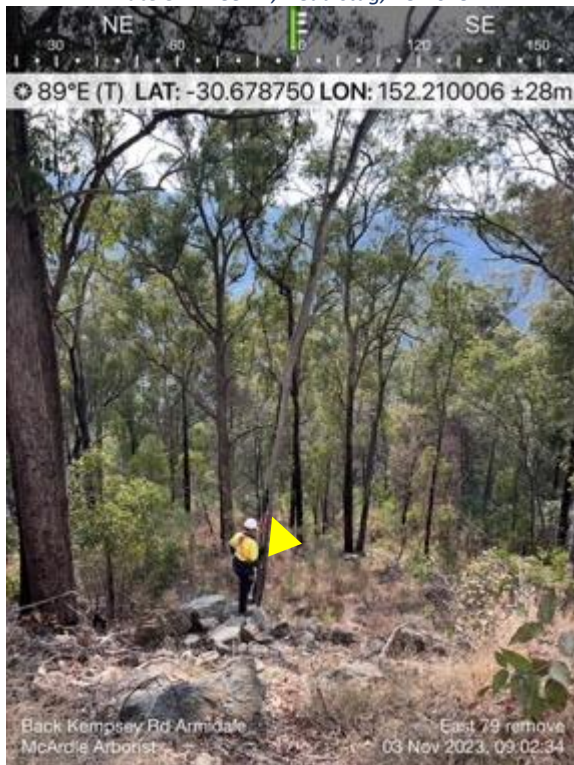
Plate 83: Tree 79, Dead stag, Remove.

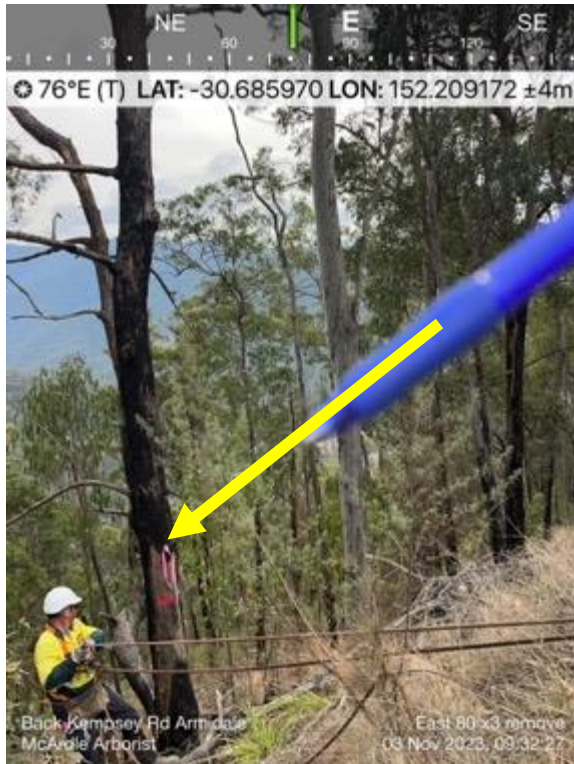
Plate 85: Tree 80, Dead stag, Remove. Yellow arrow.

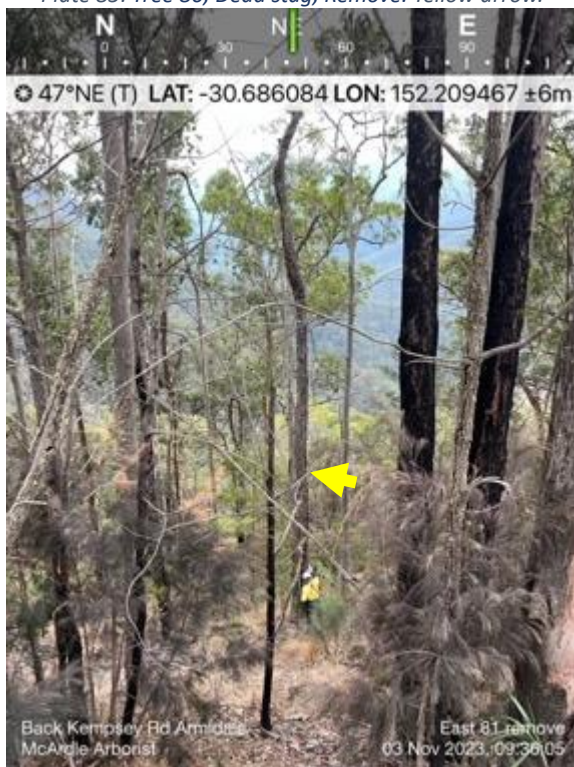
Plate 87: Tree 81, Dead stag, Remove.

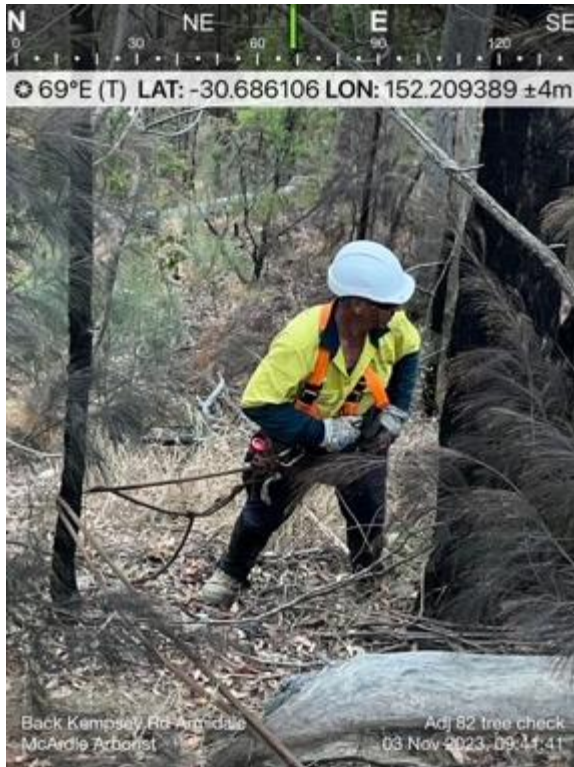
Plate 89: Tree 82, Dead stag and Dan McArdle, Remove.

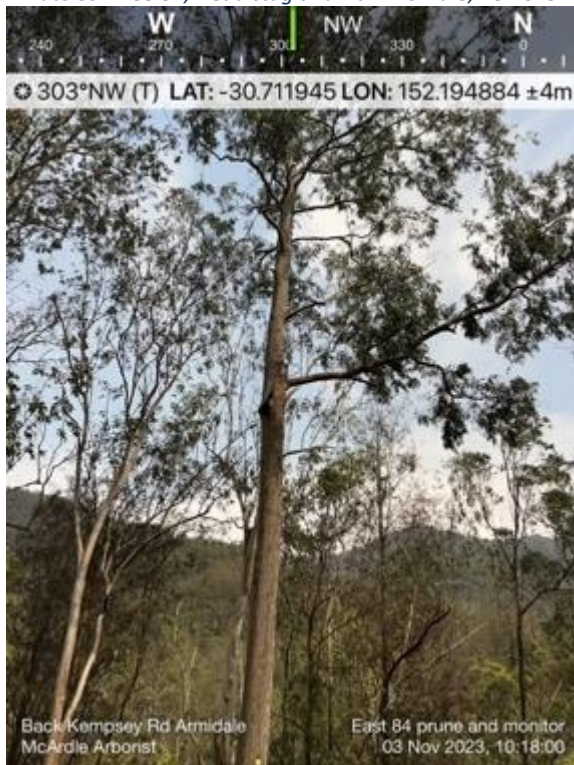
Plate 91: Tree 84, *Corymbia maculata*, Prune and monitor.

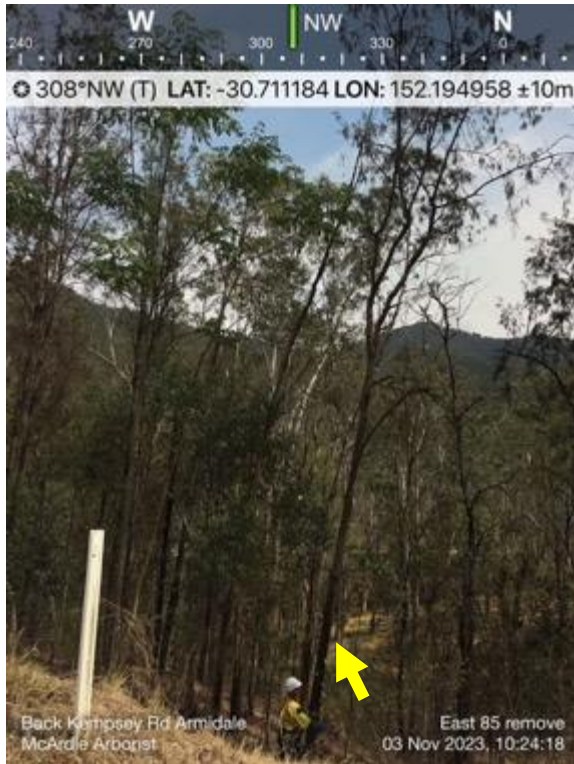
Plate 93: Tree 85, Dead stag & Casuarina speices, Remove.

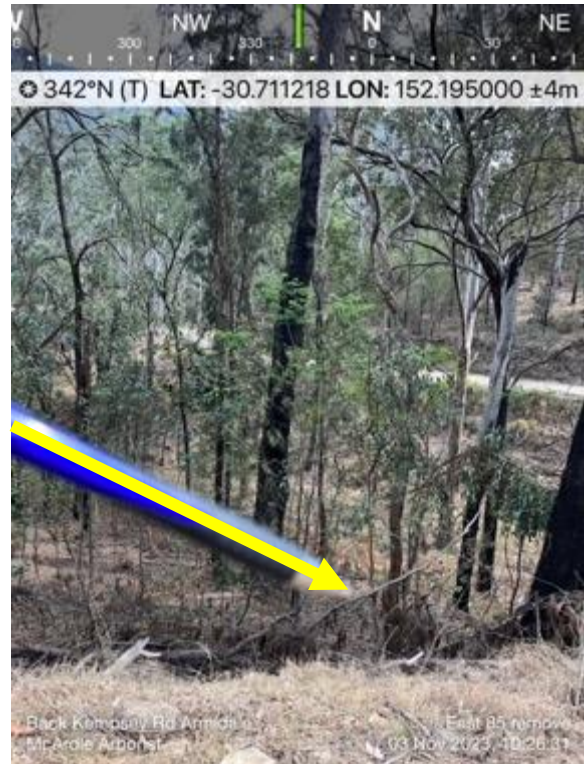
Plate 94: Tree 85, Dead stag & Casuarina speices, Remove. Yellow arrow.

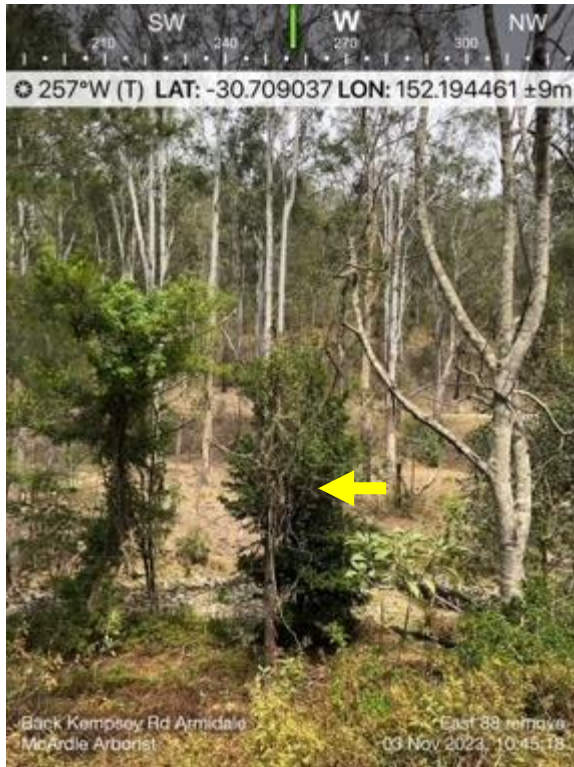
Plate 97: Tree 88, *Pittosporum undulatum*, Remove.

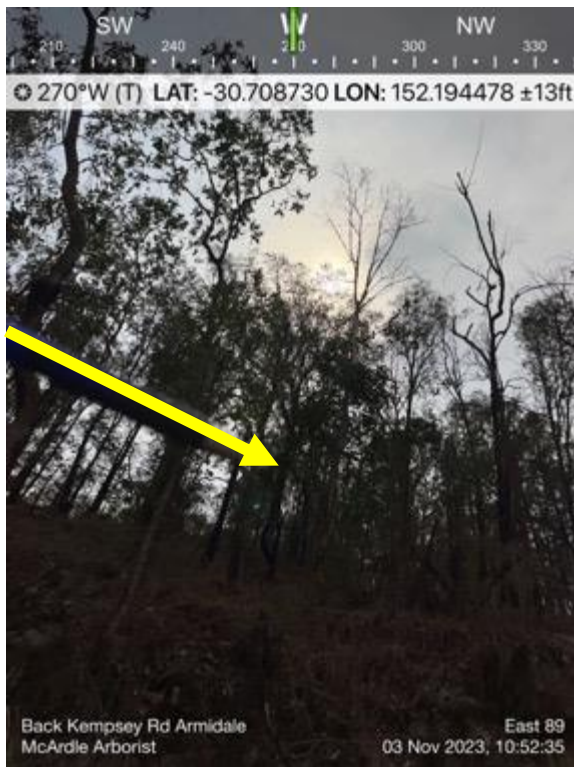
Plate 99: Tree 89, *Angophora floribunda*, Remove tree if working adjacent. Yellow arrow.
