Kempsey - Armidale Road Restoration

Arborist Report

Tree Assessment Report (Part A)

Kempsey to Armidale Road Recovery Program

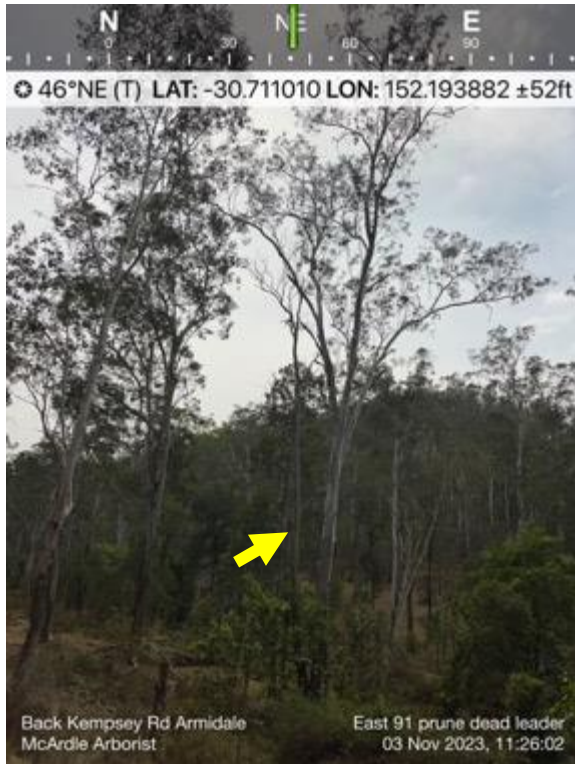
Plate 101: Tree 91, Eucalyptus Prune stag off tree.

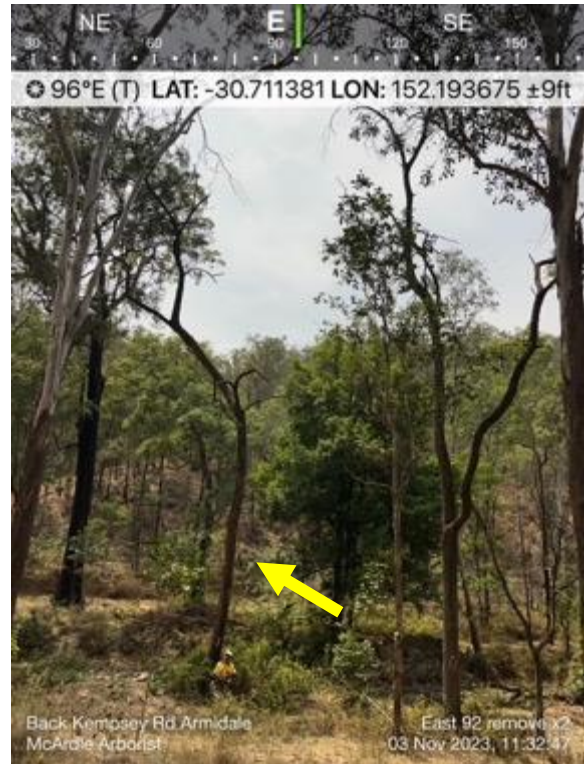
Plate 102: Tree 92, Dead stag, Remove.

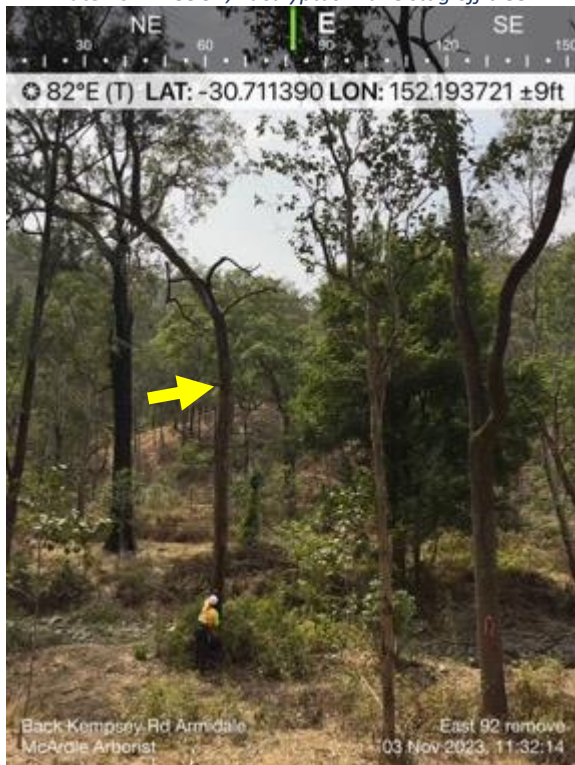
Plate 103: Tree 92, Dead stag, Remove.

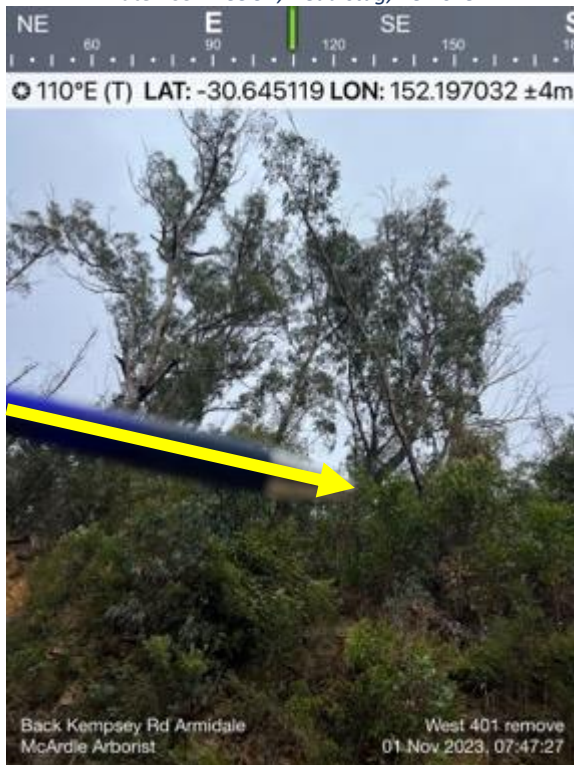
Plate 107: Tree 401, Eucalyptus species, Remove. Yellow arrow.

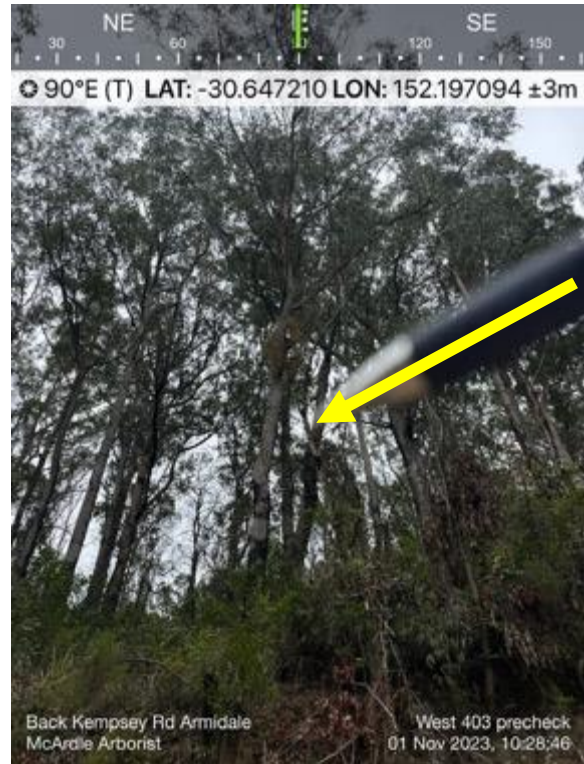
Plate 110: Tree 403, *Eucalyptus caliginosa*, Prune dehydration. Yellow arrow.

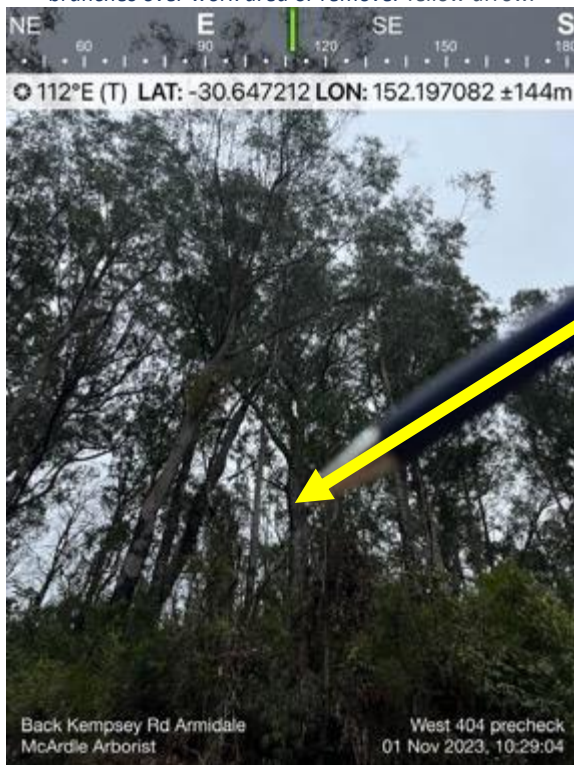
Plate 111: Tree 404, *Eucalyptus caliginosa*, Prune dead wood. Yellow arrow.

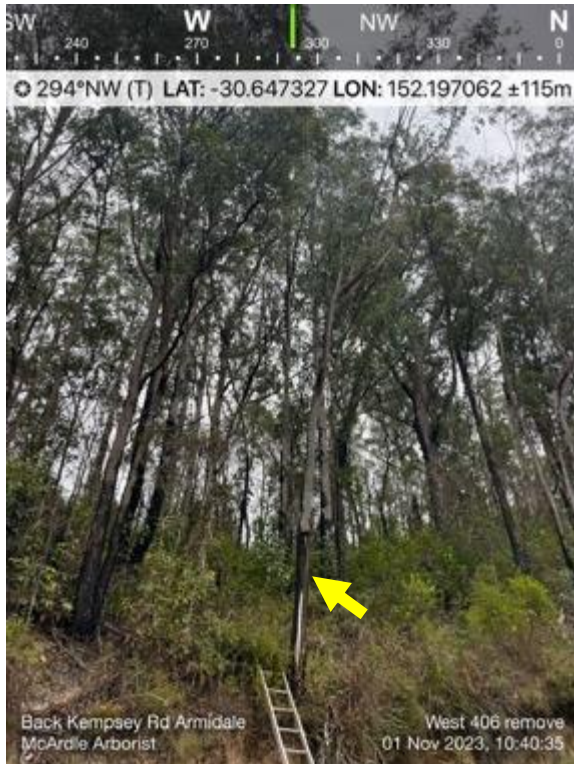
Plate 113: Tree 406, *Eucalyptus caliginosa*, Remove.

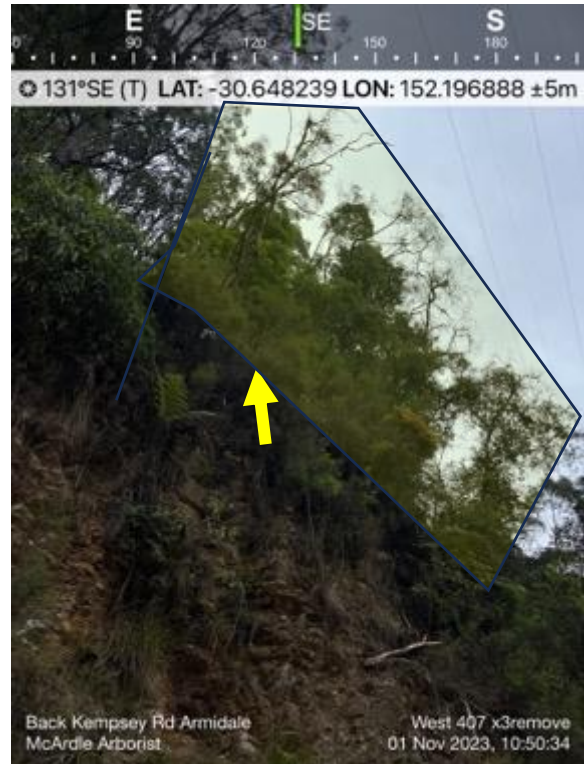
Plate 114: Tree 407, Dead tree, Remove in yellow hatch

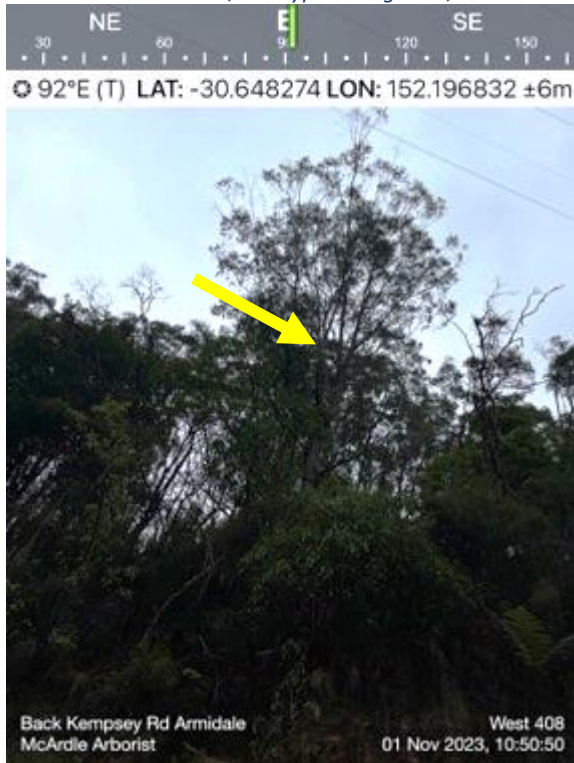
Plate 115: Tree 408, *Eucalyptus caliginosa*, Remove.

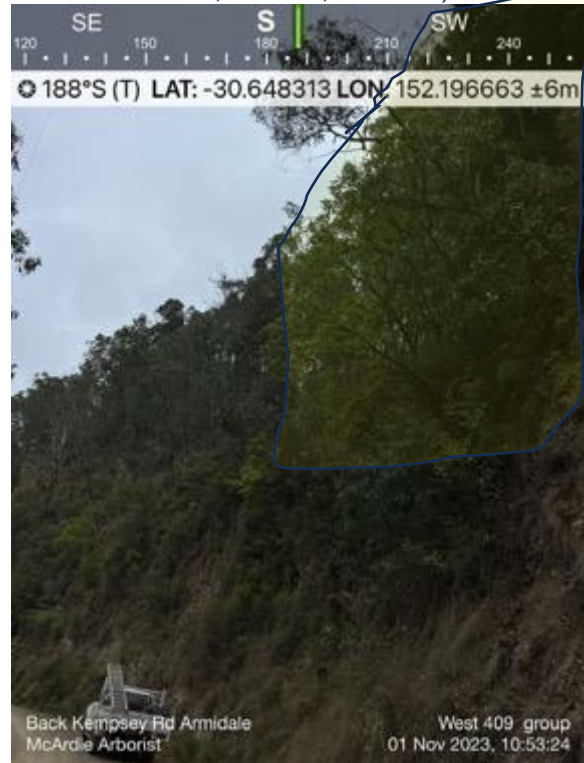
Plate 116: Tree 409, *Acacia* species, Prune branches overhanging work zone. (Hatched area).

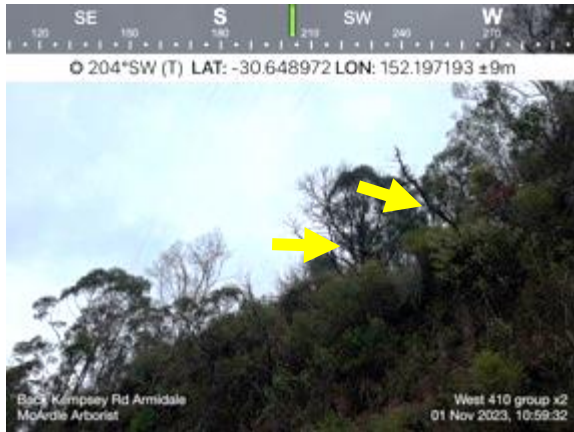
Plate 117: Tree 410, Dead stag, Remove.

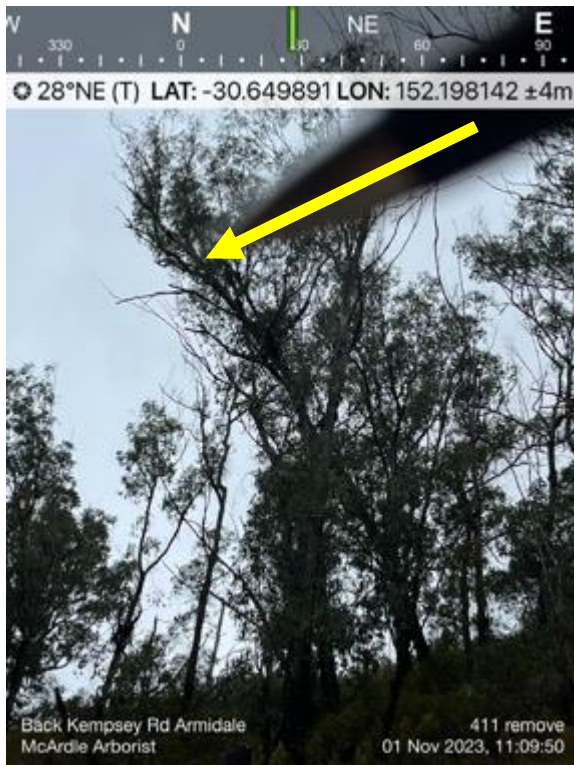
Plate 119: Tree 411, *Eucalyptus caliginosa*, Remove.
Yellow arrow.

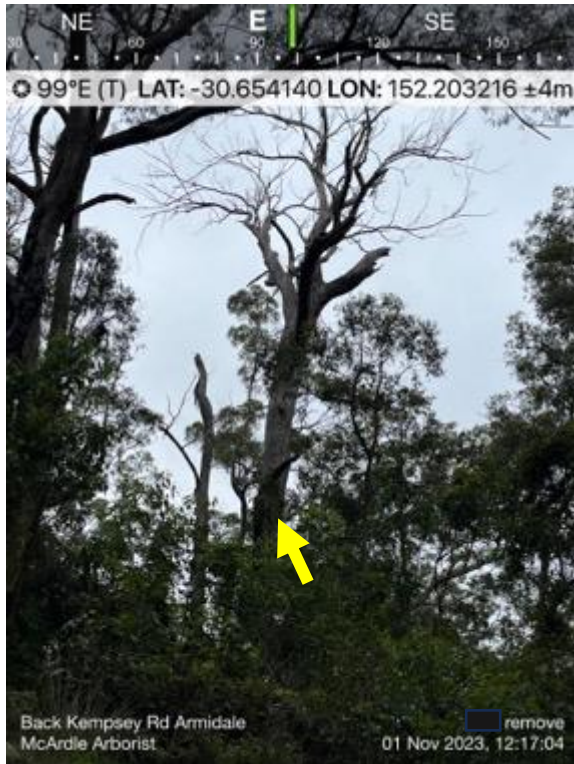
Plate 121: Tree 412, Dead, Remove.

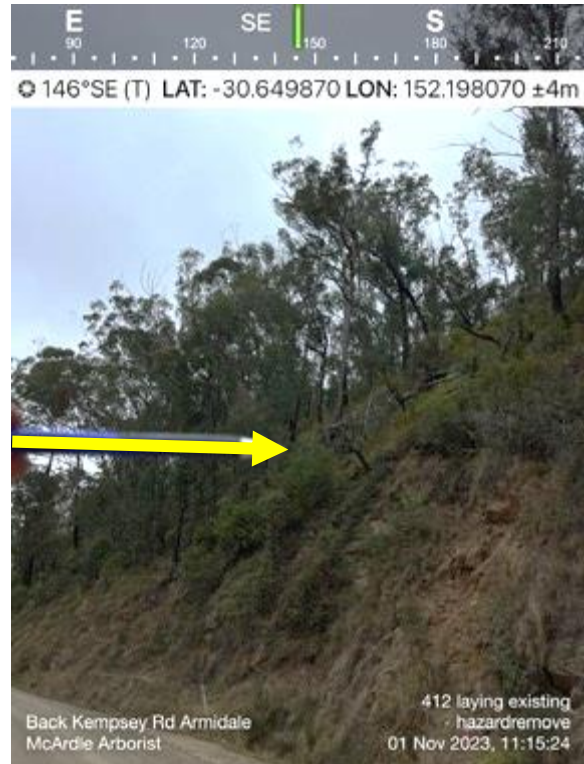
Plate 122: Tree 412, Dead, Remove. Yellow arrow.

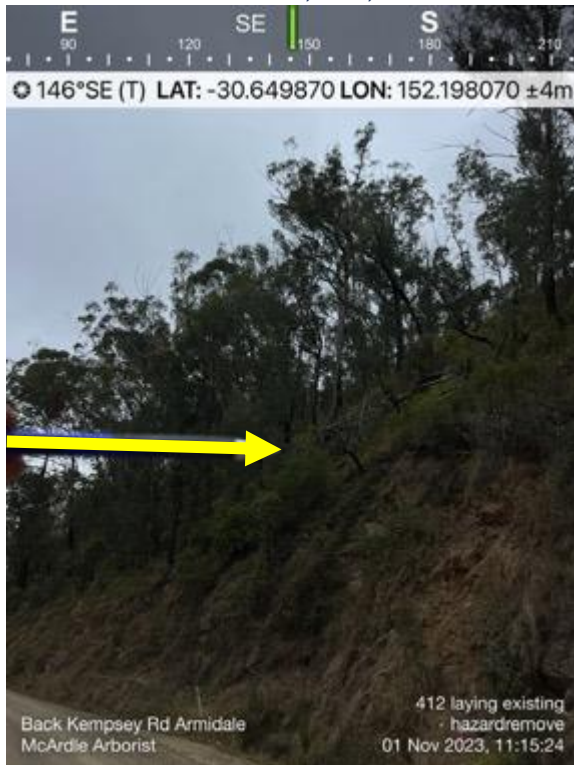
Plate 123: Tree 412, Dead, Remove. Yellow arrow.

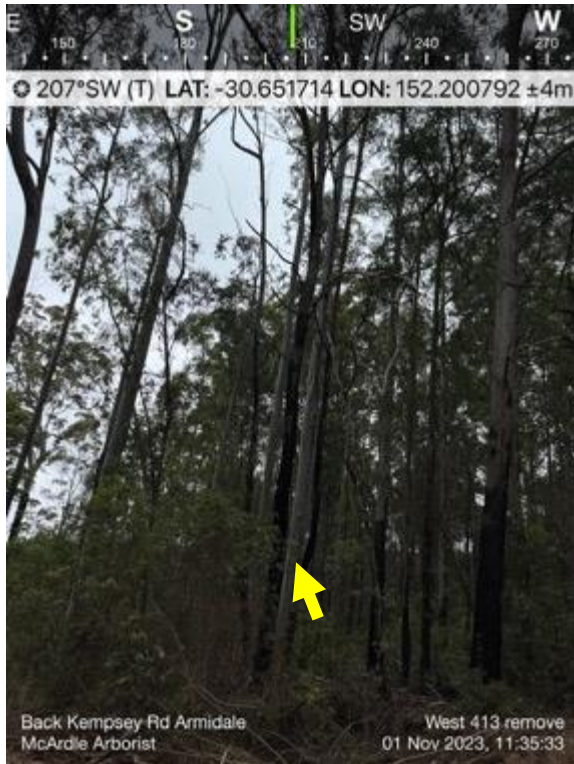
Plate 125: Tree 413, Dead, Remove.

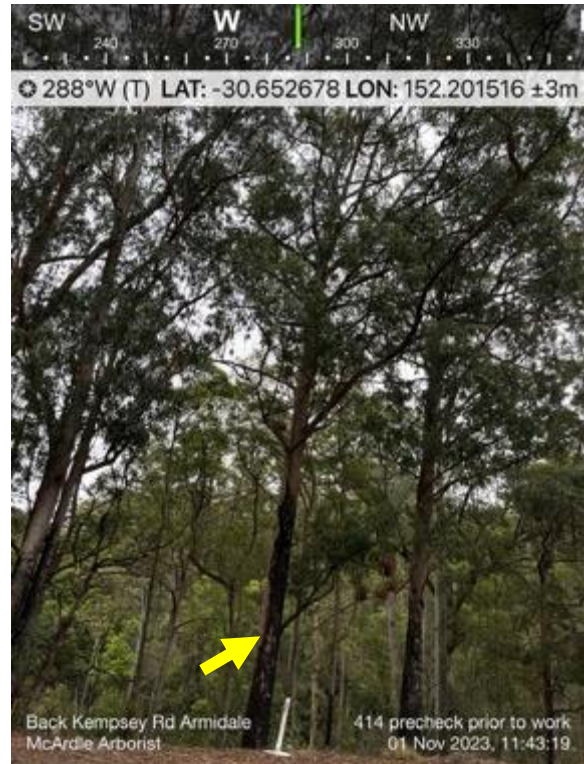
Plate 126: Tree 414, Eucalyptus caliginosa, Prune dead branch over work area.

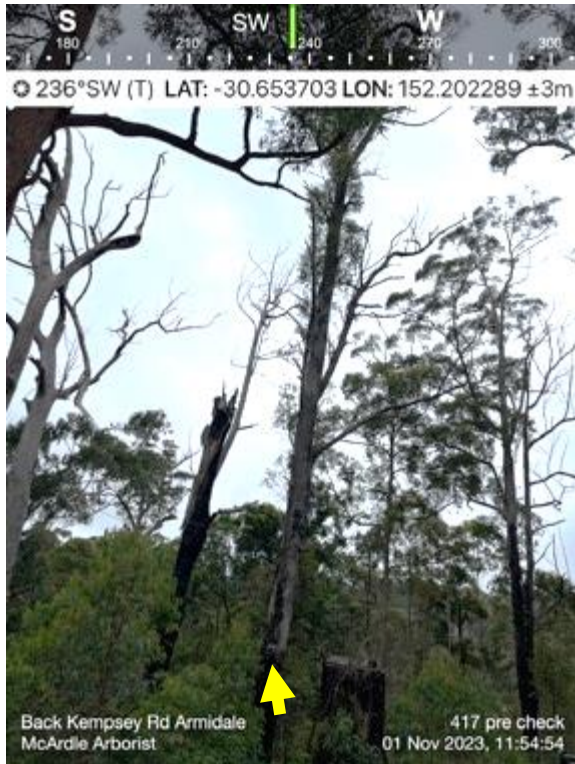
Plate 129: Tree 417, *Eucalyptus caliginosa*, Prune dead wood.

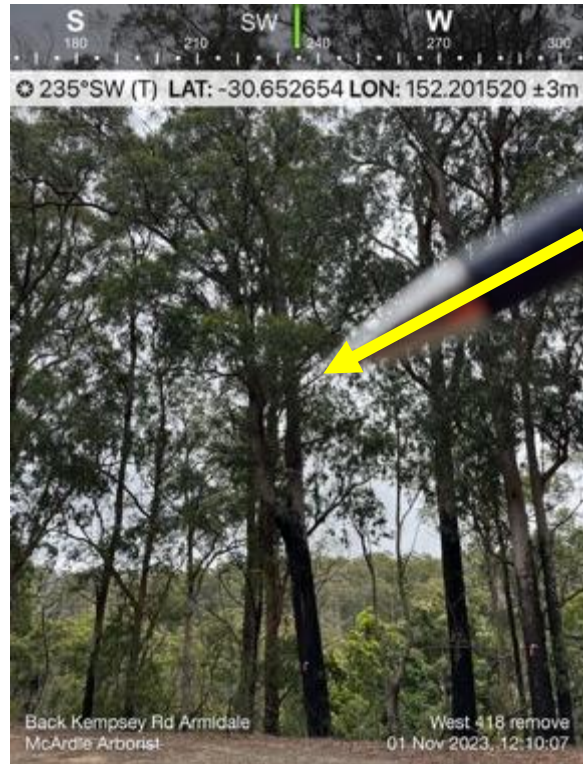
Plate 130: Tree 418, *Eucalyptus caliginosa*, Remove. Yellow arrow.

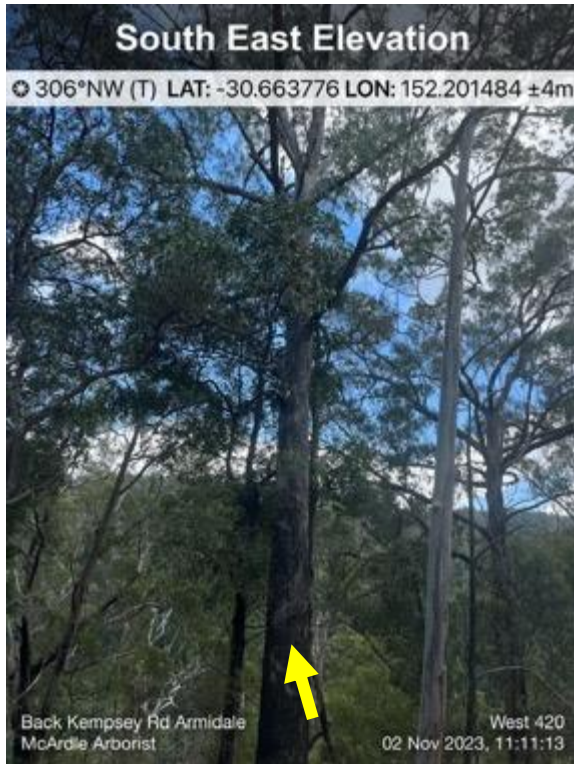
Plate 133: Tree 420, *Eucalyptus caliginosa*. Prune dead wood at 14, 16 and 12 meters.

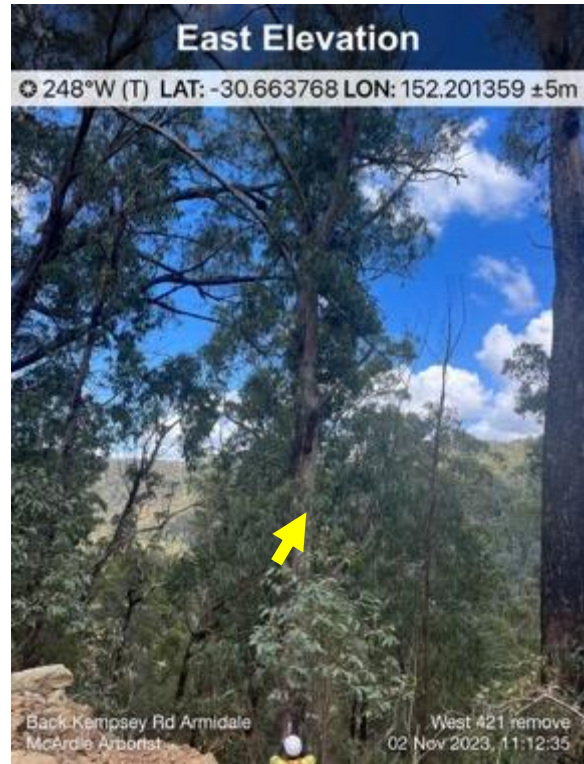
Plate 134: Tree 421, *Eucalyptus caliginosa*. Remove or prune canopy by 50%.

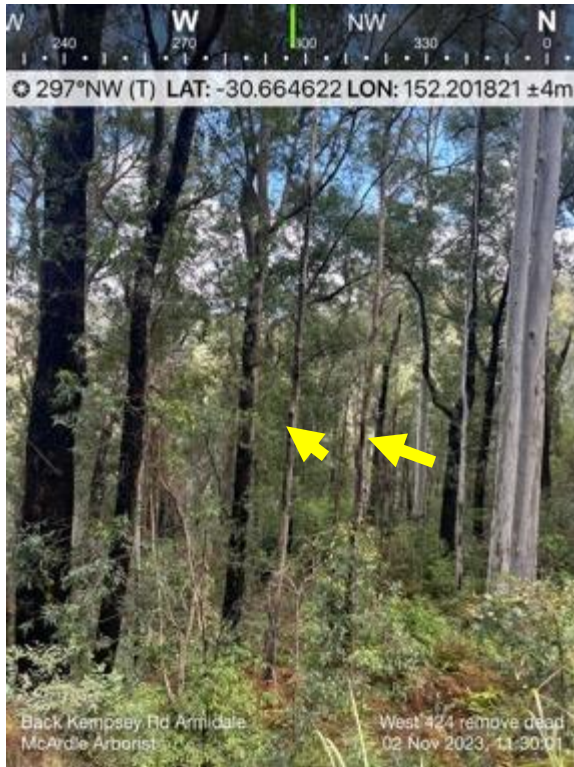
Plate 137: Tree 424, Dead stag, Remove.

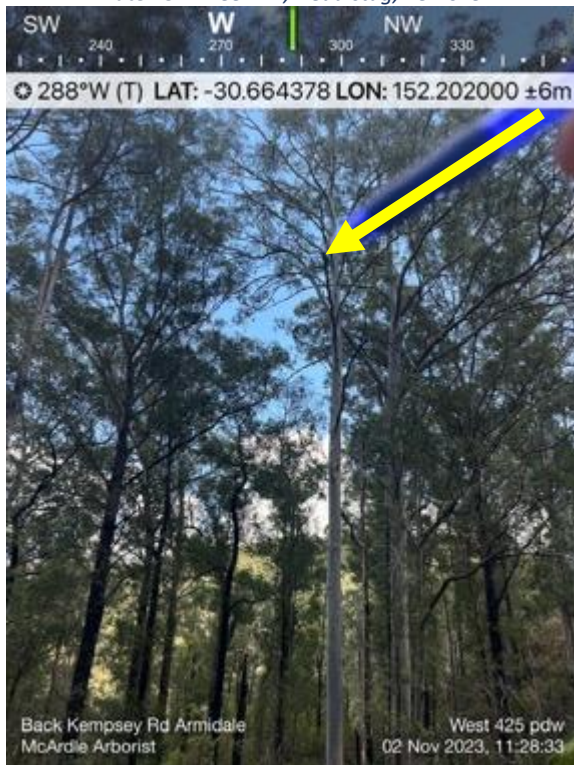
Plate 139: Tree 425, *Eucalyptus saligna*, Prune dead wood at 20 and 25 meters. Yellow arrow.

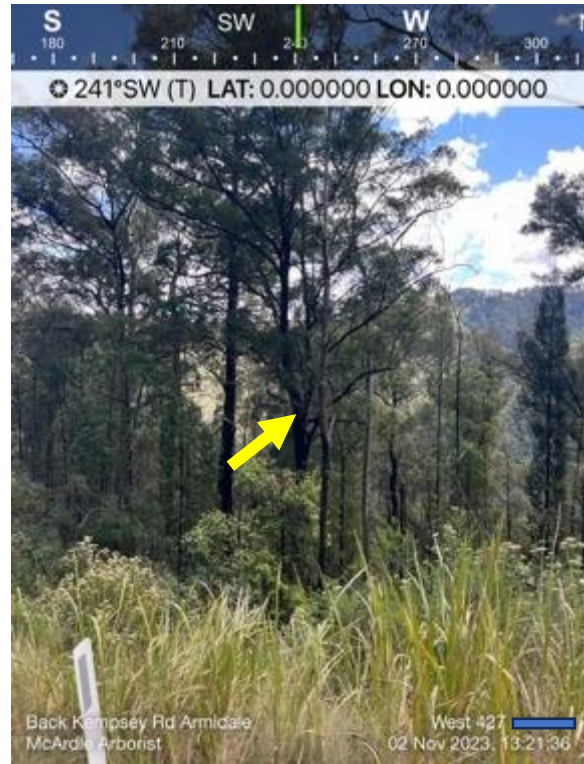
Plate 142: Tree 427, *Eucalyptus robusta*, Prune dead wood over bank.

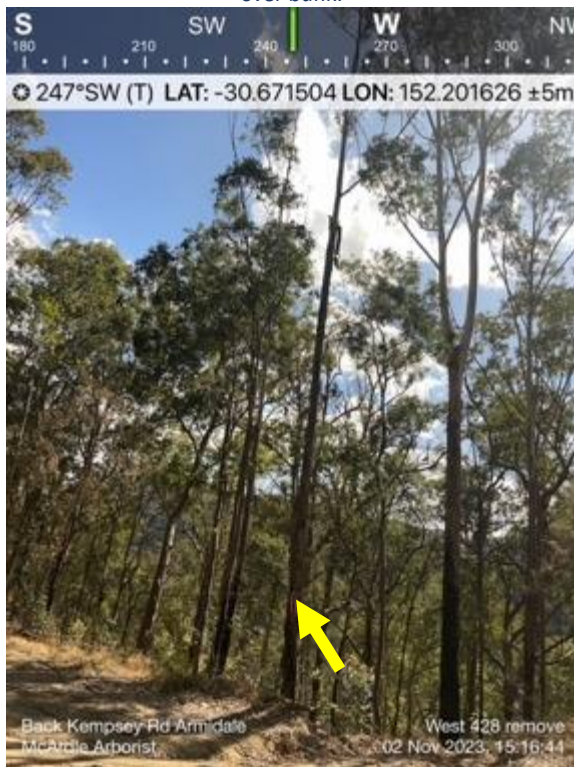
Plate 143: Tree 428, Dead stag, Remove.

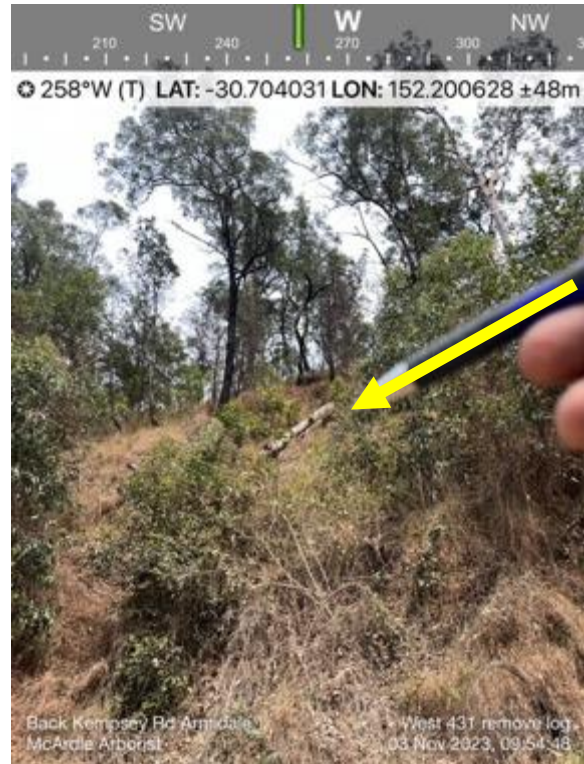
Plate 146: Tree 431, log, Remove. Yellow arrow.

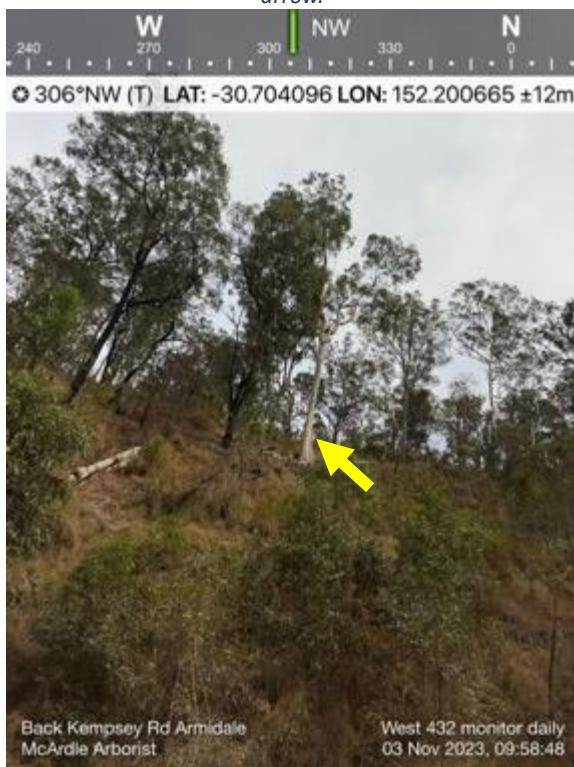
Plate 147: Tree 432, *Corymbia maculata*, Monitor.

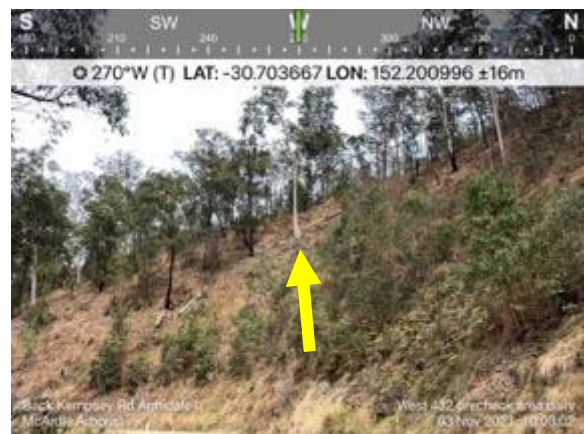
Plate 148: Tree 432, *Corymbia maculata*, Monitor.

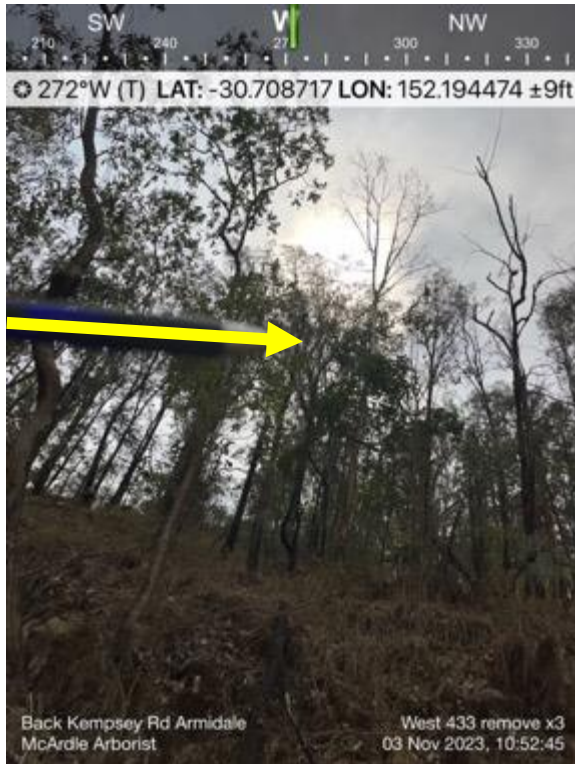
Plate 149: Tree 433, Dead stag, Remove. Yellow arrow.

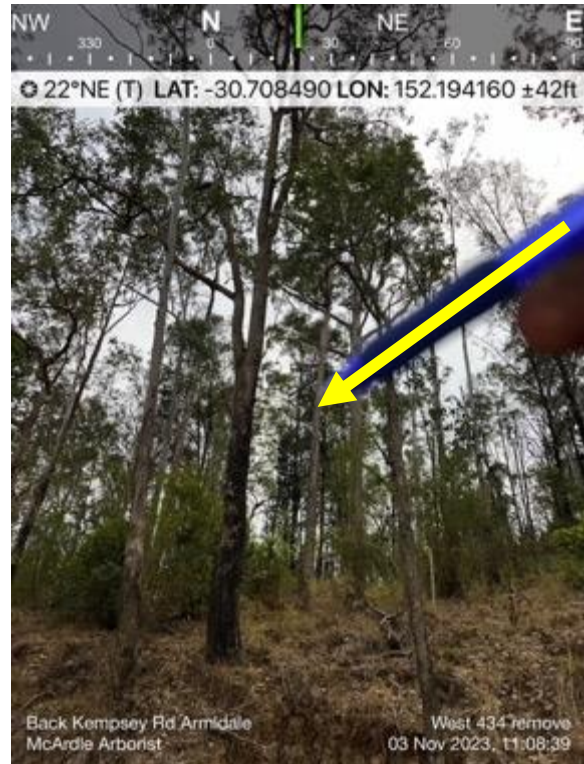
Plate 150: Tree 434, Dead stag, Remove. Yellow arrow.

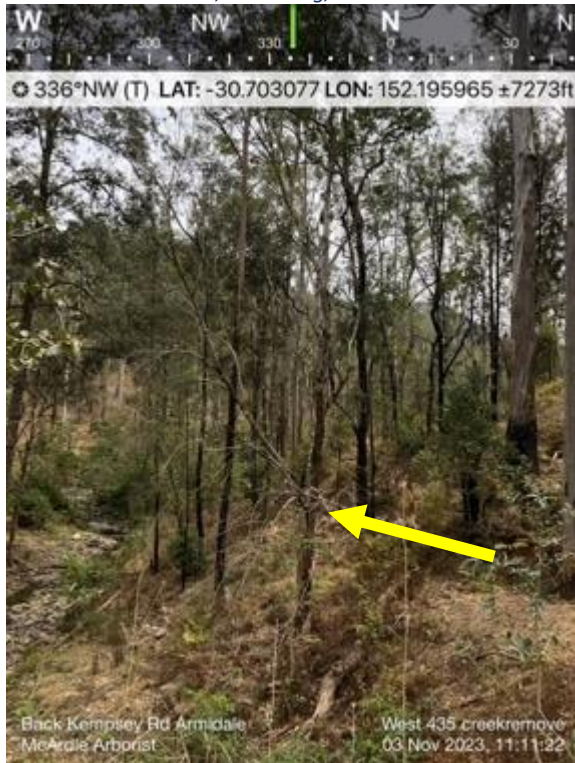
Plate 151: Tree 435, Dead stag, Remove.

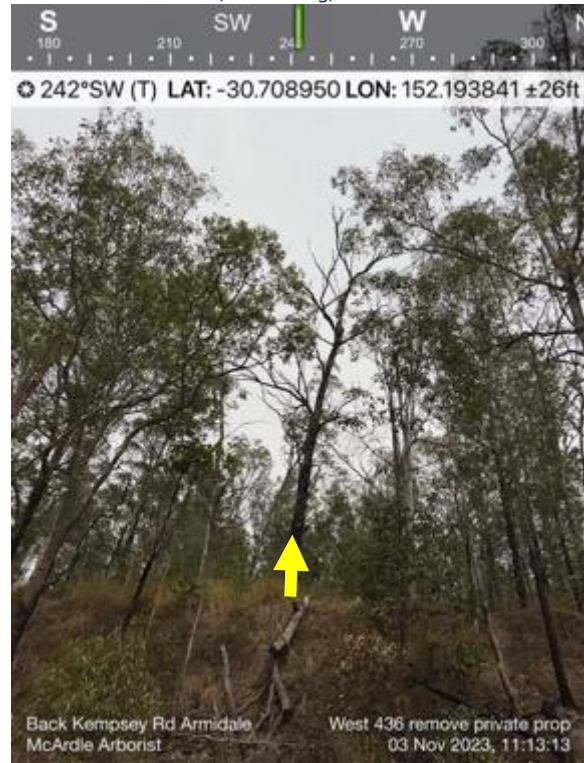
Plate 152: Tree 436, Dead stag, Remove.

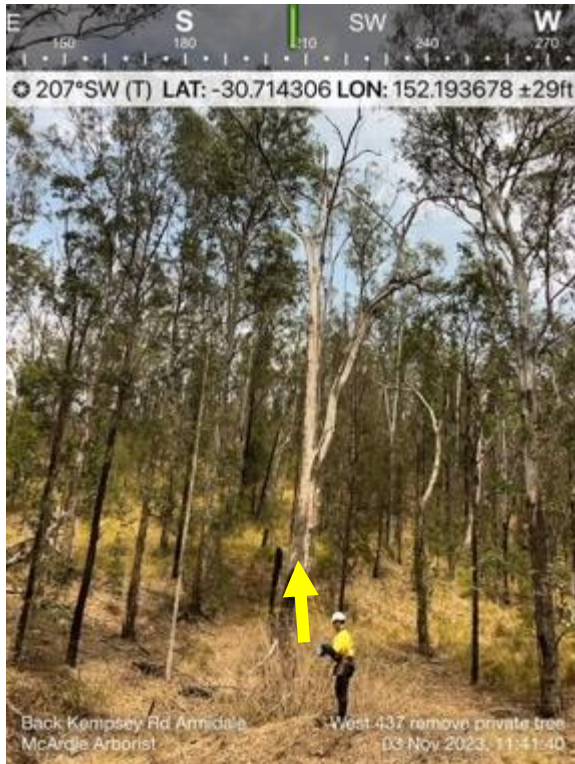
Plate 153: Tree 437, Dead stag, Remove with consent.

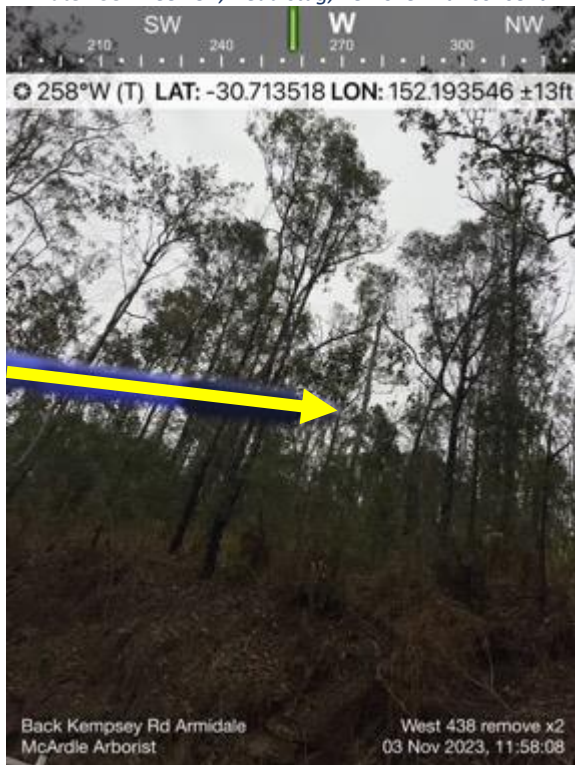
Plate 155: Tree 438, Dead stag, Remove. Yellow arrow.
