**Housing Authority of the City of Aurora  
REQUEST FOR QUALIFICATIONS NO. RFQ20261008  
ARCHITECTURAL DESIGN SERVICES**

**PROPERTY CONDITION REPORT  
TROLLEY PARK  
1445 DALLAS STREET  
AURORA, COLORADO 80010**

**D3G PROJECT NUMBER:  
2023-1793**

Property: Trolley Park  
1445 Dallas Street  
Aurora, Colorado 80010

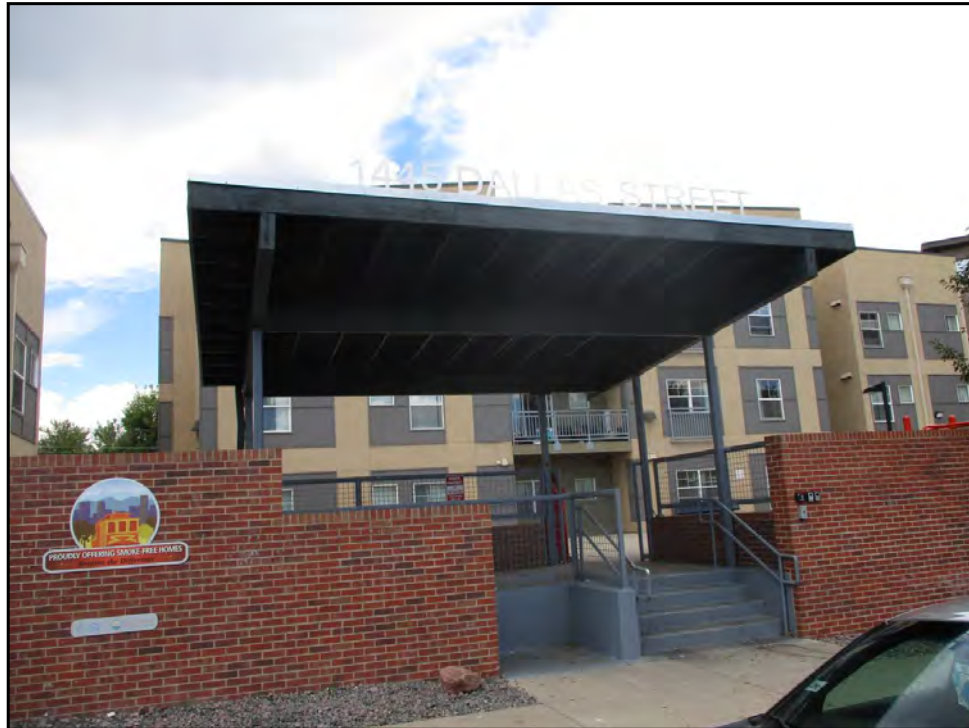
1: Primary pedestrian entrance

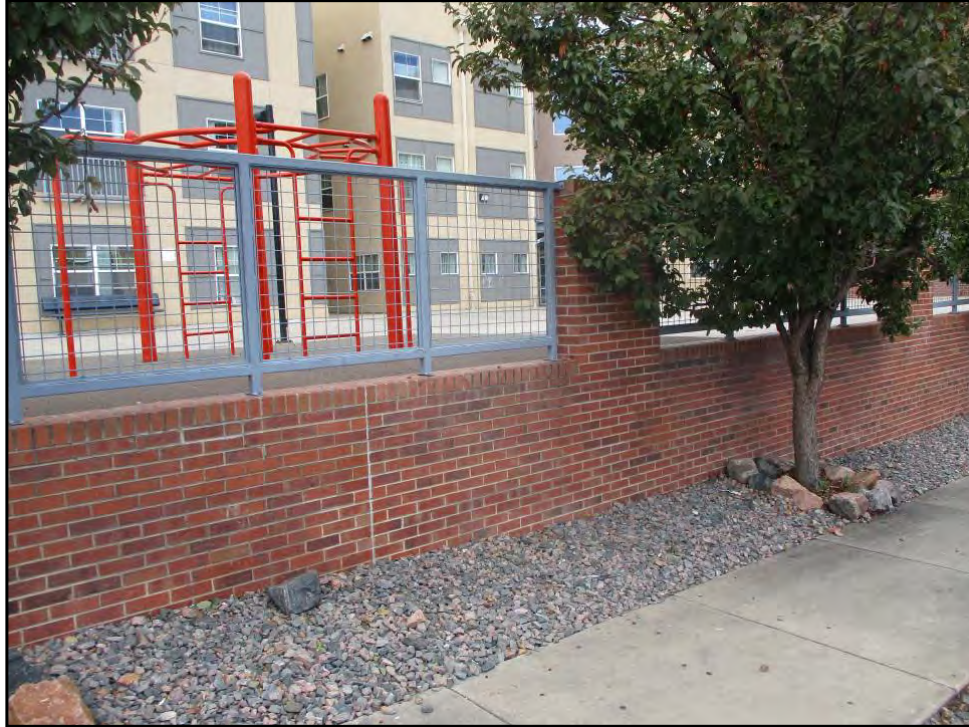
3: Site profile

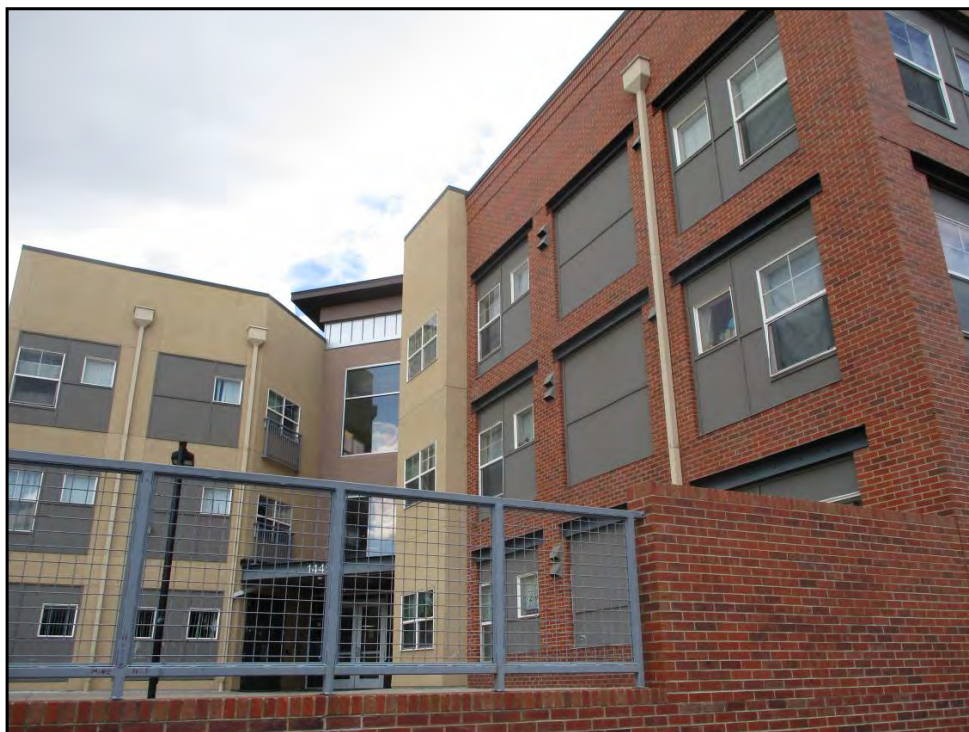
4: Building and site profile

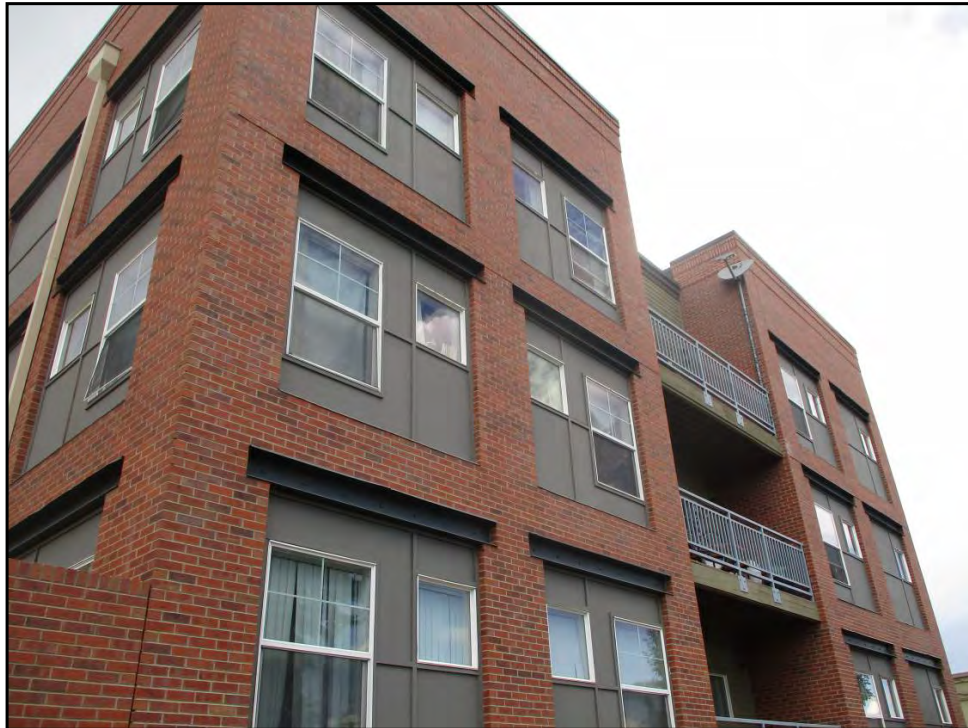
5: Building and site profile

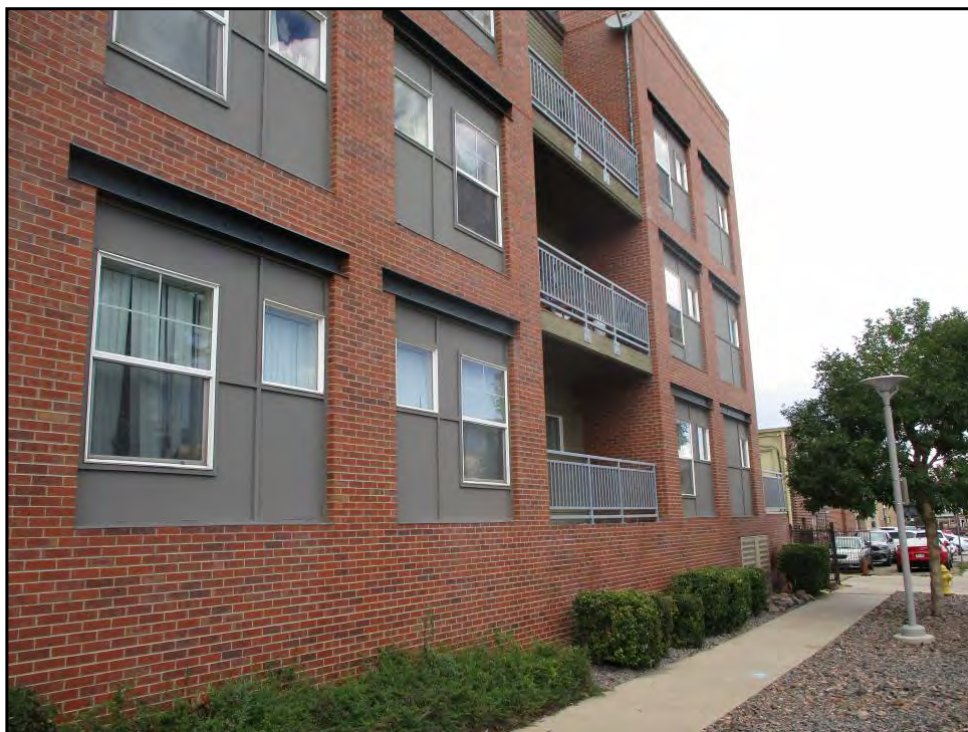
6: Building and site profile

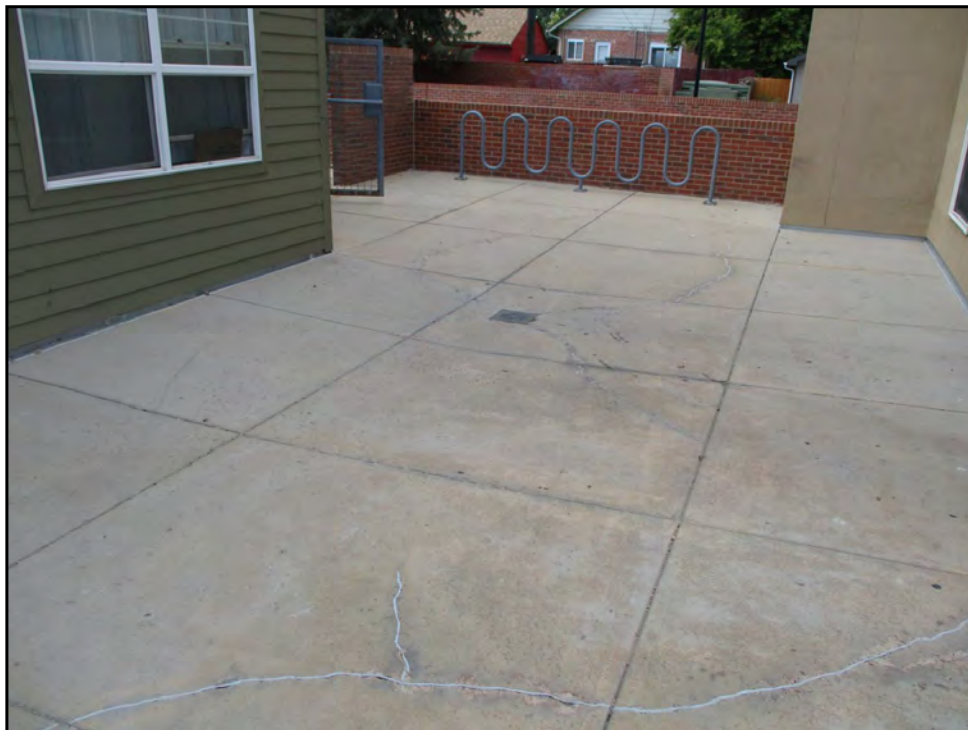
8: Courtyard area

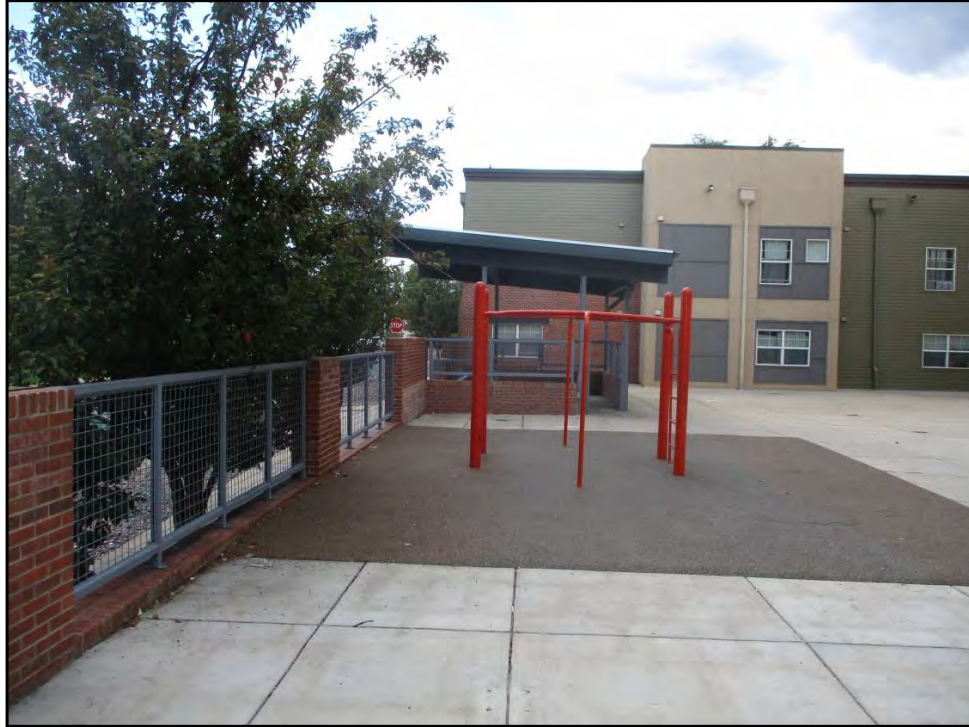
9: Courtyard area

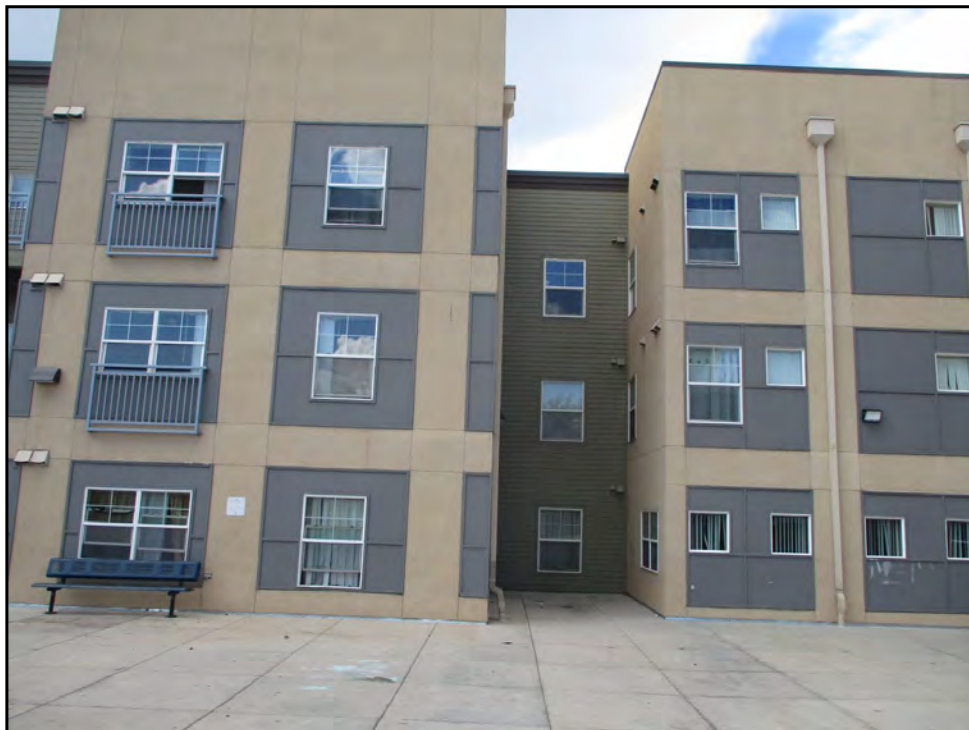
10: Building and site profile

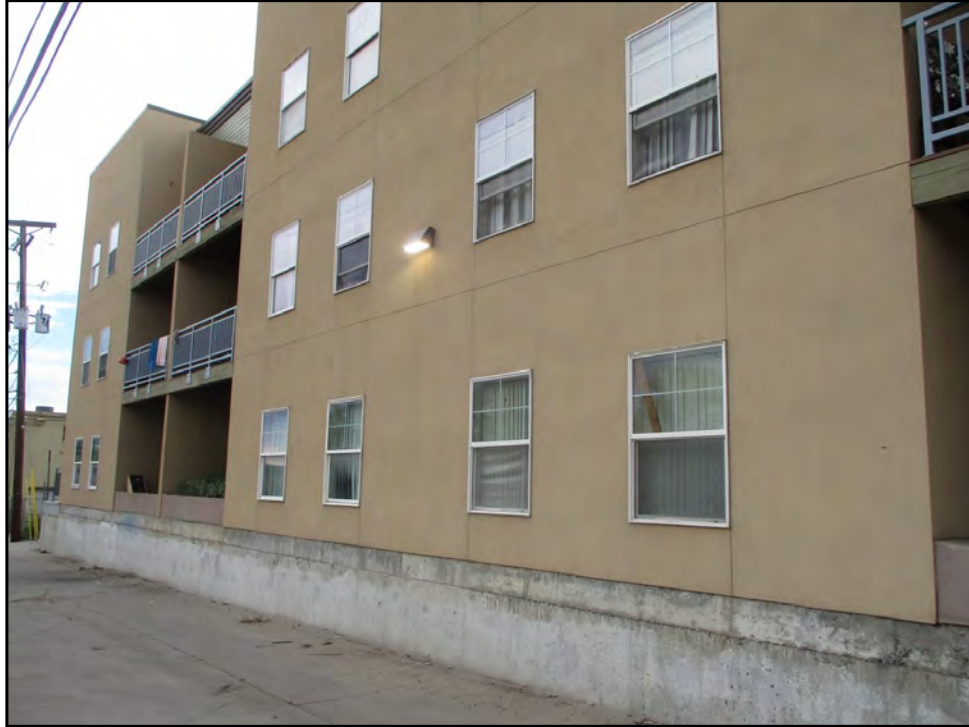
11: Building and site profile

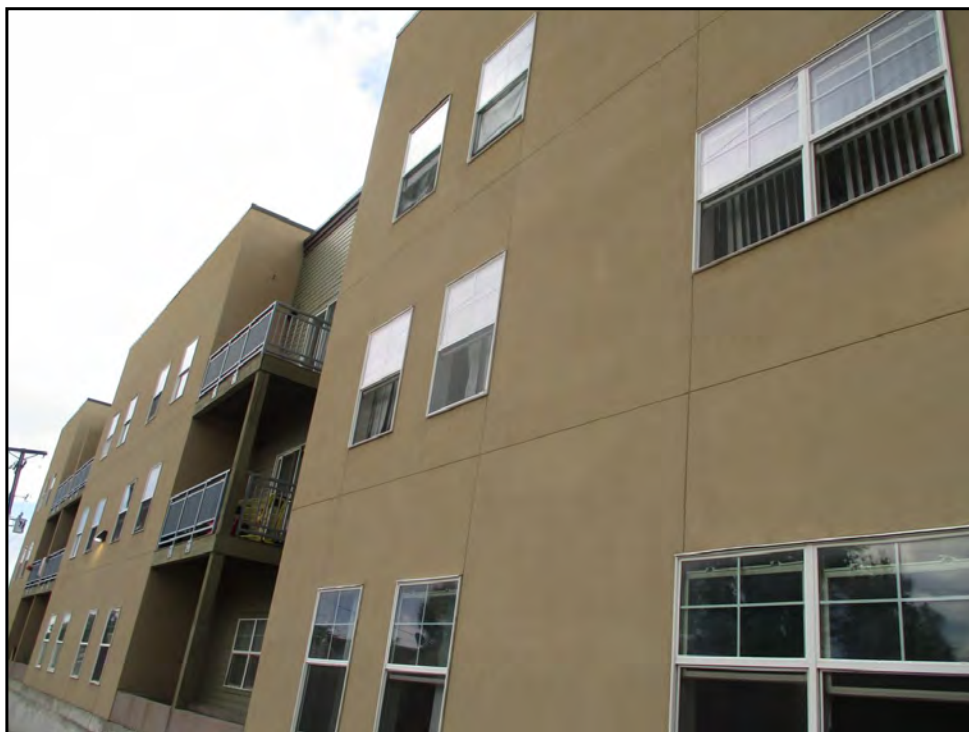
12: Building and site profile

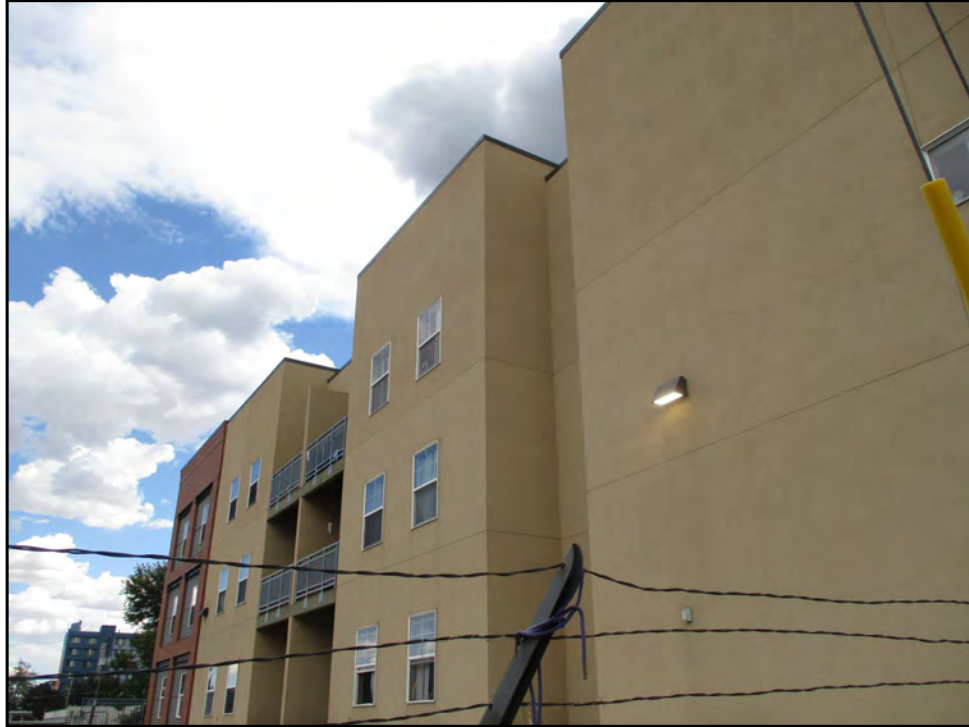
13: Building and site profile

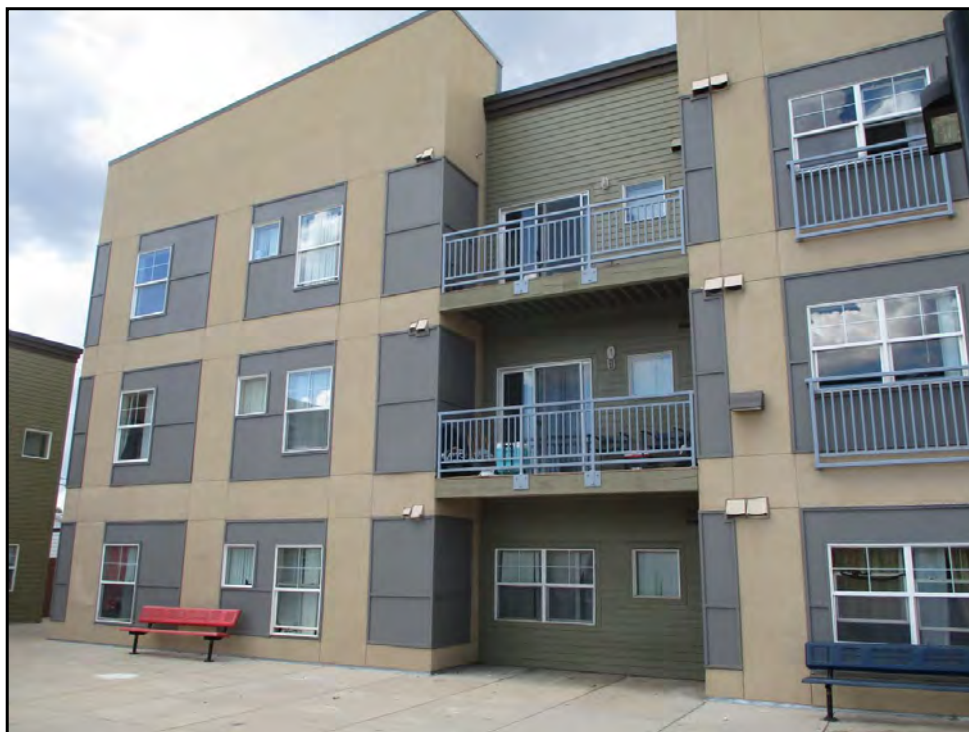
14: Building and site profile

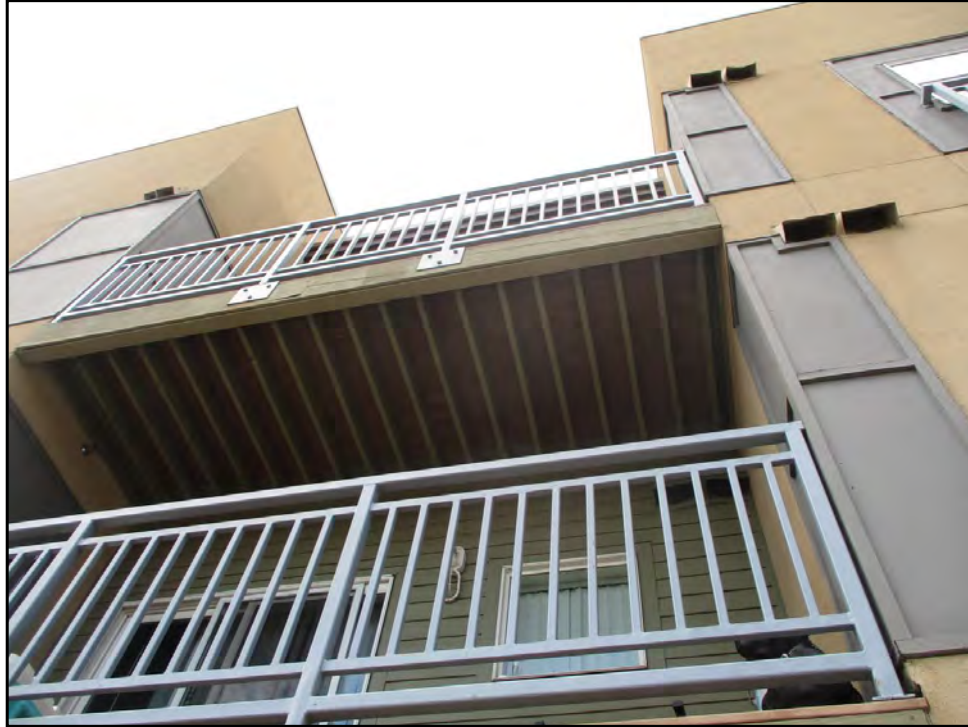
15: Balcony assembly

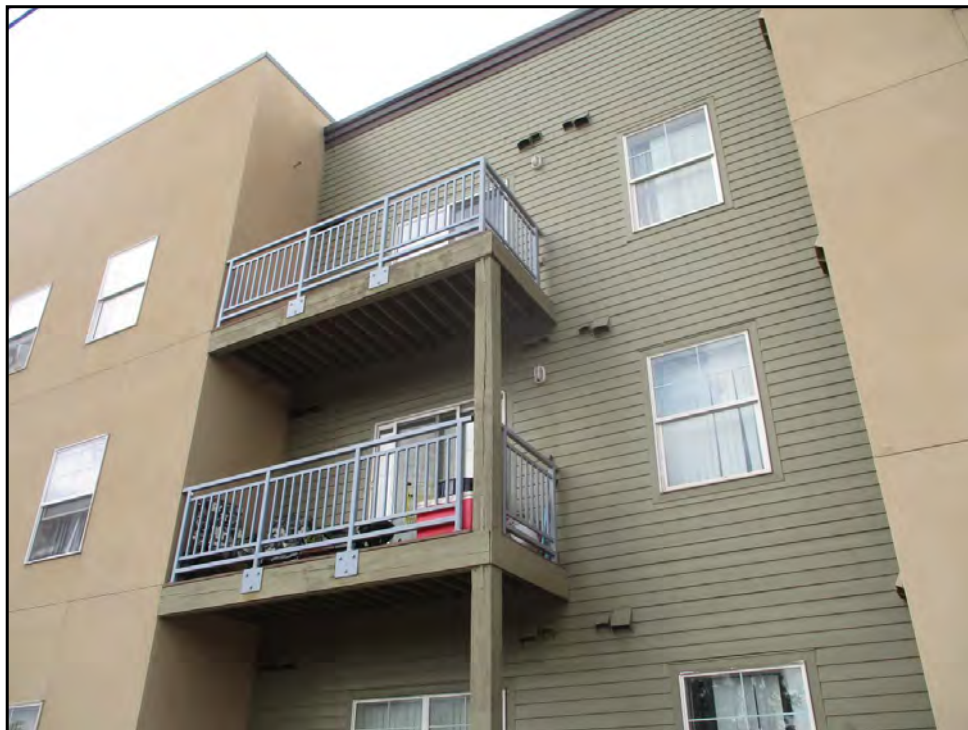
16: Additional balcony assembly

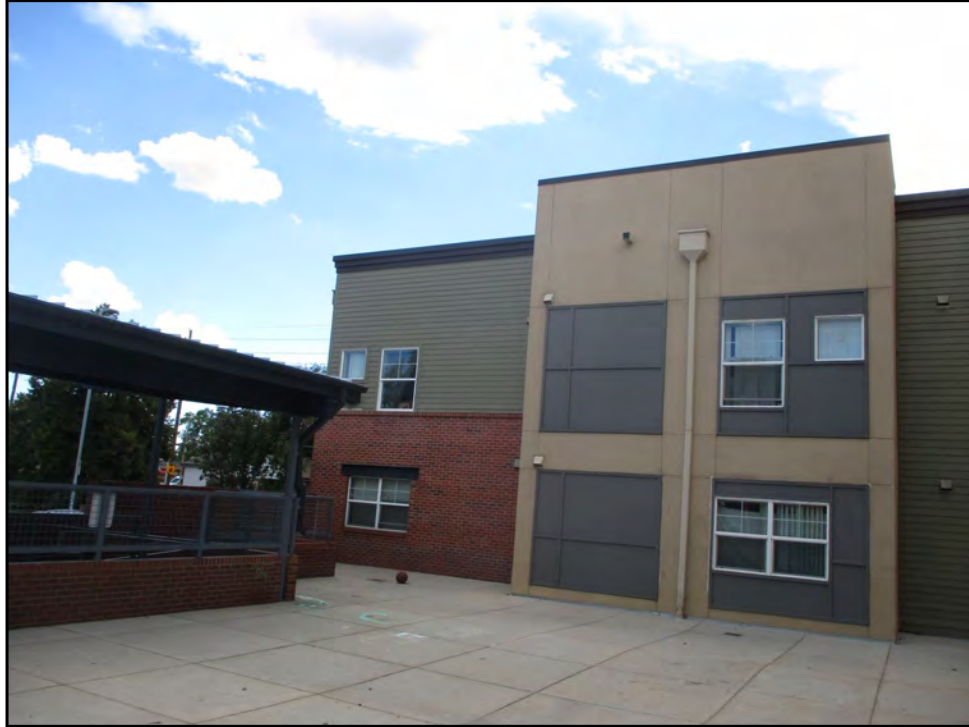
17: Building and site profile

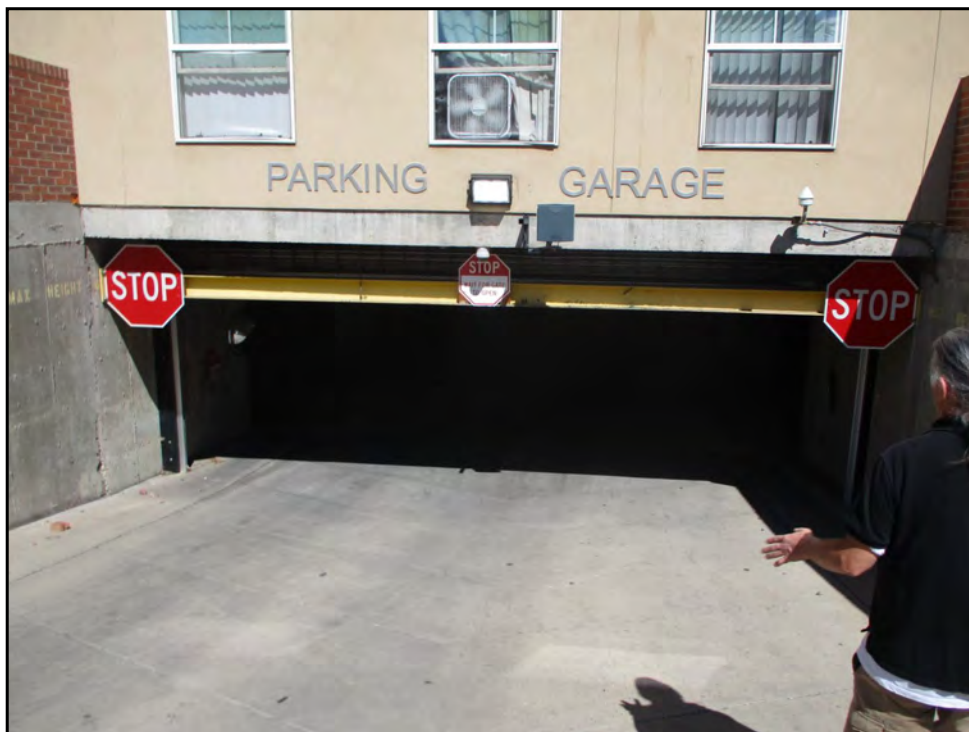
18: Parking garage entrance

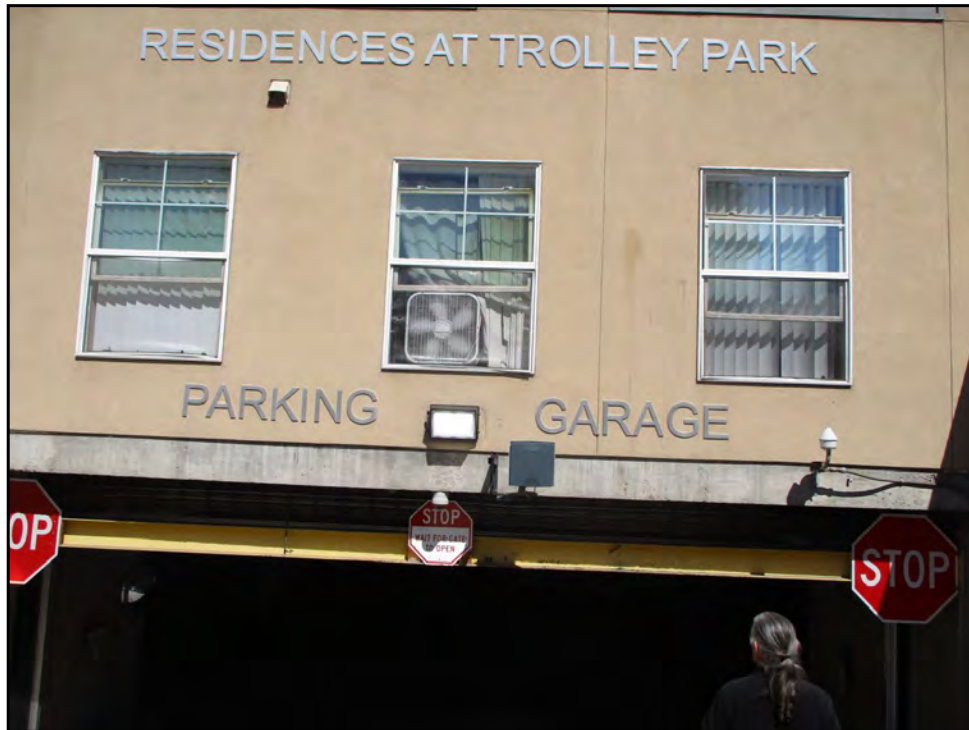
19: Building signage

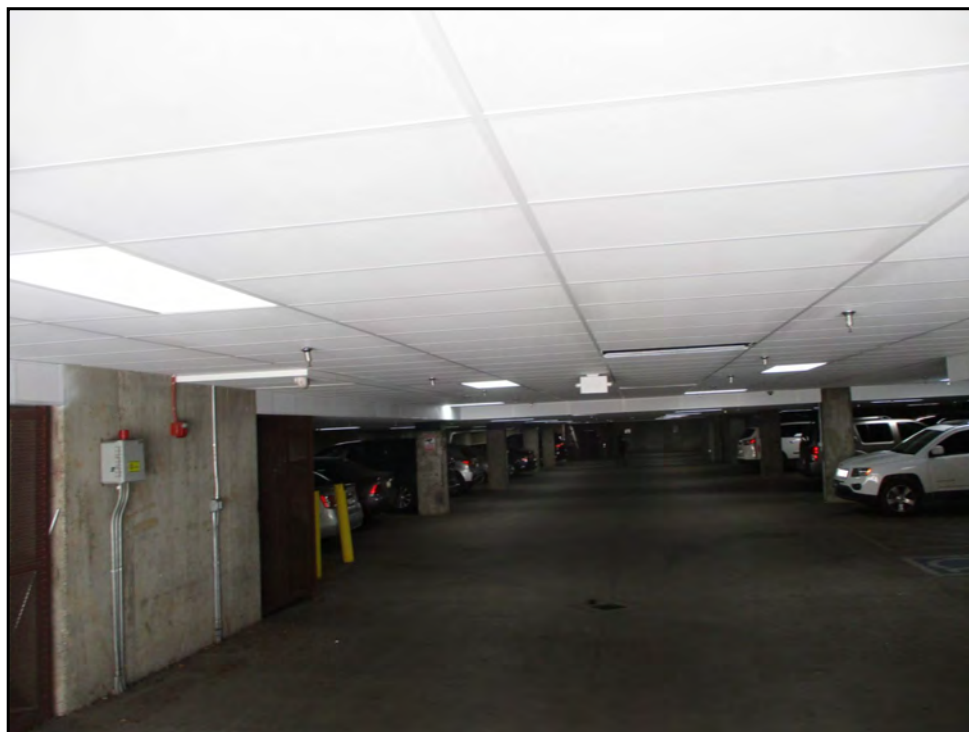
20: Parking garage

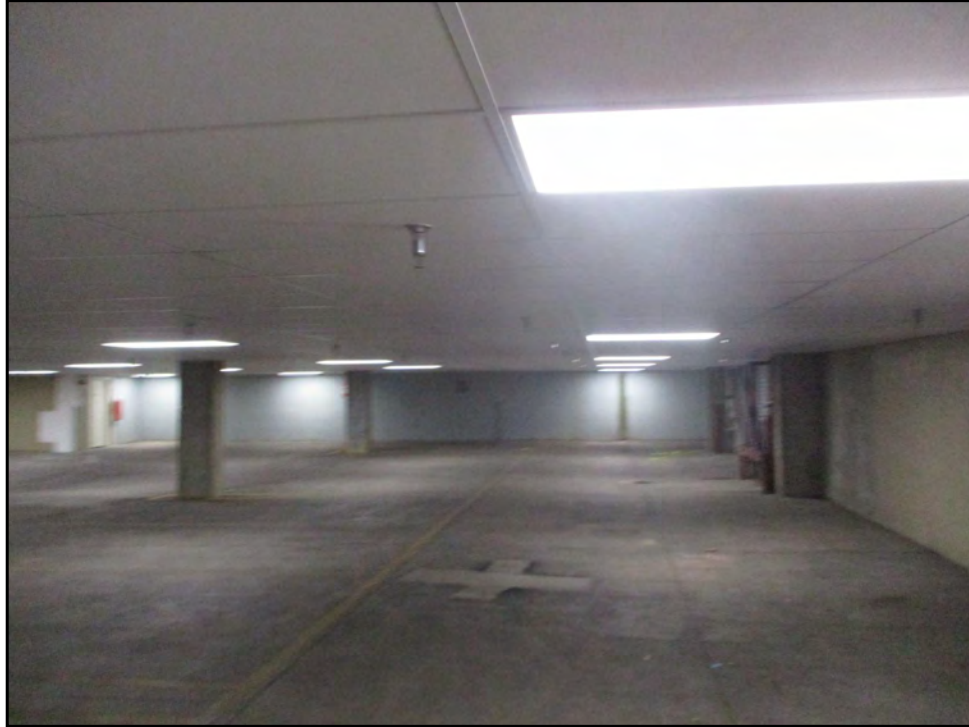
21: Parking garage

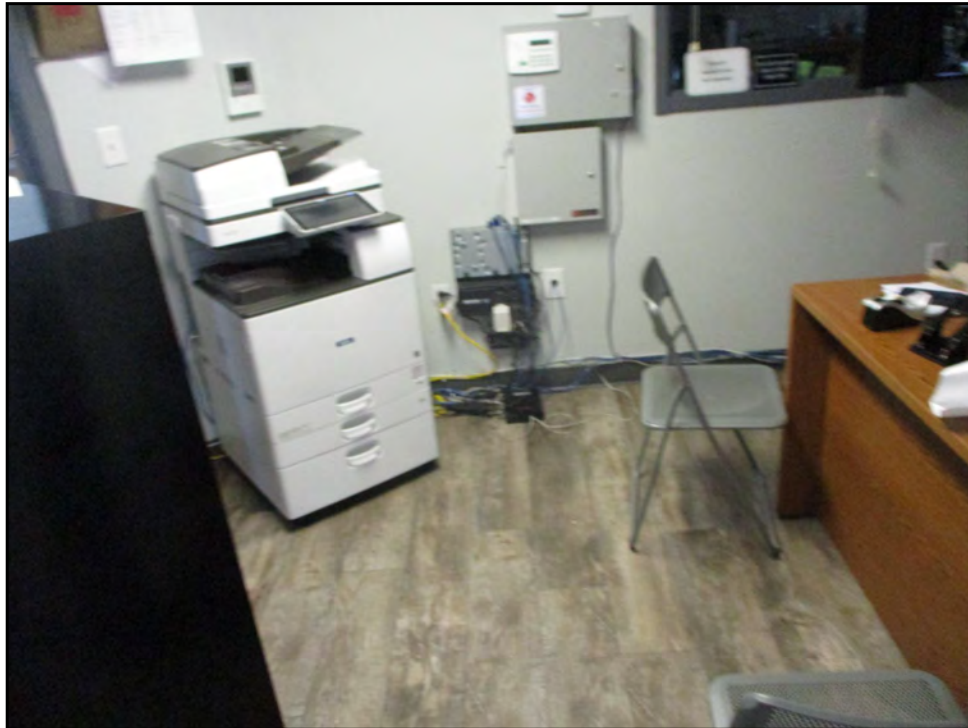
23: Leasing office

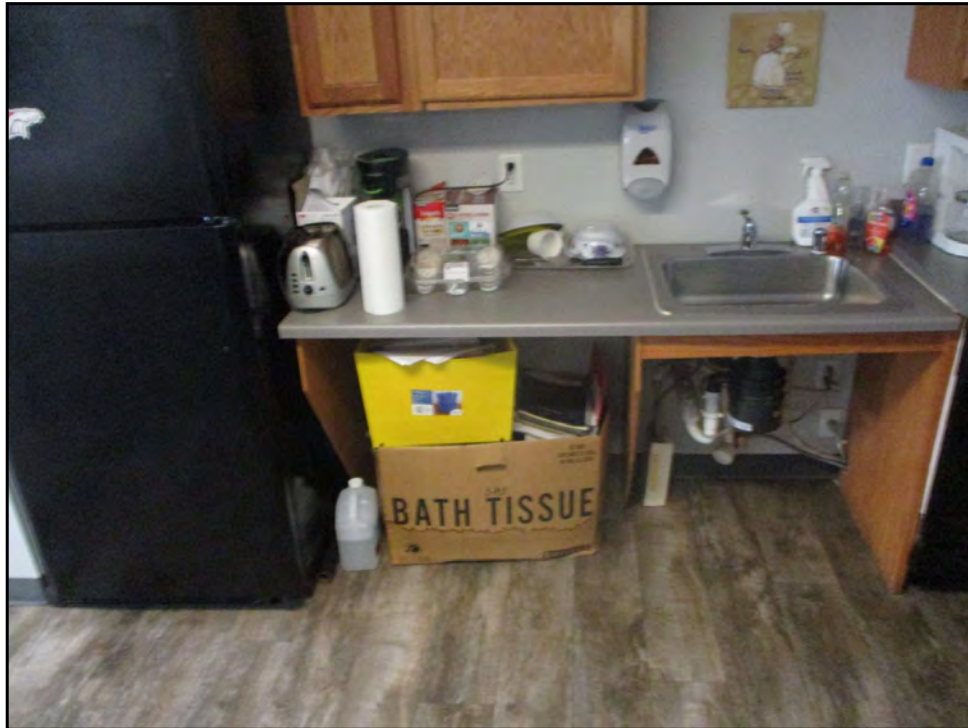
25: Community room common kitchen

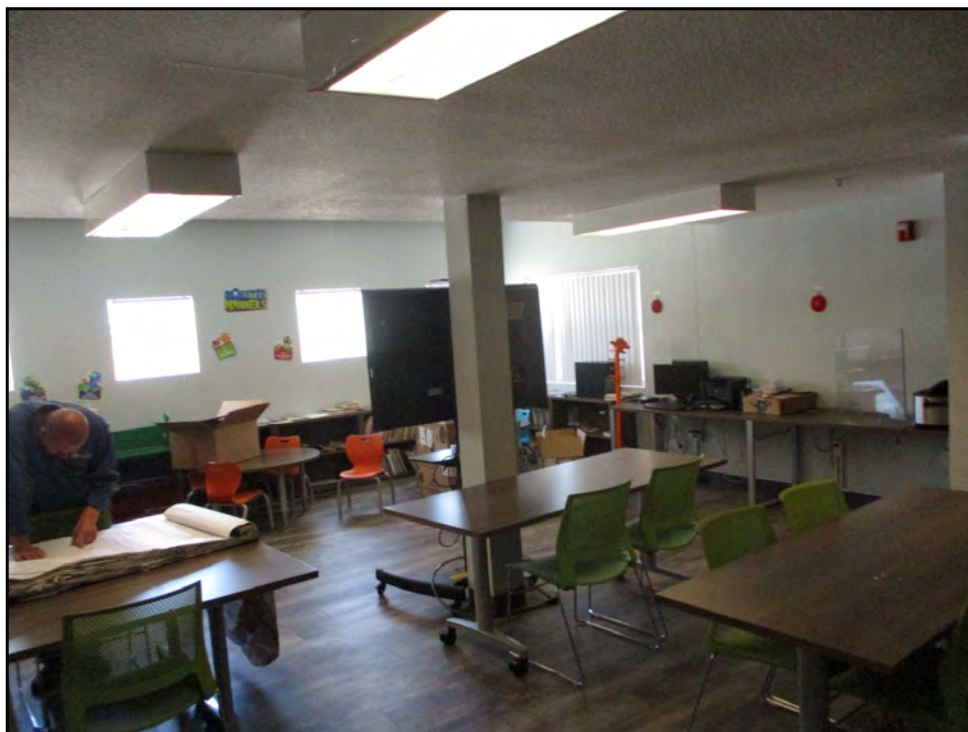
26: Community room

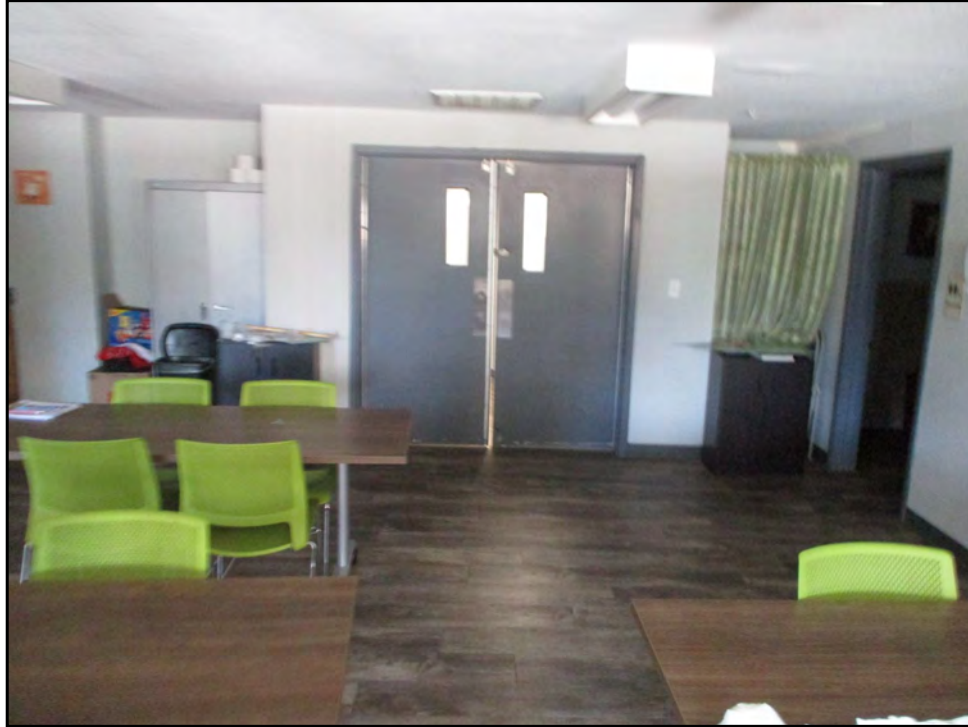
27: Community room

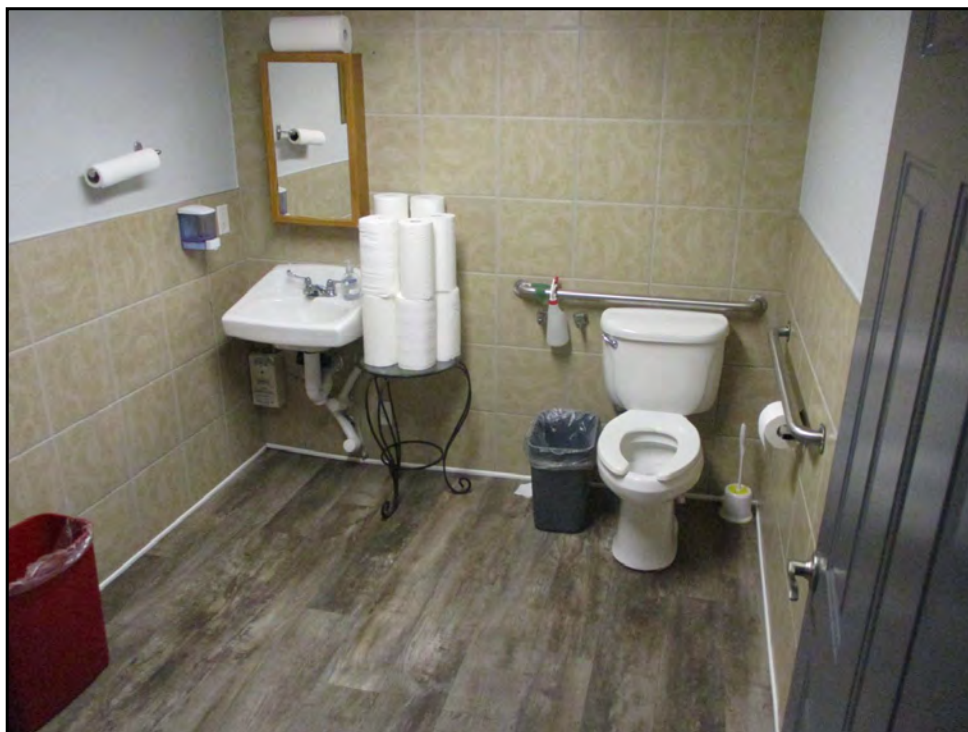
28: Common restroom within community room

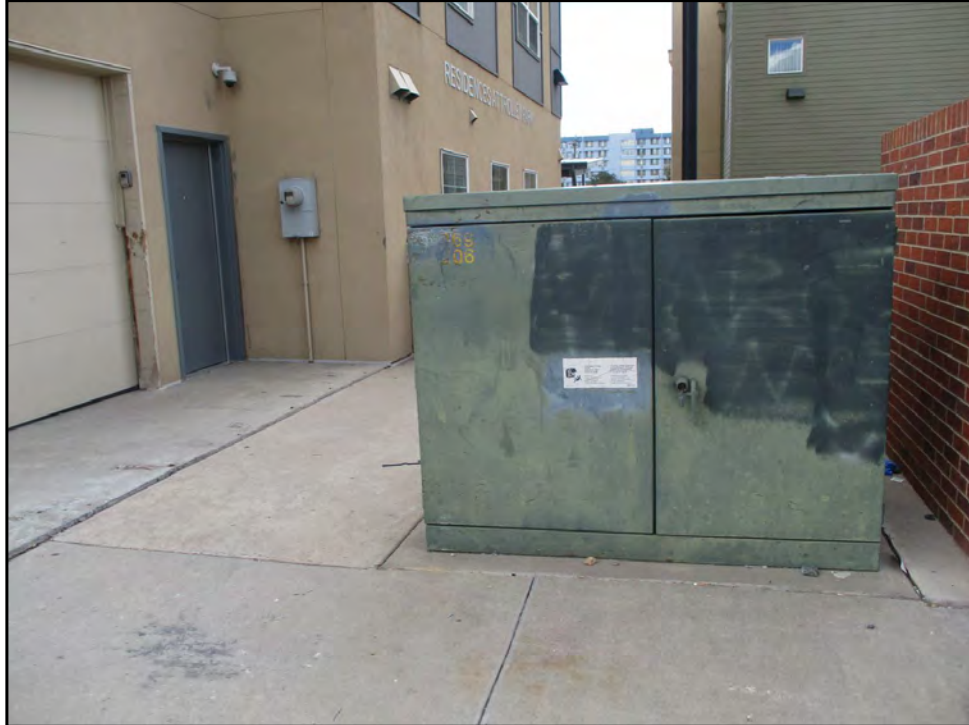
29: Building transformer

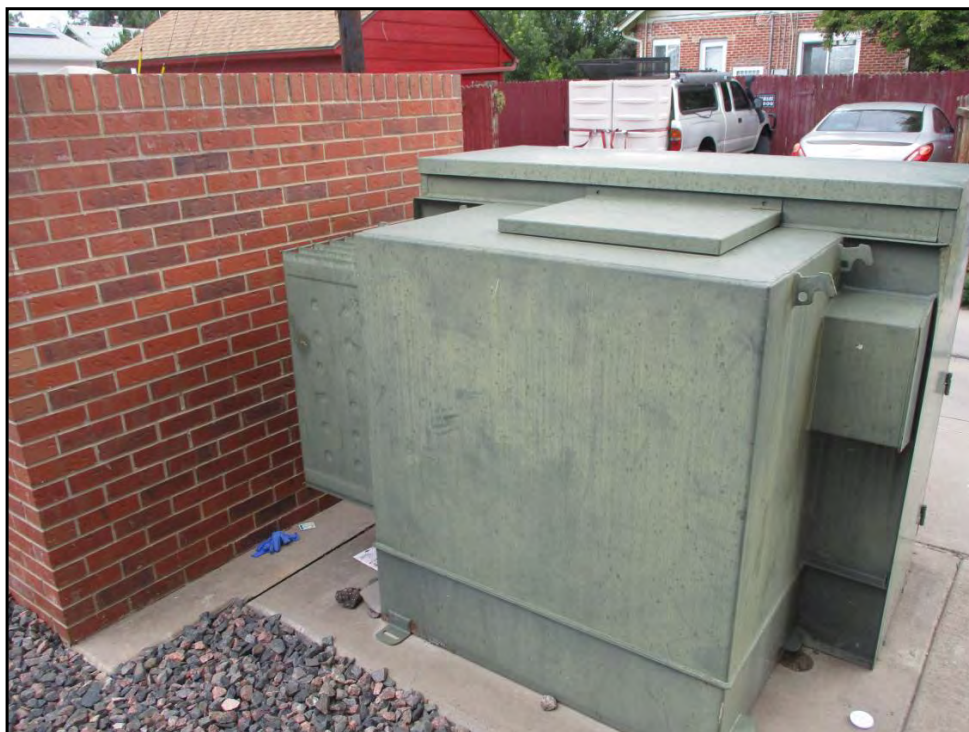
30: Building transformer

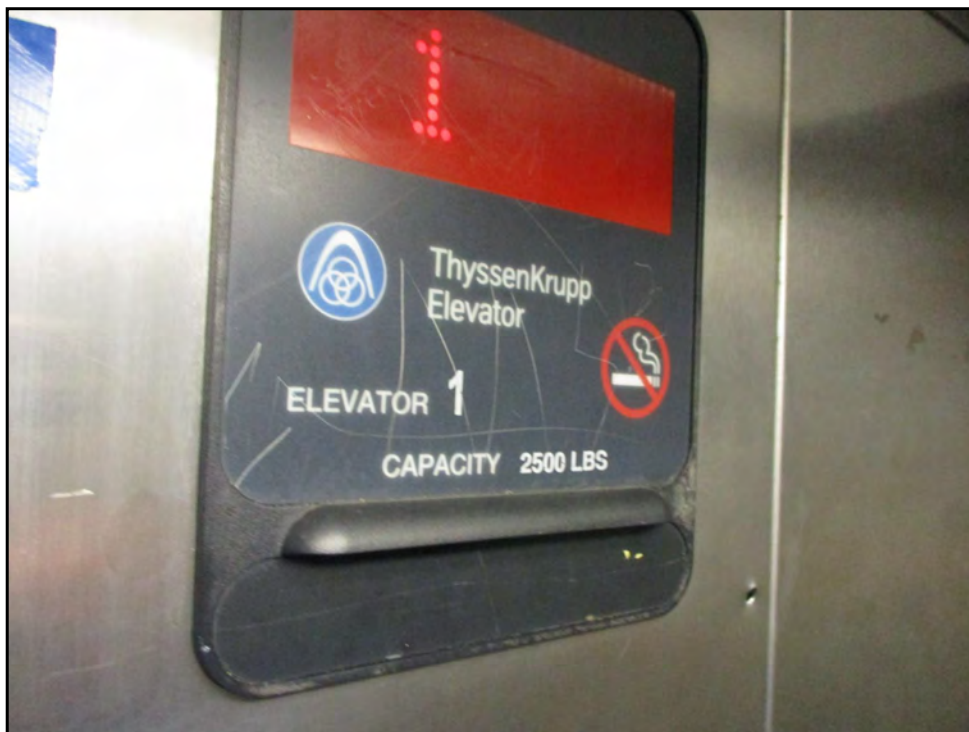
32: Elevator cab

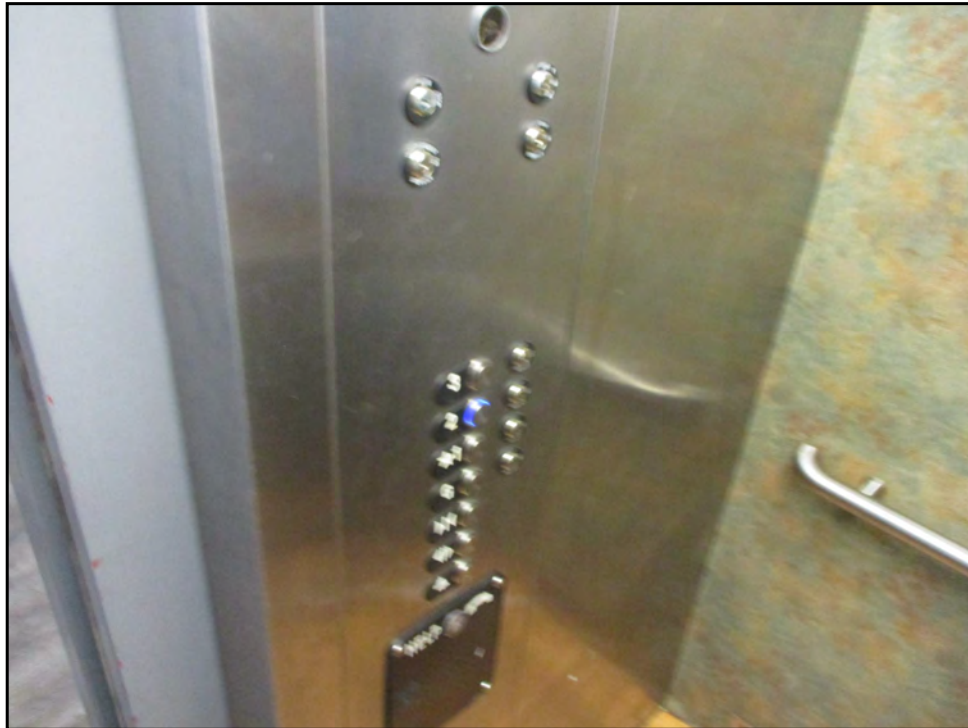
33: Elevator cab

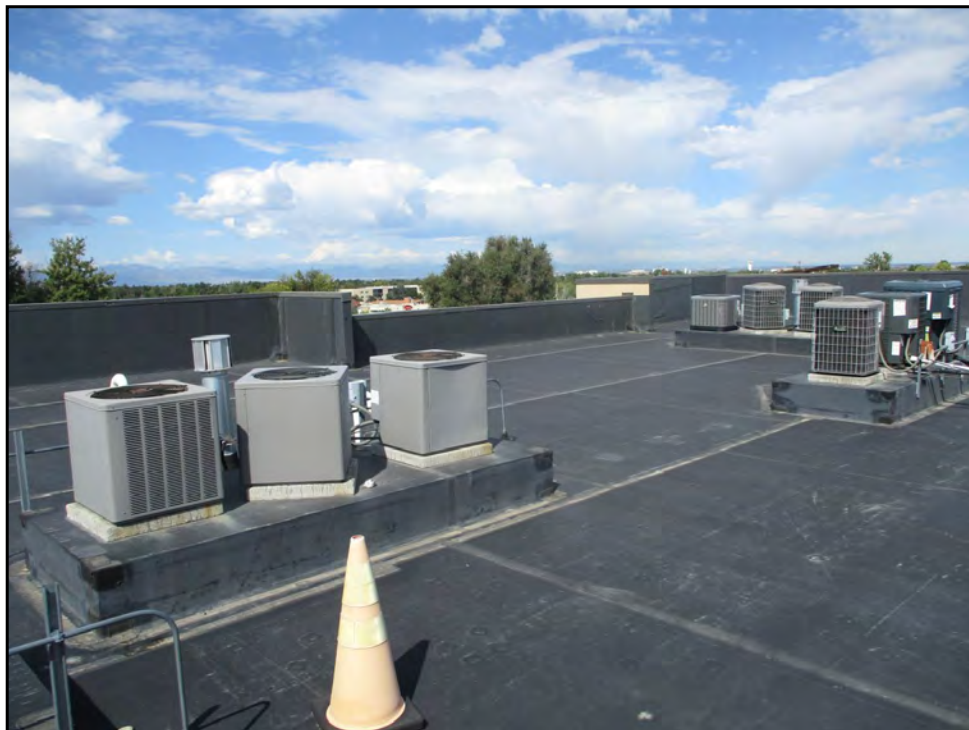
36: Roof profile and A/C equipment

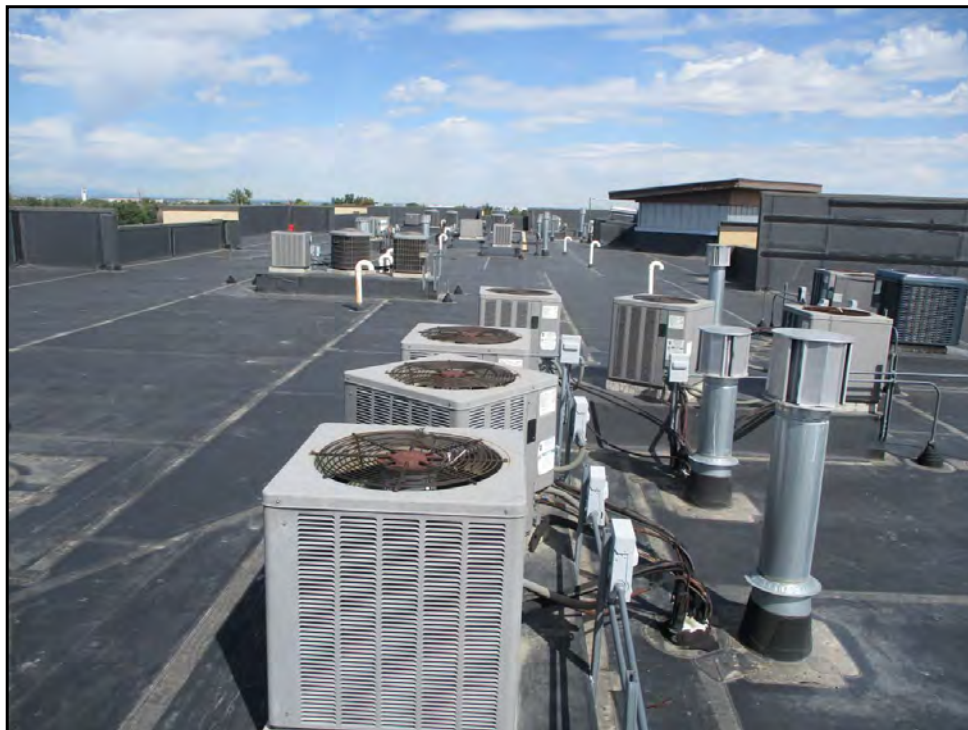
37: Roof profile and A/C equipment

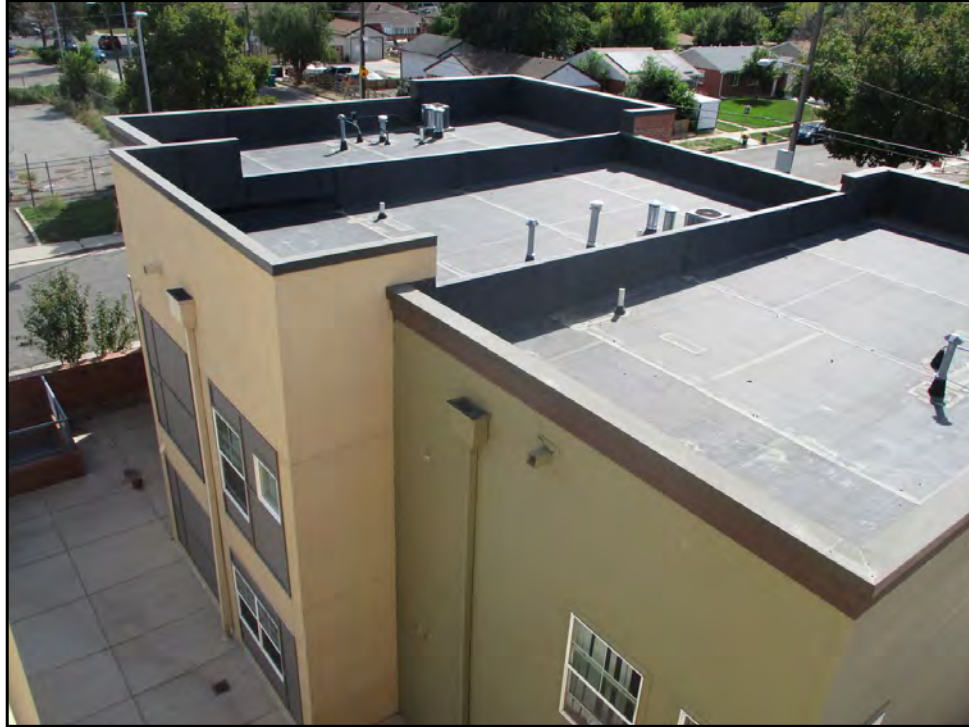
38: Roof profile and A/C equipment

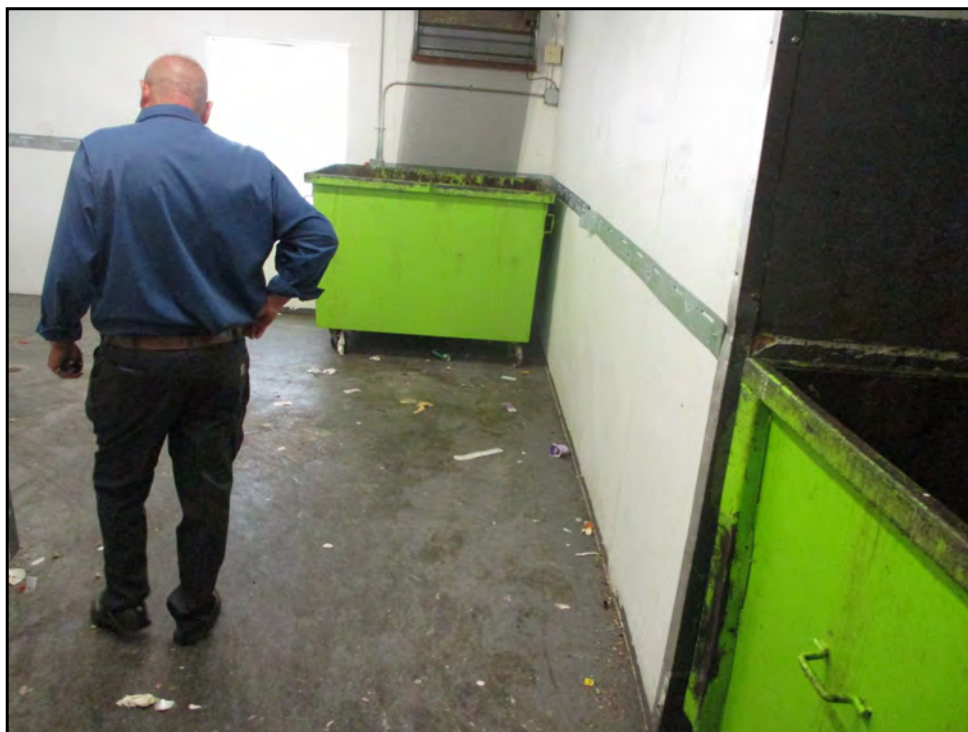
41: Trash room
