**Housing Authority of the City of Aurora  
REQUEST FOR QUALIFICATIONS NO. RFQ20261008  
ARCHITECTURAL DESIGN SERVICES**

**PROPERTY CONDITION REPORT  
TROLLEY PARK  
1445 DALLAS STREET  
AURORA, COLORADO 80010**

**D3G PROJECT NUMBER:  
2023-1793**

Property: Trolley Park  
1445 Dallas Street  
Aurora, Colorado 80010

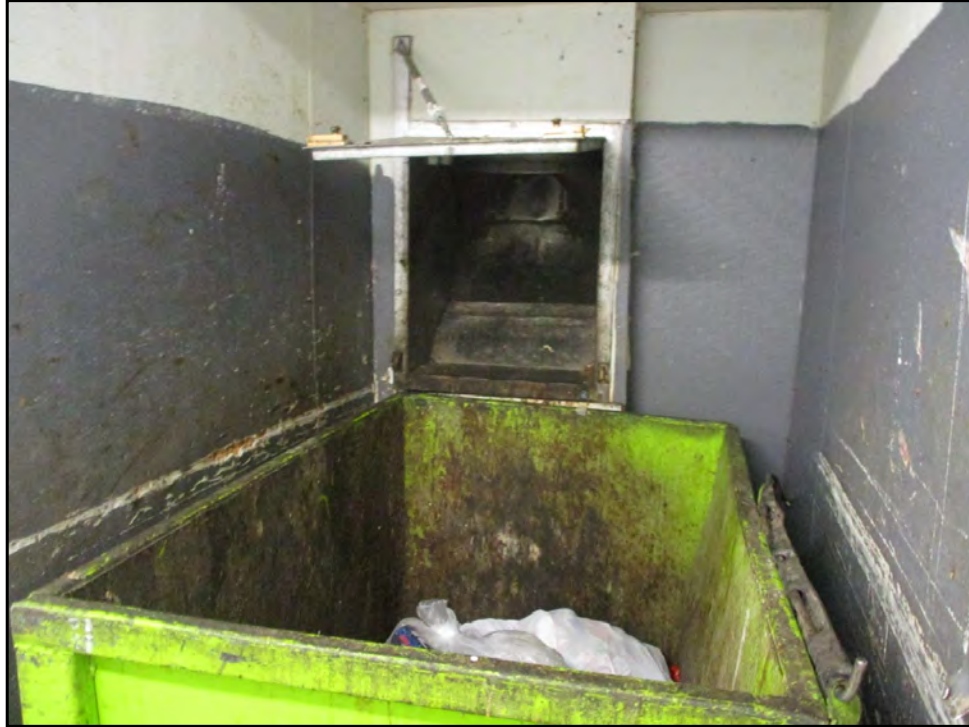
42: Trash room

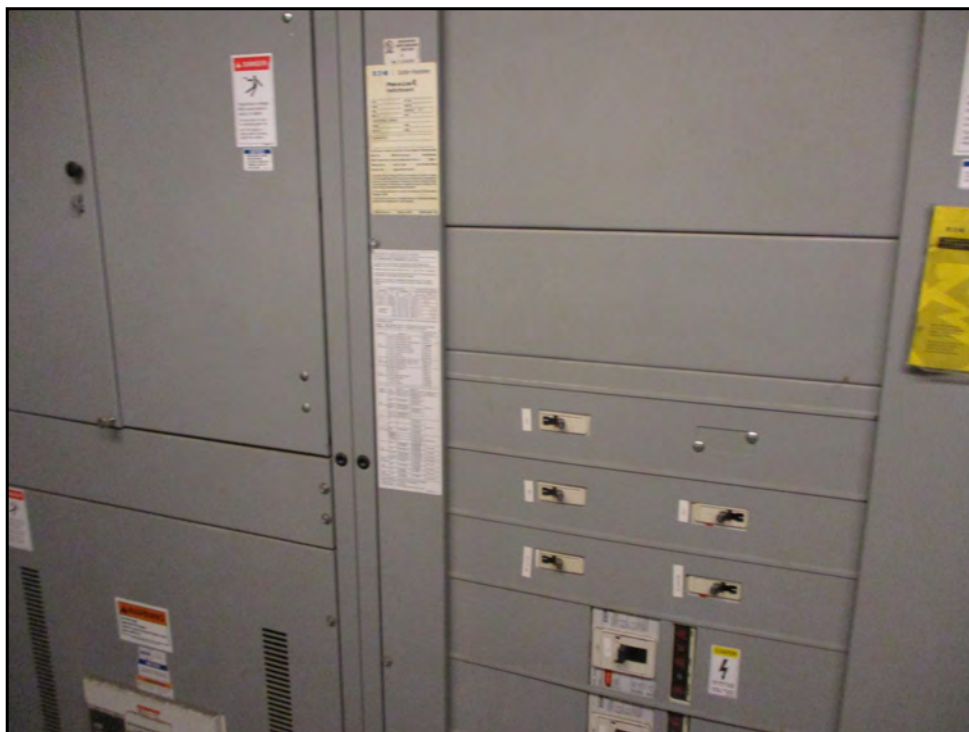
45: Main electrical equipment

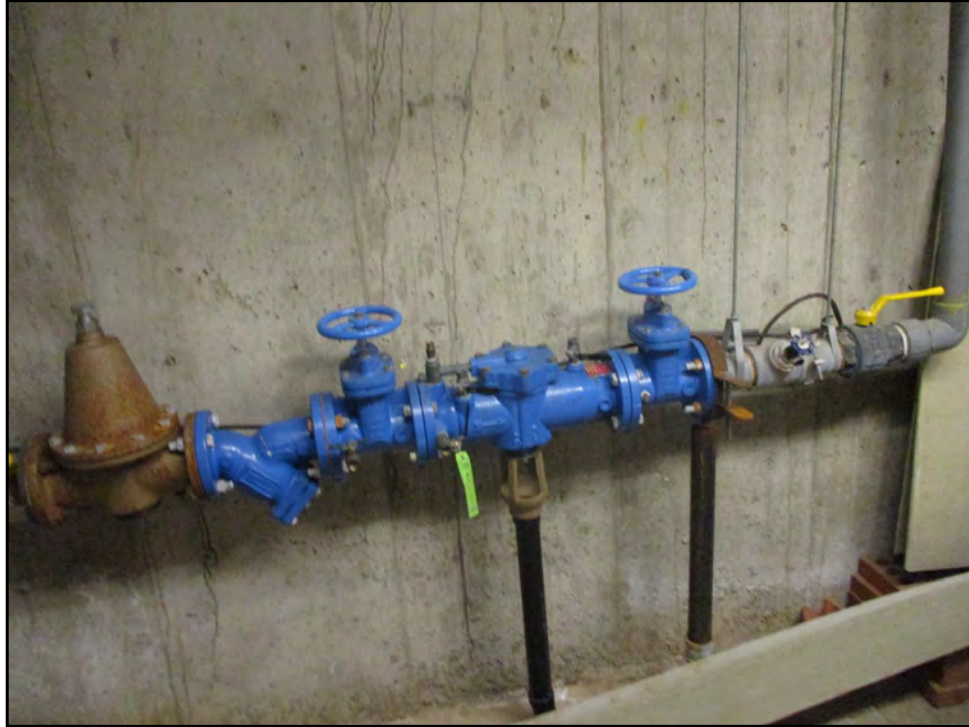
48: Fire sprinkler equipment

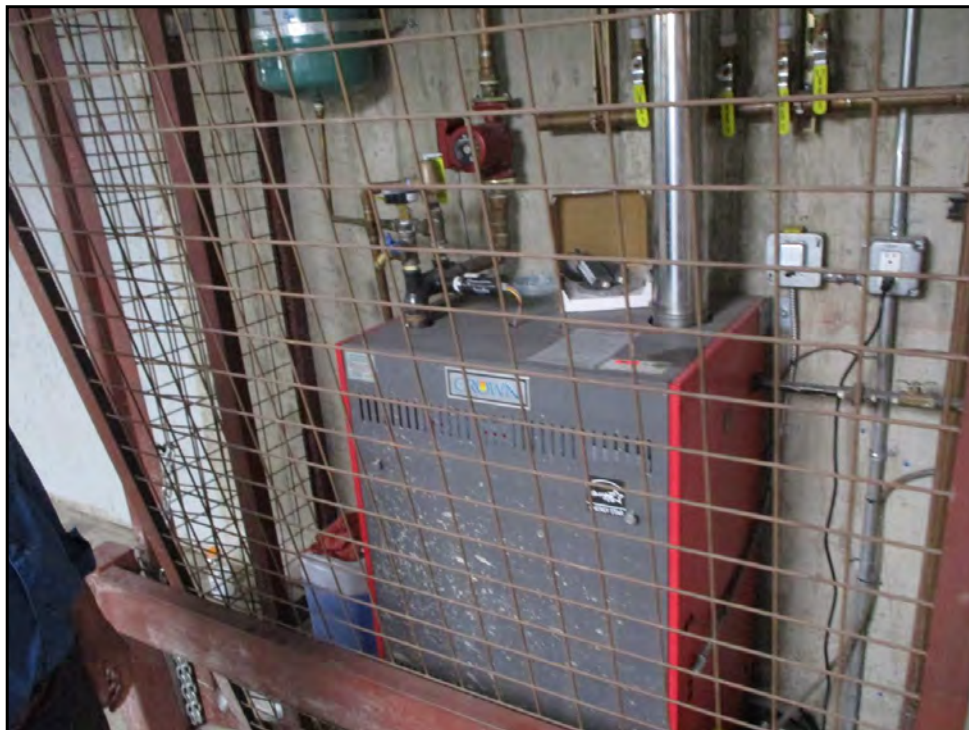
49: Primary water supply
