**Revised**  
**FULL RESERVE STUDY**  
**Ranch at Roaring Fork**  
**Homeowners Association, Inc.**

**Carbondale, Colorado**  
**Inspected - April 21, 2020**  
**Revised - July 23, 2020**

Ranch at Roaring Fork Homeowners Association, Inc.  
Carbondale, Colorado

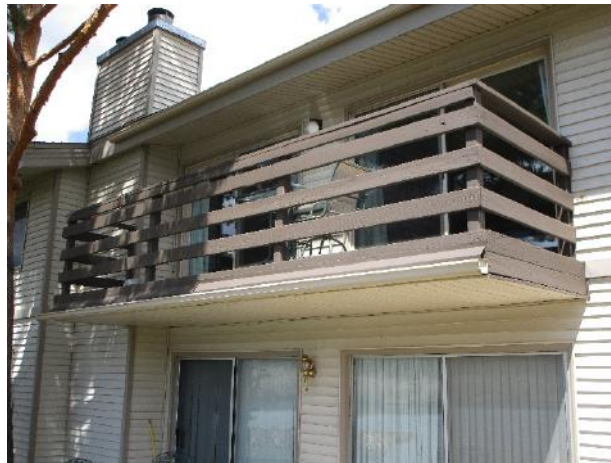
**History:** The balconies were repaired in 2017

**Condition:** Good overall

**Wood balcony overview**

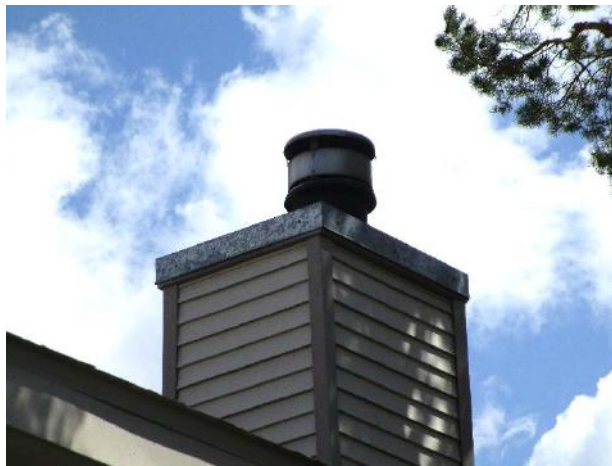
**Condition:** Good overall based on our visual inspection from the ground

**Metal chimney cap overview**

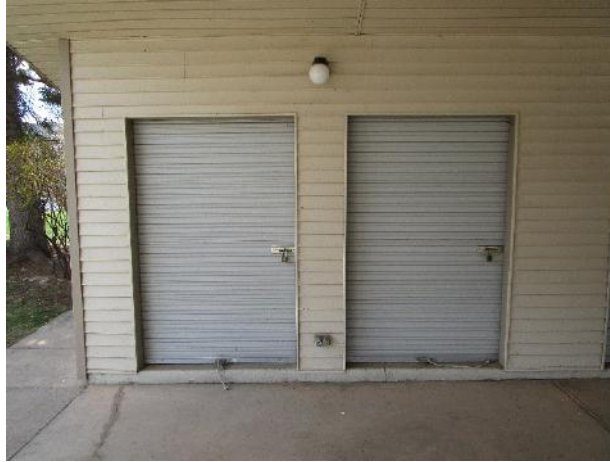
**Condition:** Good overall

**Metal storage doors**

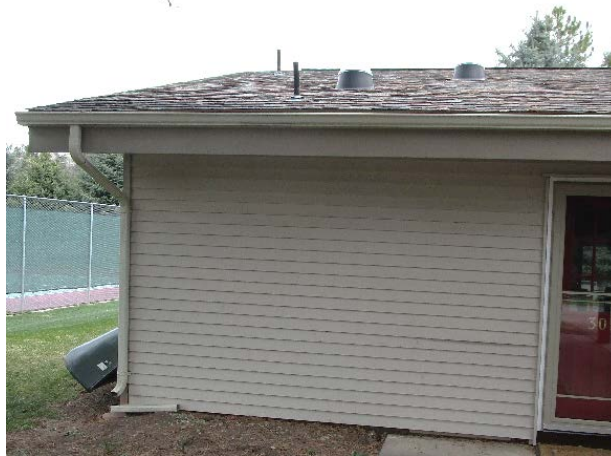
**Condition:** Good overall

**Gutter and downspout assembly**

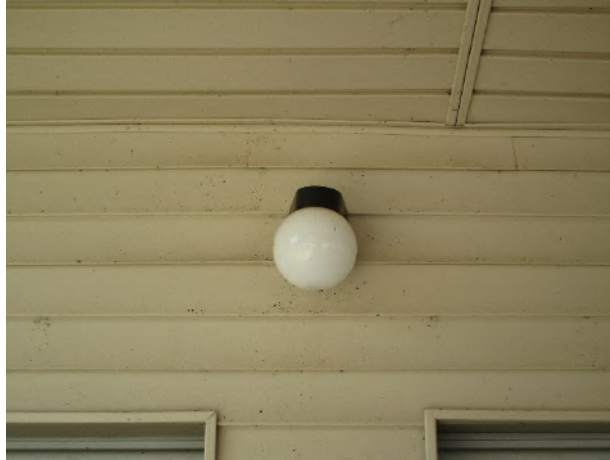
**Condition:** Good overall

Light fixture overview

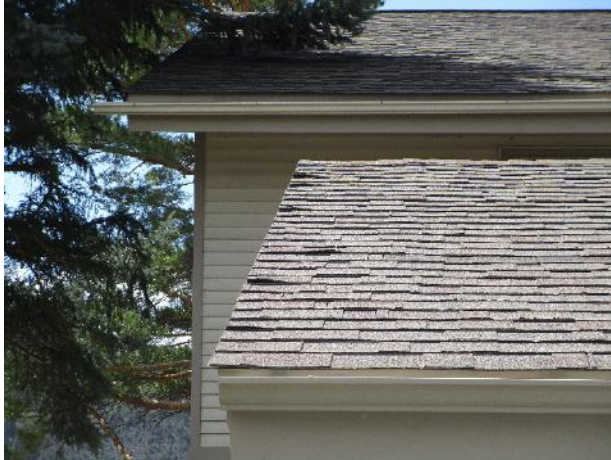
**Condition:** Good to fair overall with shingle lift and sheathing deflection evident from our visual inspection from the ground. Management and the Board report a limited history of leaks.

**Shingle lift at Building 101-102**

Contractors use one of two methods for replacement of sloped roofs, either an overlayment or a tear-off. Overlayment is the application of new shingles over an existing roof. However, there are many disadvantages to overlayment including hidden defects of the underlying roof system, absorption of more heat resulting in accelerated deterioration of the new and old shingles, and an uneven visual appearance. Therefore, we recommend only the tear-off method of replacement. The tear-off method of

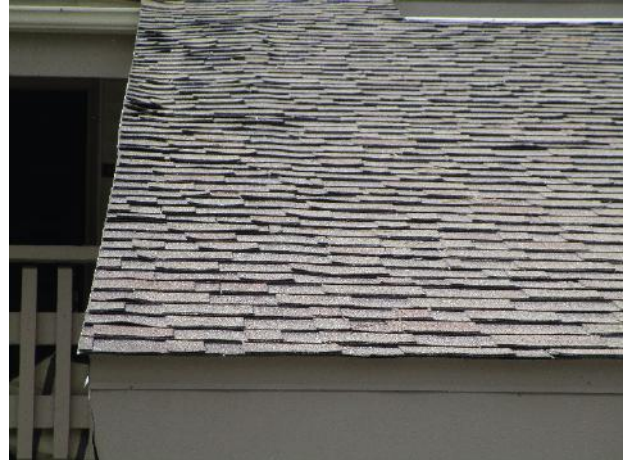
**Shingle lift at Building 119-125**

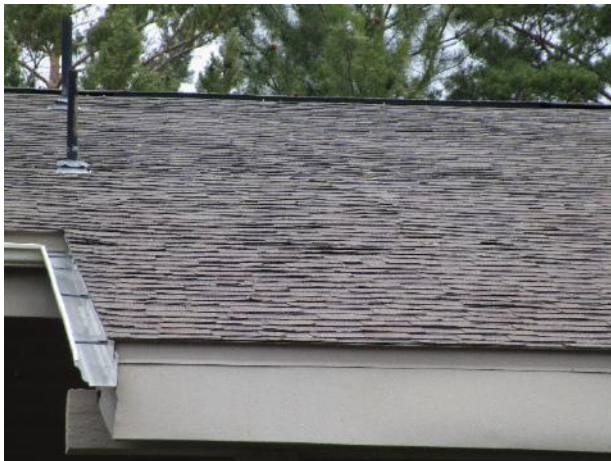
**Shingle lift at Building 287-293**

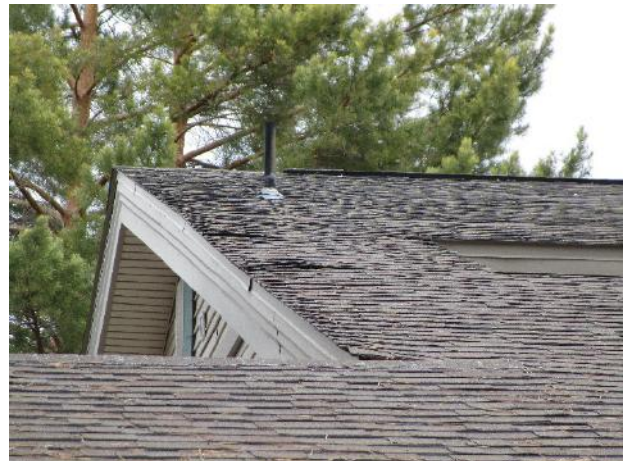
**Shingle lift at Building 295-305**

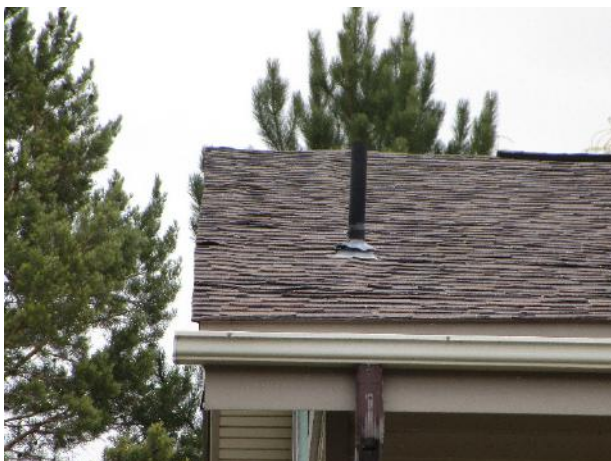
**Shingle lift at Building 271-274**

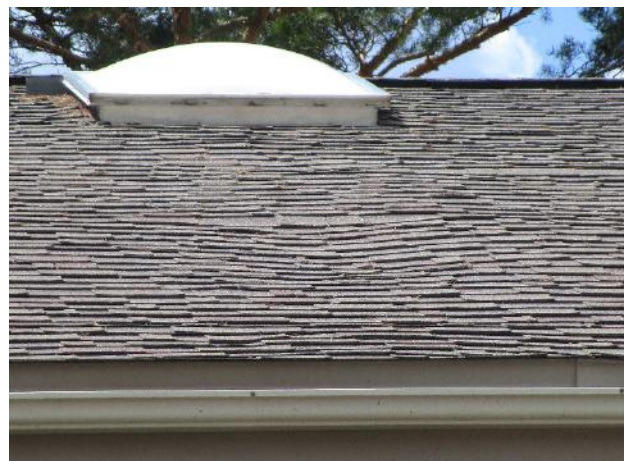
**Shingle lift and sheathing deflection at Building 115-118**

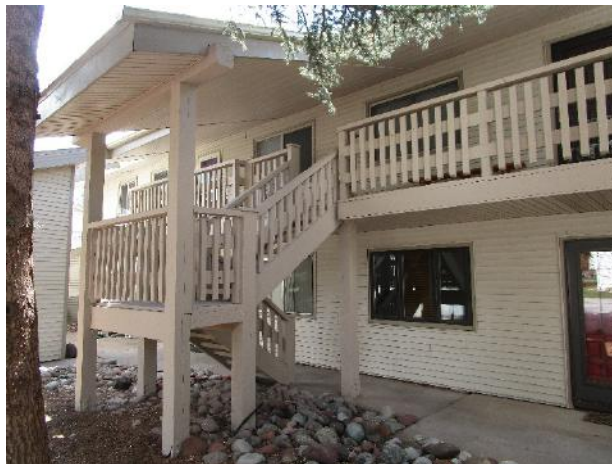
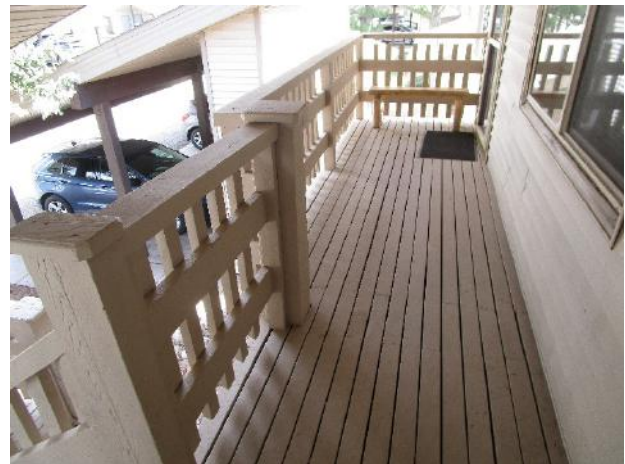
**History:** Repairs conducted in 2017 and the Association plans to conduct repairs to the railings in 2020. See “**2020 Condominiums Reserve Expenditures**” for our inclusion of this cost.

**Condition:** Good overall

Wood staircase overview

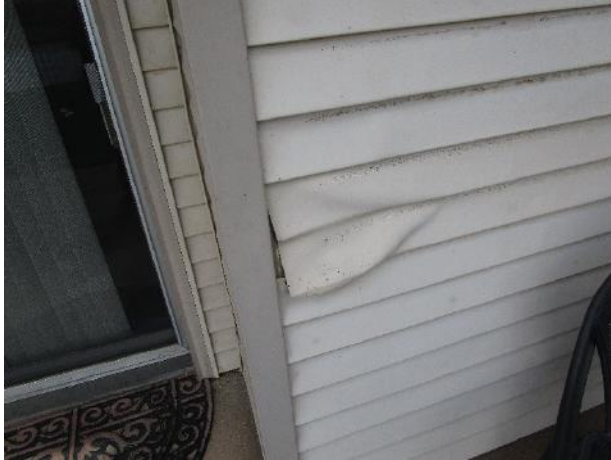
**Siding warp at Building 135-138**

The lack of water-vapor permeable building paper underneath the siding can result in premature loosening of the siding fasteners from water damage to the substrate sheathing. Therefore, the Association should anticipate a decreased useful life due to the lack of water proofing beneath the siding.

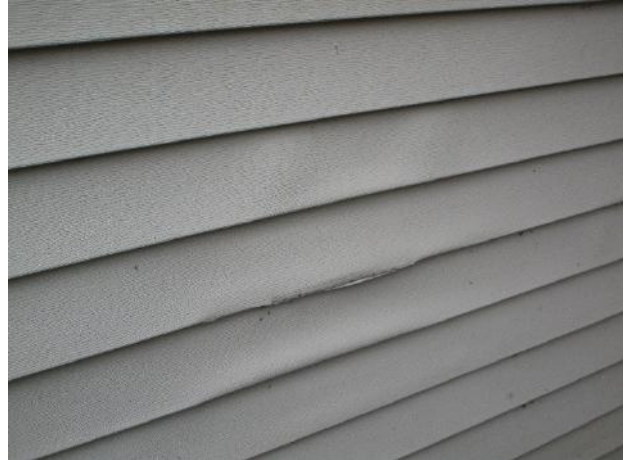
**Siding warp at Building 288-258**

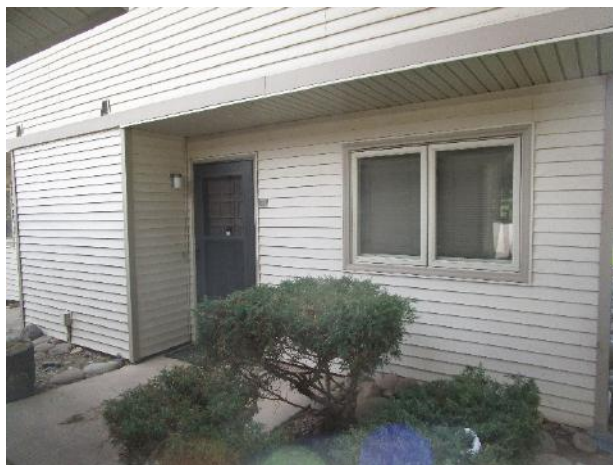
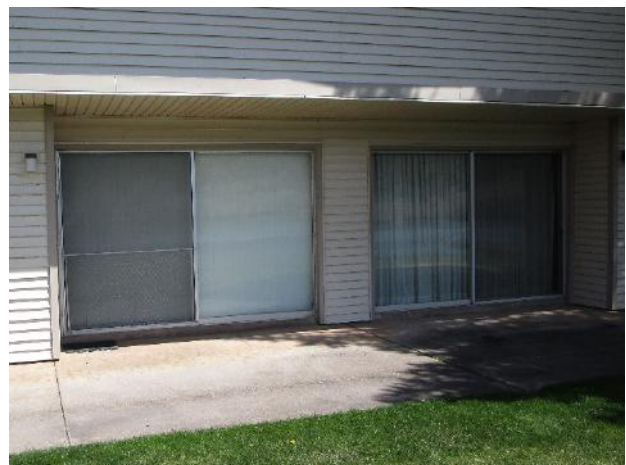
**Condition:** Good overall

Window and door overview

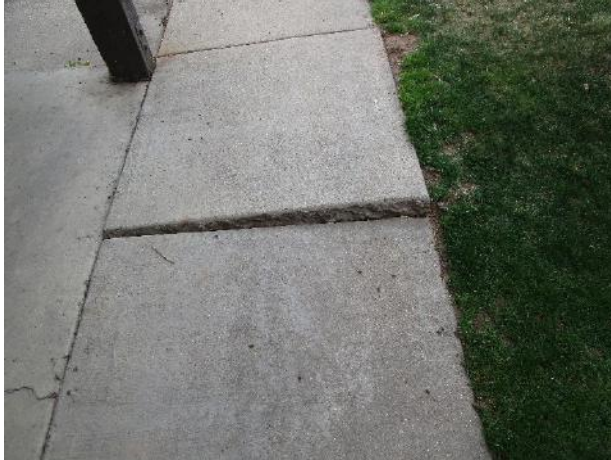
**Concrete settlement at Building 275-281**

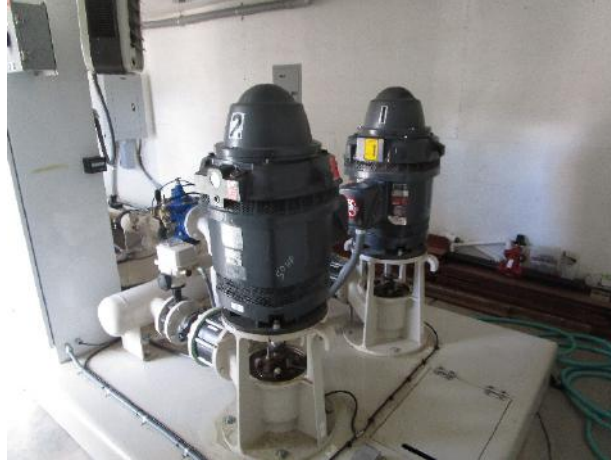
**Condition:** Reported satisfactory

**Irrigation system pumps overview**

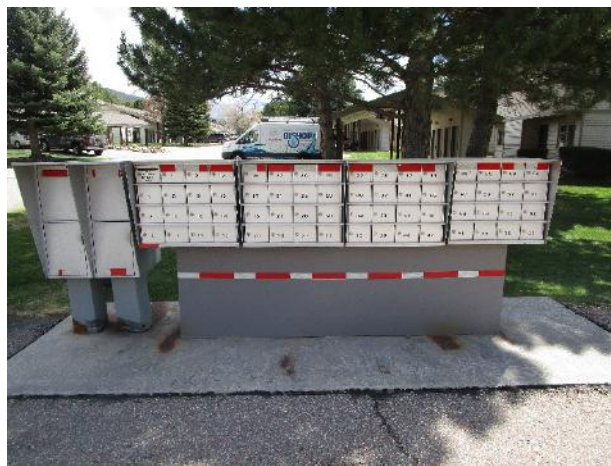
**Condition:** Good overall

Mailbox stations overview

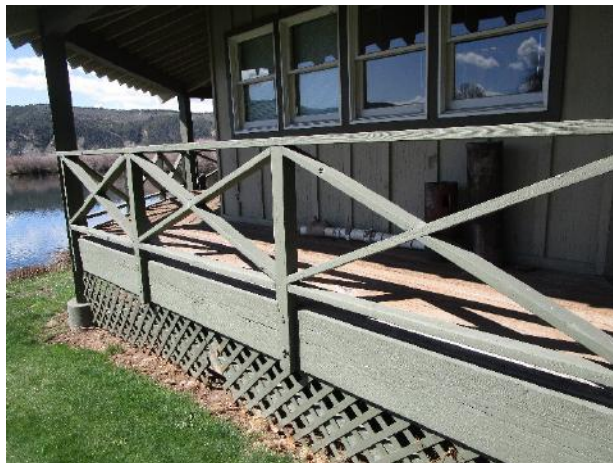
***Condition:*** Fair overall condition with split wood, wood rot and damage evident

**Wood deck overview**

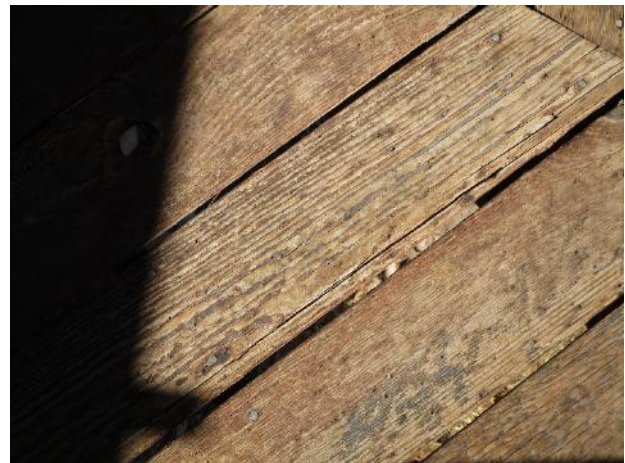
**Split wood deck board**

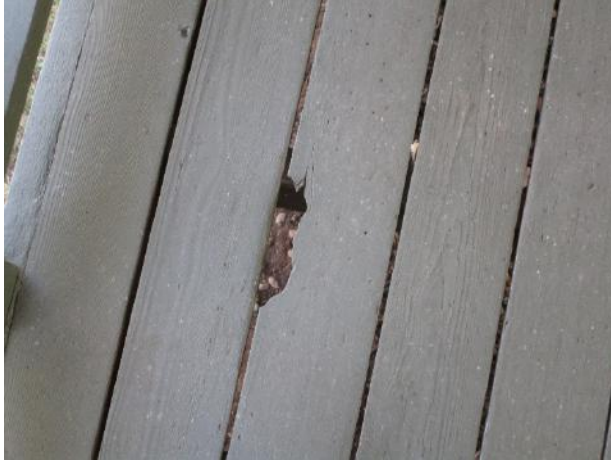
**Deck board damage**

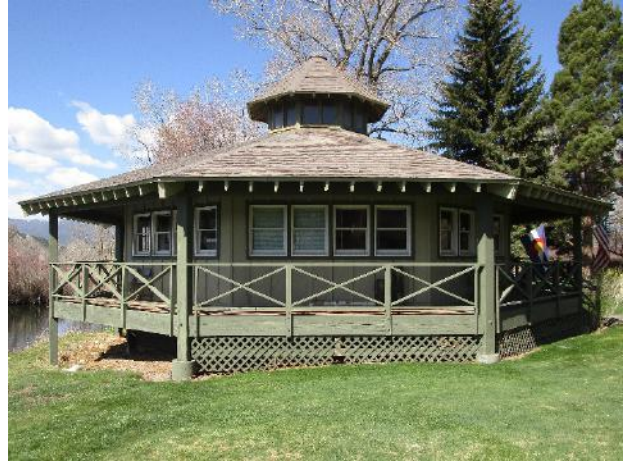
**Office building asphalt shingle roof overview**

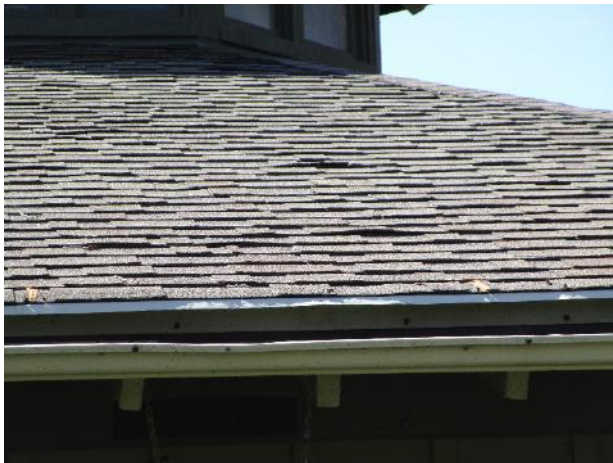
**Condition:** Good overall with minor shingle lift at the office building evident from our visual inspection from the ground. Management and the Board do not report a history of leaks.

**Shingle lift at the office building**

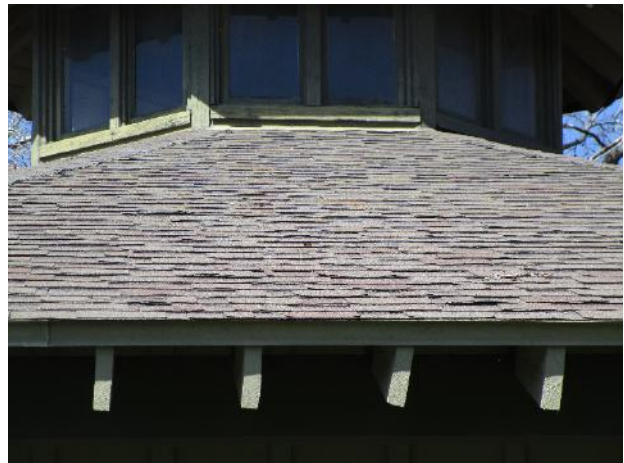
**Shingle lift at the office building**

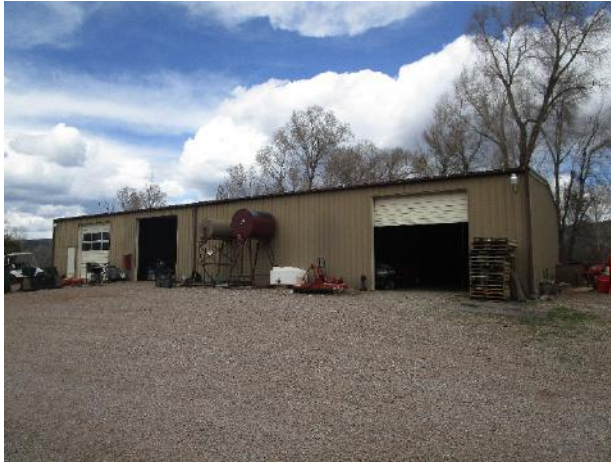
**Condition:** The siding is in fair overall with damage evident

**Maintenance building overview**

**Expenditure Detail Notes:** Expenditure timing and costs are depicted in the **Common Reserve Expenditures** table in Section 3. Vinyl siding is the predominant replacement

material for aluminum siding. For purposes of this Reserve Study, we assume replacement with .048-inch thick vinyl siding.

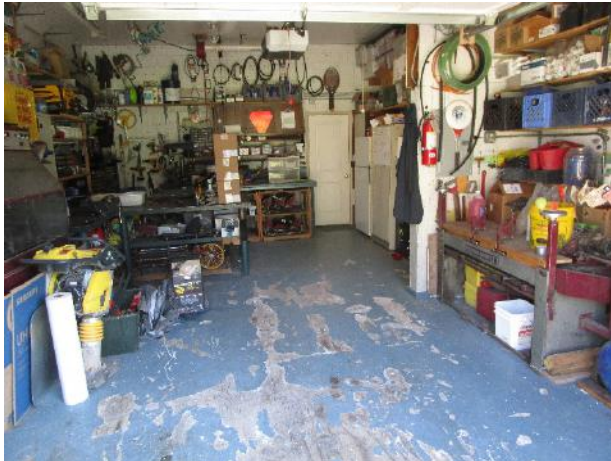
**Condition:** Fair overall with carpet stains and floor finish deterioration evident

**Golf shop common interior; Floor finish deterioration**

**Expenditure Detail Notes:** Expenditure timing and costs are depicted in the **Common Reserve Expenditures** table in Section 3. The complete renovation should include replacement of all the interior components listed above and the partial renovations should include the following:

- Application of paint finish to all surfaces
- Replacement of the carpet
- Replacement of up to fifty percent (50%) of the appliances and furnishings

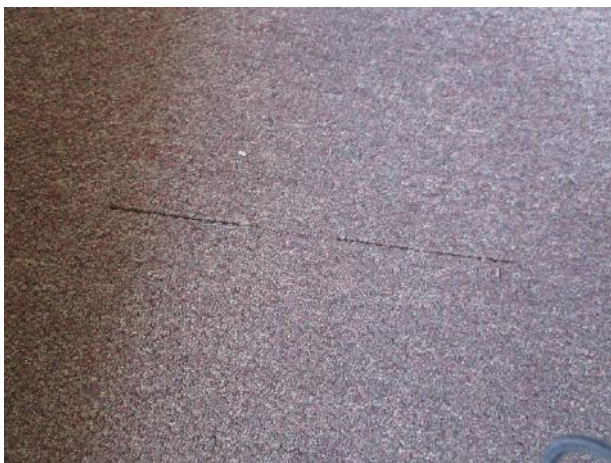
**Condition:** Fair overall with carpet frays and paint finish deterioration evident

Carpet frays

**Expenditure Detail Notes:** Expenditure timing and costs are depicted in the **Common Reserve Expenditures** table in Section 3. The complete renovation should include replacement of all the interior components listed above and the partial renovations should include the following:

- Application of paint finish to all surfaces
- Replacement of the carpet
- Replacement of up to fifty percent (50%) of the appliances and furnishings

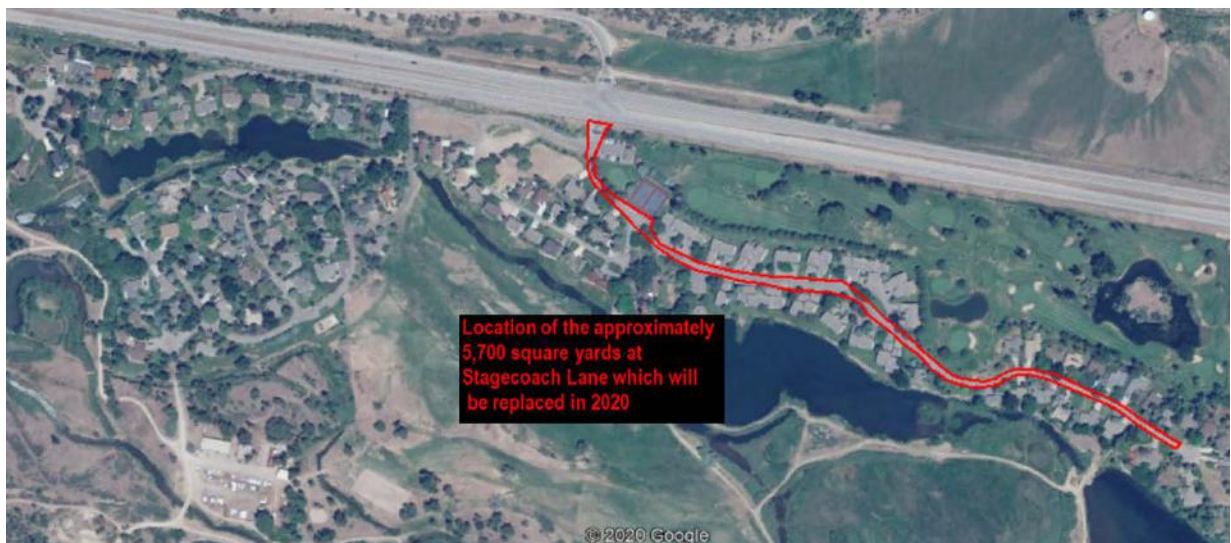
**History:** The pavement is reported to be original. The Association plans to replace approximately 5,700 square yards of Stagecoach Lane from the entrance to the eastern end of the street, not including the cul-de-sac, Golf Course and office building parking areas or condominium responsibility of pavement in 2020. See “**2020 Common Reserve Expenditures**” for our inclusion of this cost. The following image depicts the location of these replacements:

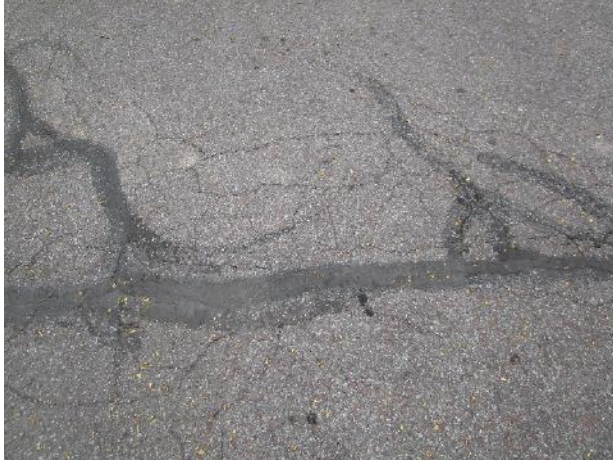
**Condition:** Varying conditions ranging from good to poor overall with cracks and pot holes evident

**Pavement cracks at Stagecoach Drive**

**Expenditure Detail Notes:** Expenditure timing and costs are depicted in the **Common Reserve Expenditures** table in Section 3. Our cost includes an allowance for crack repairs and patching of up to two percent (2%) of the pavement.

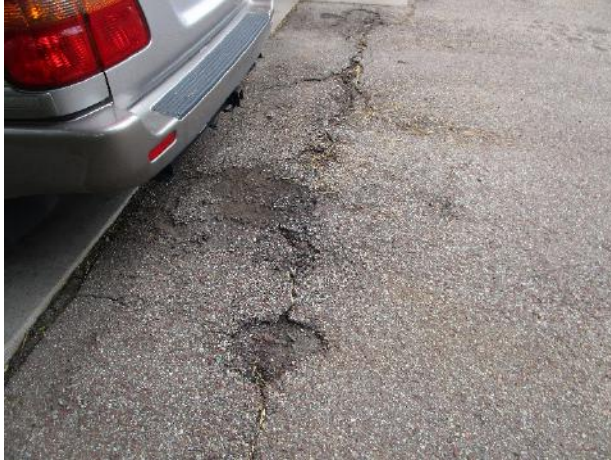
**Pavement cracks and deterioration at Building 287-293**

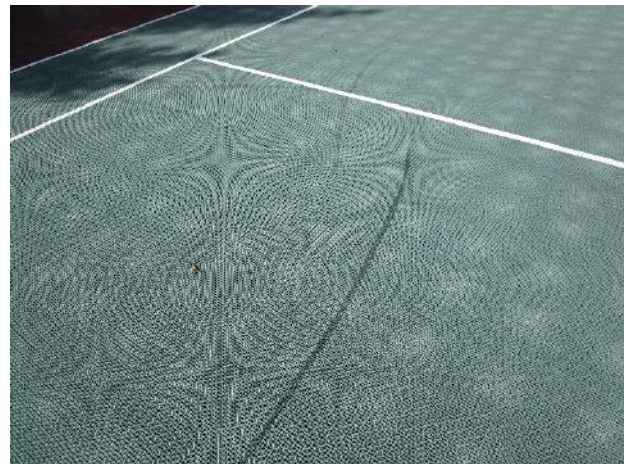
**Condition:** Good overall with isolated scuffs evident

**Court scuffs**

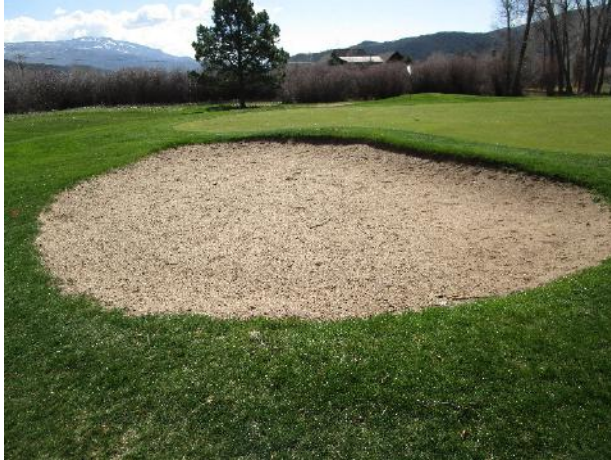
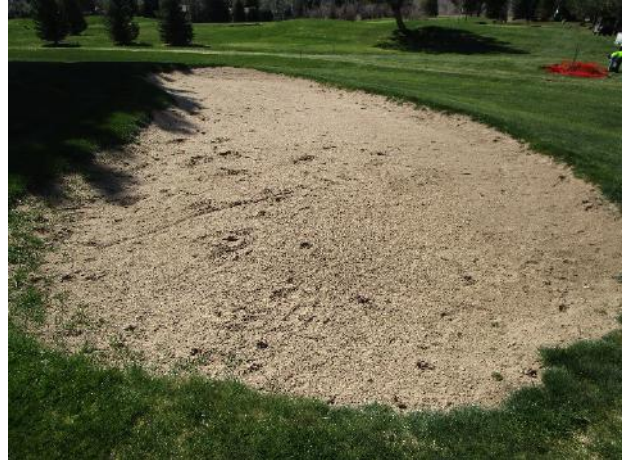
**Condition:** Good to fair overall

**Sand bunker overview**

**Expenditure Detail Notes:** Expenditure timing and costs are depicted in the **Common Reserve Expenditures** table in Section 3. We recommend the Association fund for general maintenance of the bunkers through the operating budget as needed.

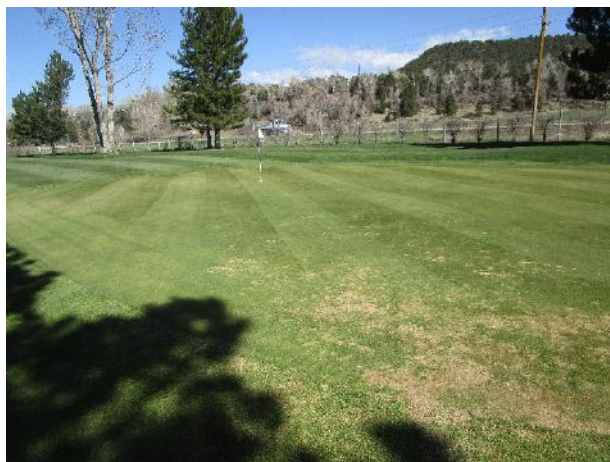
**Condition:** Good overall

**Green overview**

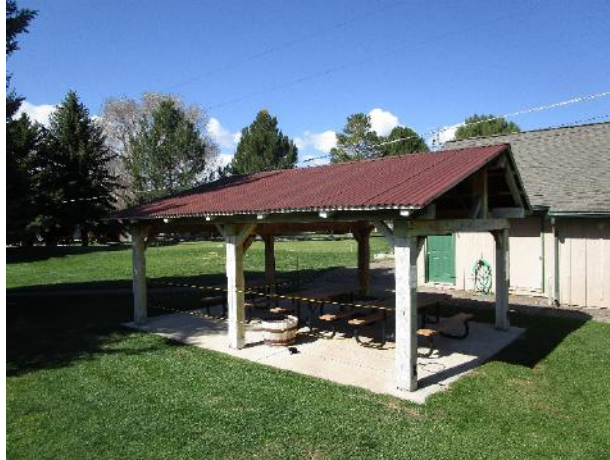
**Condition:** Good overall

**Pavilion overview**

**Expenditure Detail Notes:** Expenditure timing and costs are depicted in the **Common Reserve Expenditures** table in Section 3. We recommend the Association budget for paint applications and repairs through the operating budget.

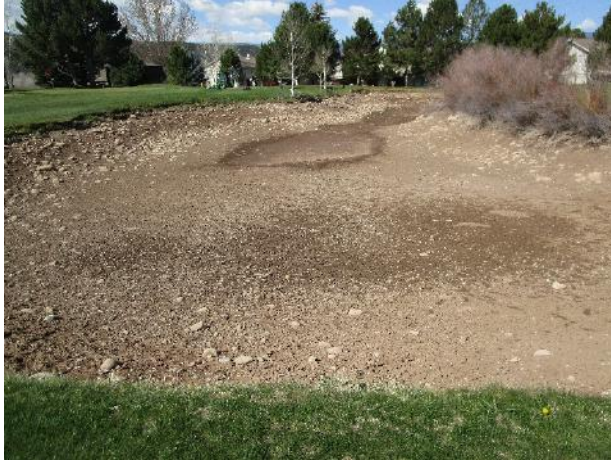
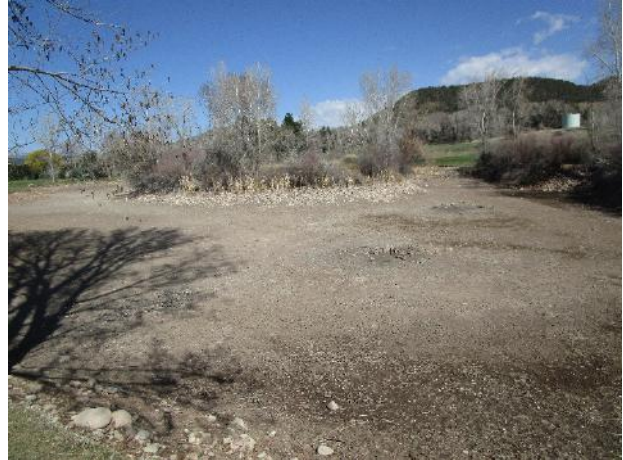
**Condition:** Good overall

**Pond overview; note the pond level naturally changes and at the time of our inspection the ponds were completely empty**

**Expenditure Detail Notes:** Expenditure timing and costs are depicted in the **Common Reserve Expenditures** table in Section 3. We recommend the Association plan to install a combination of plantings and rip rap around the pond along 690 linear feet, or approximately thirty percent (30%), of the shoreline per event.

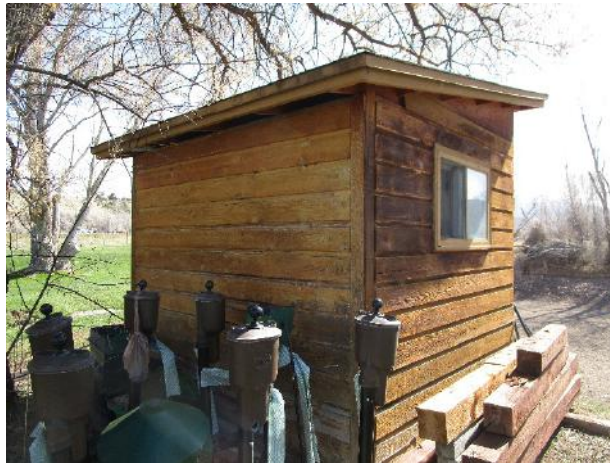
**Condition:** Good overall

**Shed overview**

**Expenditure Detail Notes:** Expenditure timing and costs are depicted in the **Common Reserve Expenditures** table in Section 3. We recommend the Association apply paint finish applications to the exterior of the shed through the operating budget as needed.

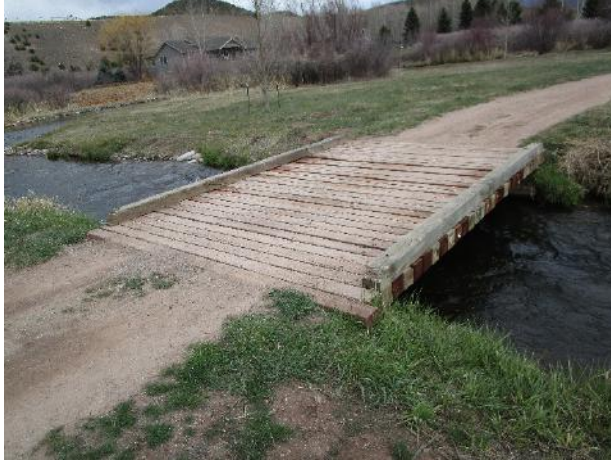
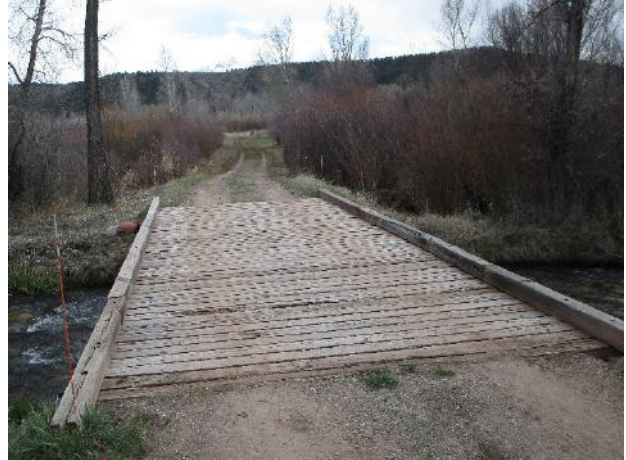
**Condition:** Various conditions ranging from good to poor overall with wood rot and split deck boards evident

Wood bridge overview

- Annual inspections to identify and correct any unsafe conditions
- Securing of loose fasteners and replacement of deteriorated fasteners
- Replacement of deteriorated wood components
- Power washing with an algaecide and application of a sealer/stain

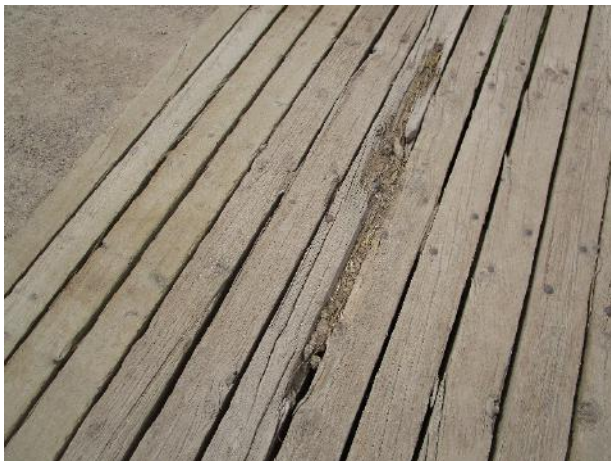
Wood rot and split deck boards

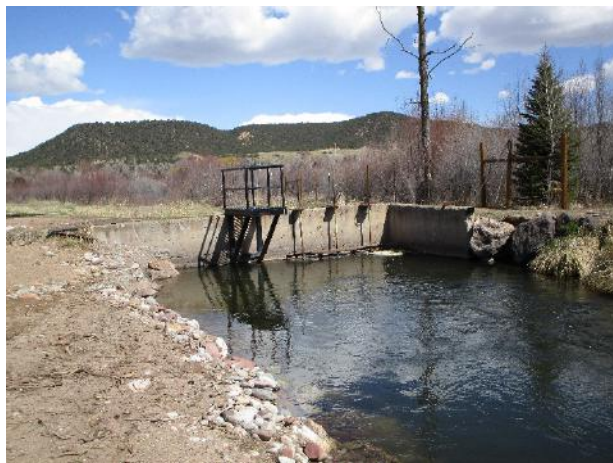
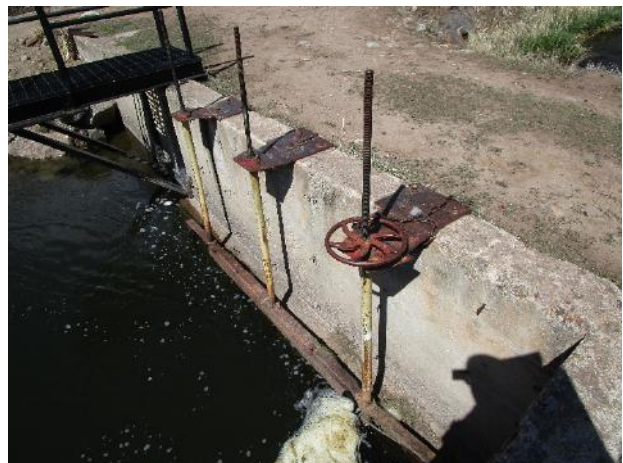
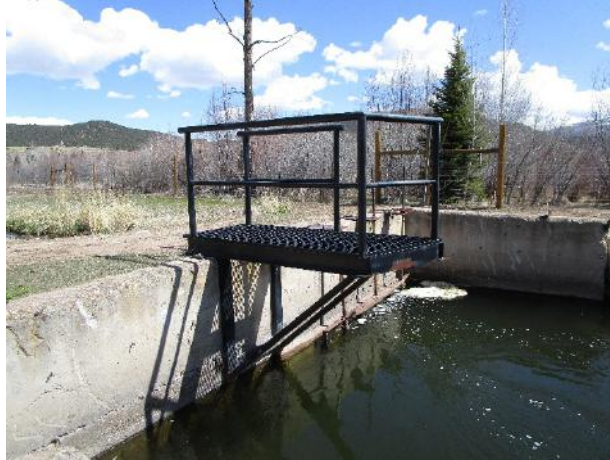
**Condition:** Reported in satisfactory condition

Head gate overview

**Head gate catwalk**

**Component Detail Notes:** We note various trees, shrubbery and other landscape elements at the downstream embankment of the head gates. Under normal best management practices which include periodic independent condition assessments and related repairs, we do not foresee the need for replacement/re-building of the head gates during the next 30 years. However, the Association should plan for periodic inspections and capital repairs to the head gates and we recommend the Association inspect the upstream and downstream sides of the head gates. More frequent inspections as normal maintenance may be necessary depending on the findings of invasive condition assessments and state/local regulations.

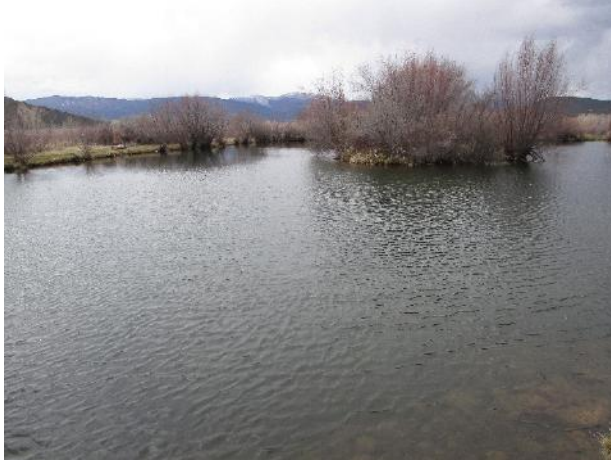
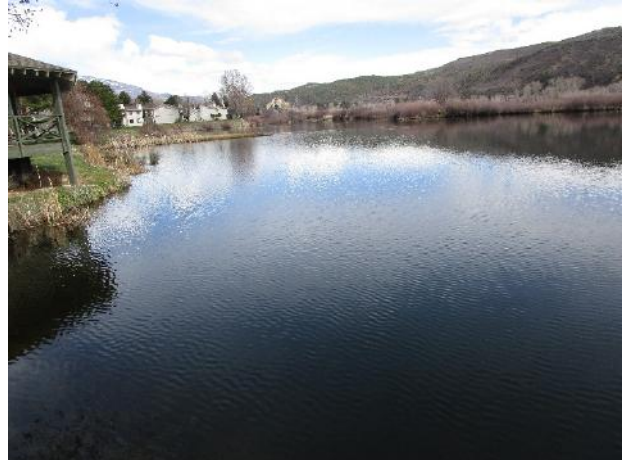
**Condition:** Reported in good to fair condition

Common pond overview

**Useful Life:** Based on the visual condition, construction, adjacent deciduous trees and visibly apparent erosion, we recommend the Association anticipate the need to remove pond sediment up to every 20 years.

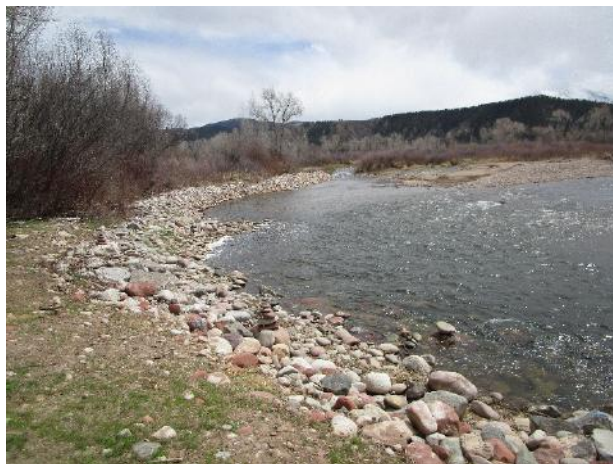
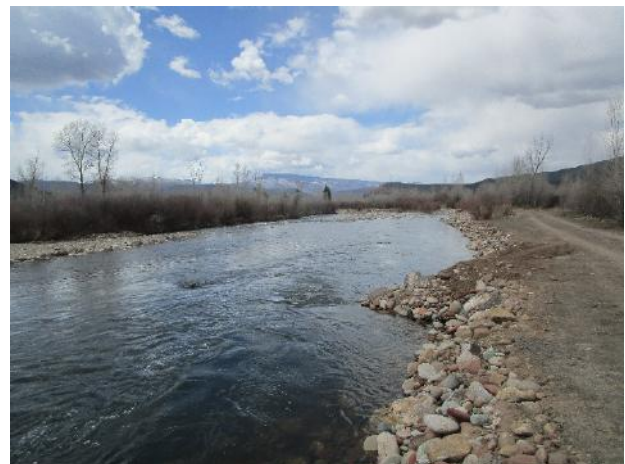
**Condition:** Good overall

**Roaring Fork River overview**

**Component Detail Notes:** We recommend all capital repairs and shoreline remediation projects adhere to local and state standards governing such work including storm water best management practices, erosion and sediment control planning and design manuals and the Colorado Department of Environment and Natural Resources best practice standards when applicable. Adherence to these state and local standards will help to minimize sedimentary runoff and its immediate watershed and mitigate the annual and periodic costs of erosion control maintenance.

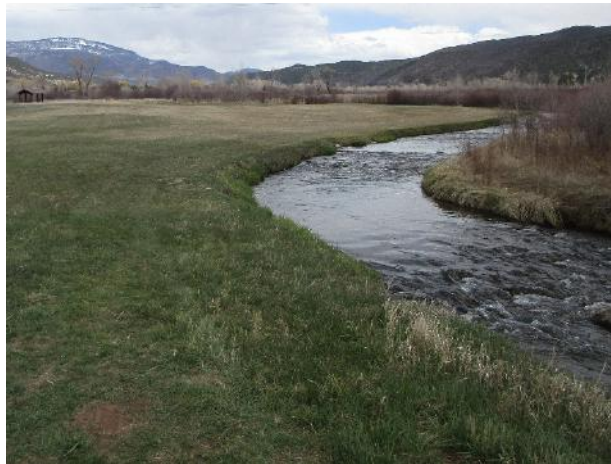
**Condition:** Various conditions ranging from good to fair

**Stream shoreline overview**

**Component Detail Notes:** We recommend all capital repairs and shoreline remediation projects adhere to local and state standards governing such work including storm water best management practices, erosion and sediment control planning and design manuals and the Colorado Department of Environment and Natural Resources best practice standards when applicable. Adherence to these state and local standards will help to minimize sedimentary runoff and its immediate watershed and mitigate the annual and periodic costs of erosion control maintenance.

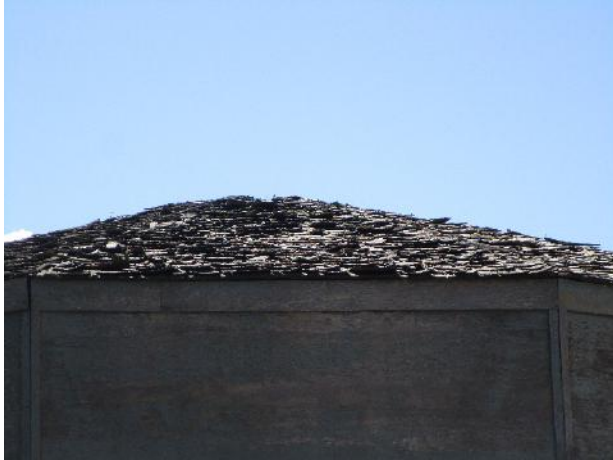
**Condition:** Fair to poor overall with damaged and curled shingles evident from our visual inspection from the ground.

**Cedar shake roof overview**

The Association should install new cedar shakes to meet the requirements of *Cedar Shake and Shingle Bureau*. Once replacement is complete, the Association must develop a maintenance policy for the new cedar shake roofs. Ranch at Roaring Fork should fund all maintenance to the roofs through the operating budget.

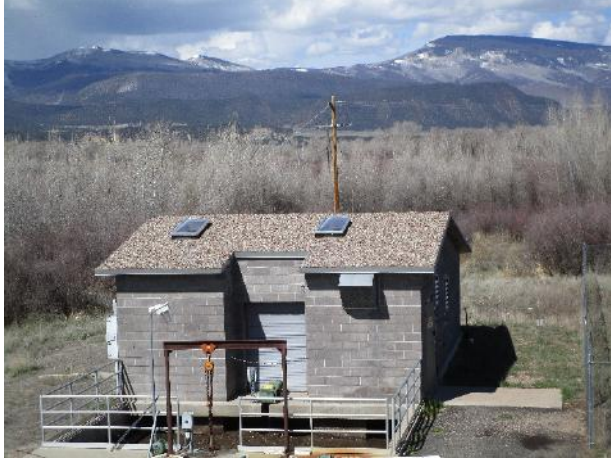
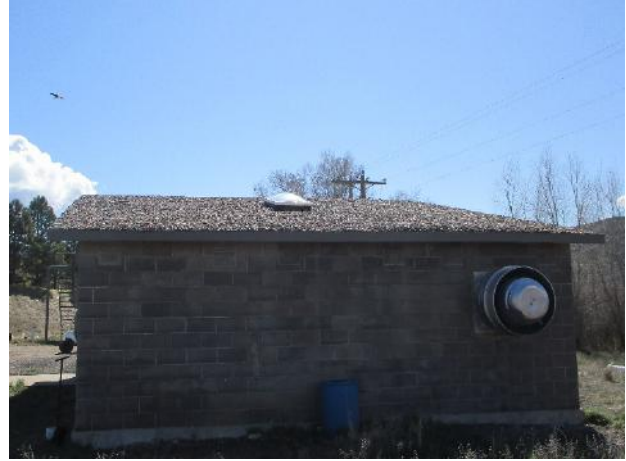
**Condition:** Good overall condition

Coal tar roof overview

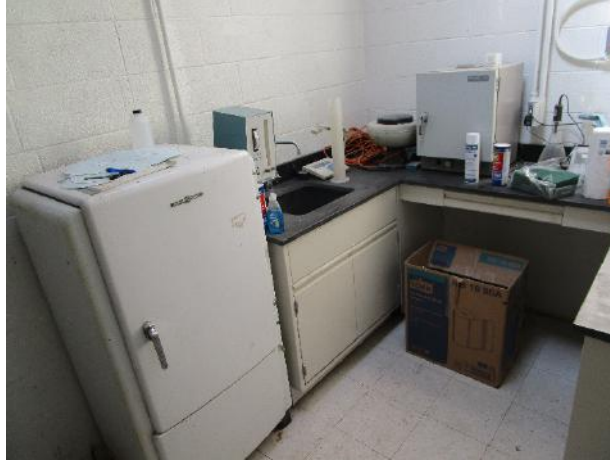
**Condition:** Good overall

**Chemical room overview**

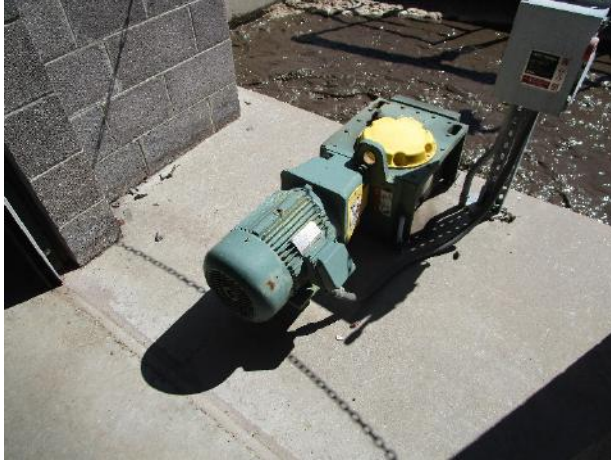
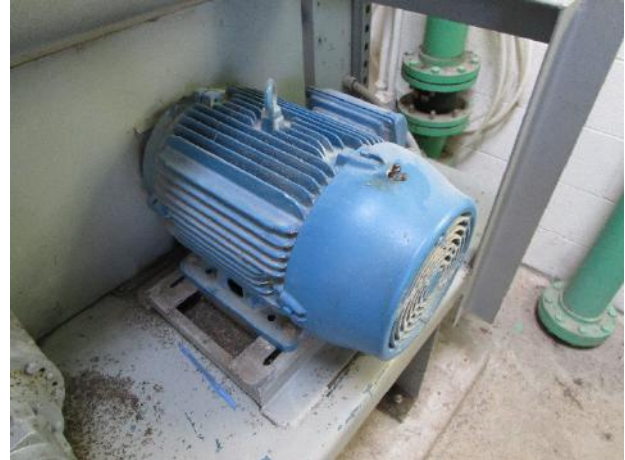
- Water Treatment - 5-HP, one each, likely date to 2000, reported satisfactory
- Water Treatment - 20-HP, two each, likely date to 2000, reported satisfactory

**Water treatment 5-HP pump**

**Water treatment 20-HP pump**

***Preventative Maintenance Notes:*** We recommend the Association obtain and adhere to the manufacturer's recommended maintenance plan. We also recommend the Association maintain a maintenance contract with a qualified professional. The required preventative maintenance may vary in frequency and scope based on the unit's age, operational condition, or changes in technology. Valuable motor information to note in a preventative maintenance plan or schedule includes age of unit and last time of repair, horsepower and rpm (revolutions per minute), bearing type and conditions surrounding motor/pump. We note the following select recommended preventative maintenance activities to maximize the remaining useful life:

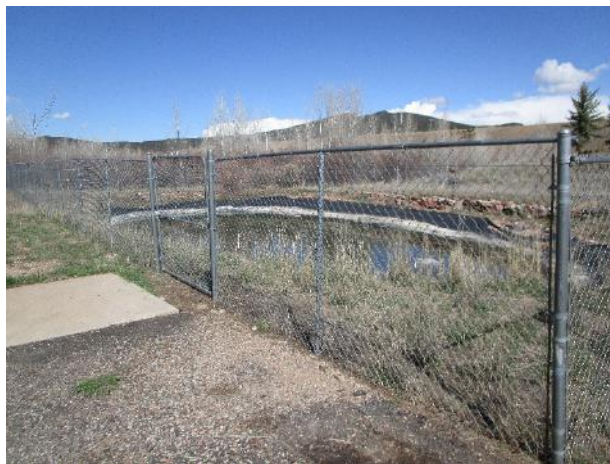
**Condition:** Good overall

Chain link fence overview

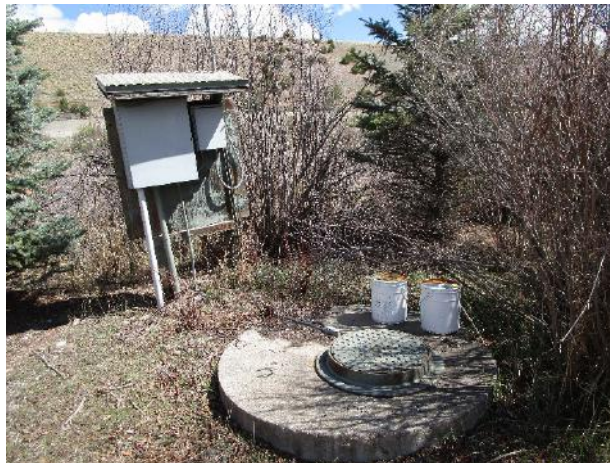
**Condition:** Reported good overall without any reports of service interruptions

**Lift station overview**

**Expenditure Detail Notes:** Expenditure timing and costs are depicted in the **Water Treatment Reserve Expenditures** table in Section 3. Rebuilding of the station includes replacement of pumps, motors, guide rails and electrical components including controls. The Association should fund interim repairs and replacements through the operating budget.

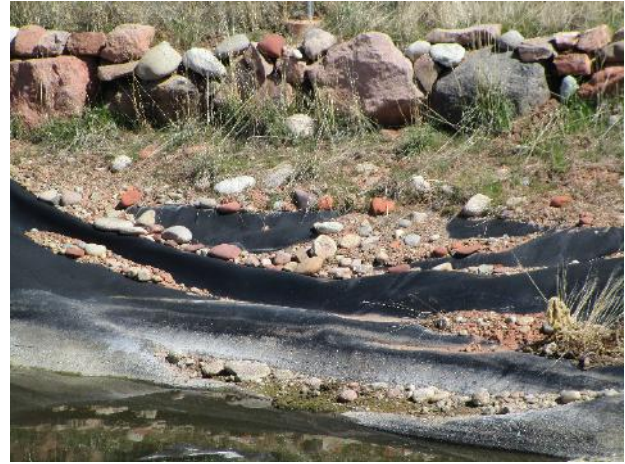
**Condition:** Good to fair overall with folds and debris evident

**Folds and debris on liner**

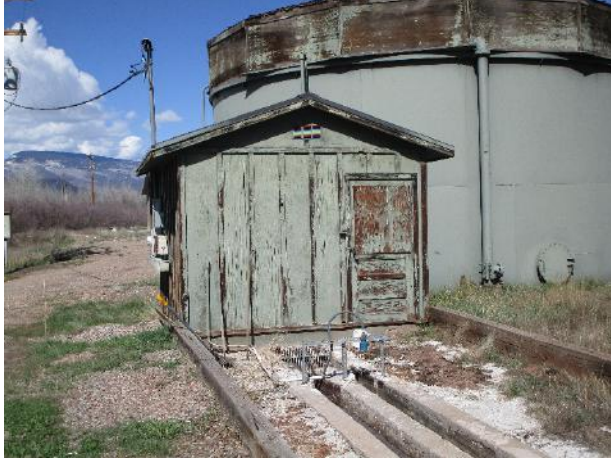
**Condition:** Good to fair overall with siding finish deterioration and damage evident

**Shed overview**

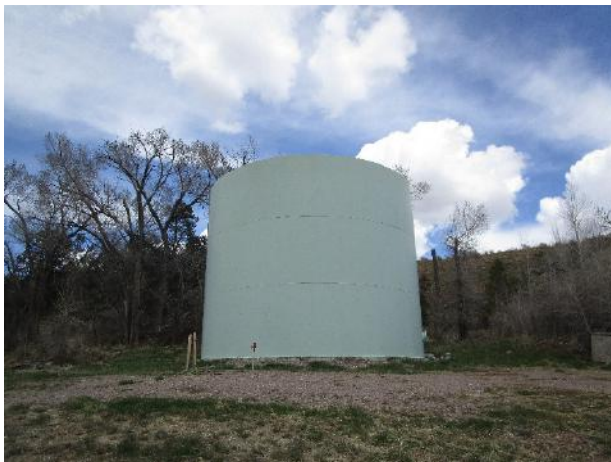
**Condition:** Good to fair overall with minor rust evident

**Storage tank overview**
