O'BRIEN
BUILDING INSPECTIONS INC.

SAMPLE
INSPECTION REPORT
3576 Main Street
Goleta, CA

Prepared for Island Investments LLC

12/8/2025

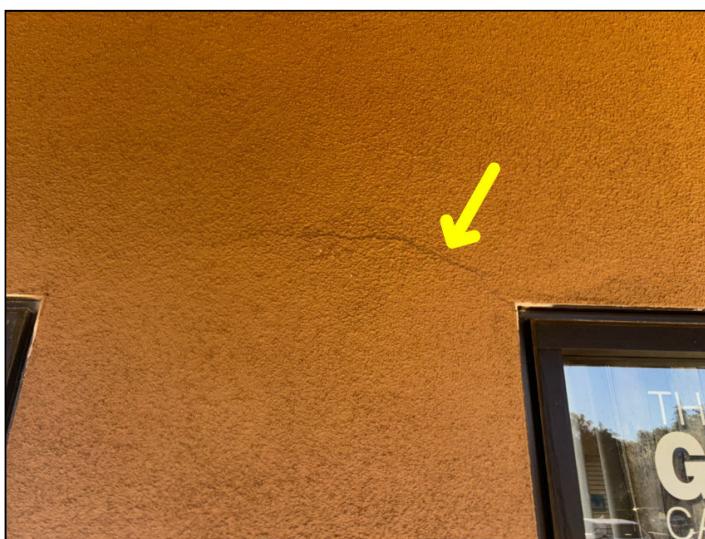
Cracks and patching were noted in many places at the exterior walls.

Recommend all of the exterior walls be evaluated and improved as needed by a qualified licensed contractor.

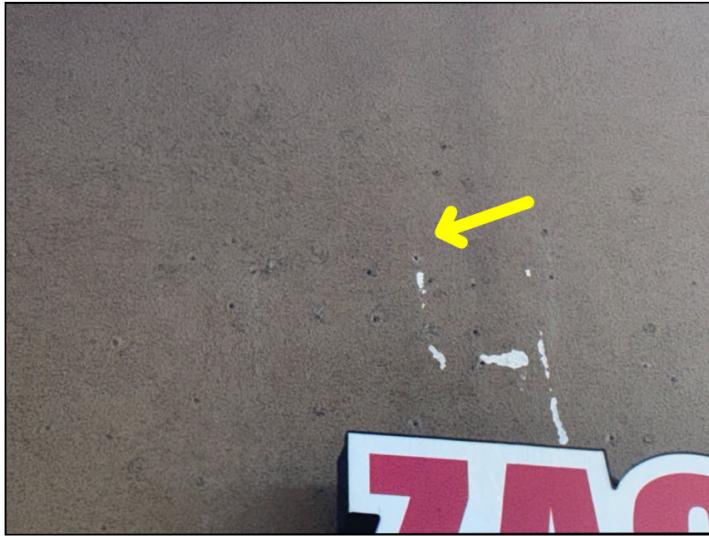
Cosmetic damage was noted in many places where fasteners have been removed adjacent to business signs.

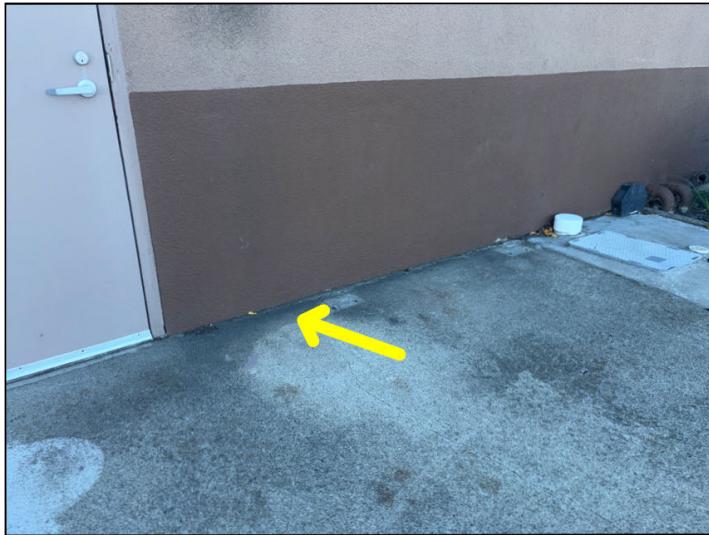
The stucco weep screed is blocked by paving at various places. This can cause moisture problems.

The stucco weep screed is blocked by paving at various places. This can cause moisture problems. Recommend monitoring for moisture problems and improving if needed.

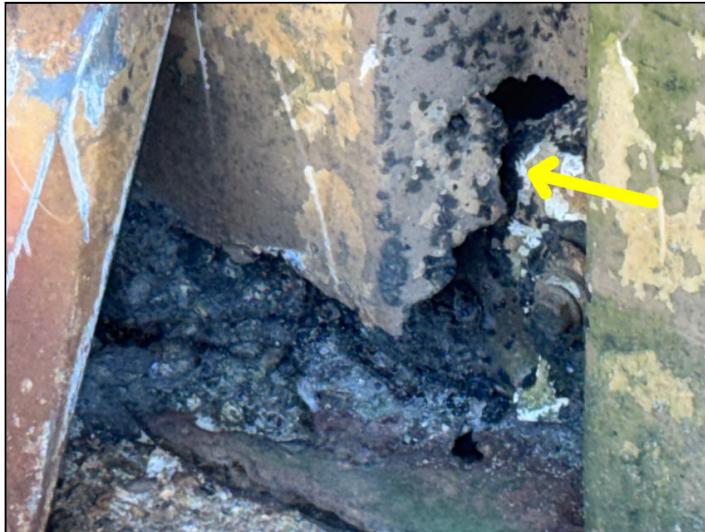
corrosion was noted in various places at the base of the rear exterior metal siding.

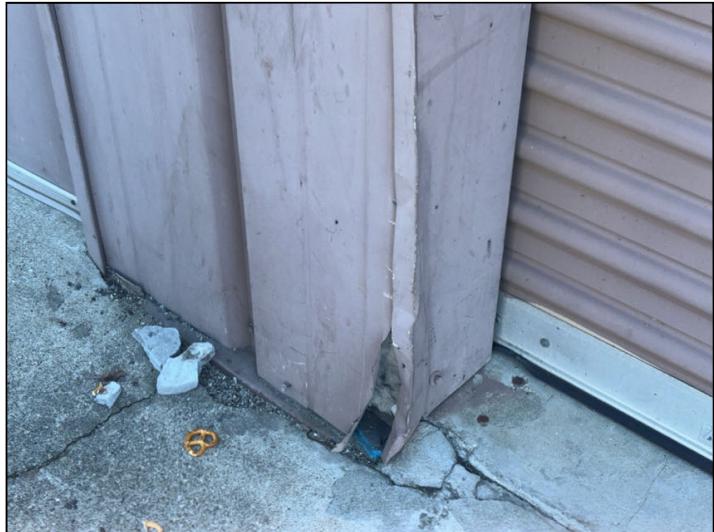
Vehicle damage was noted adjacent to the rollup door at the rear exterior of 12310

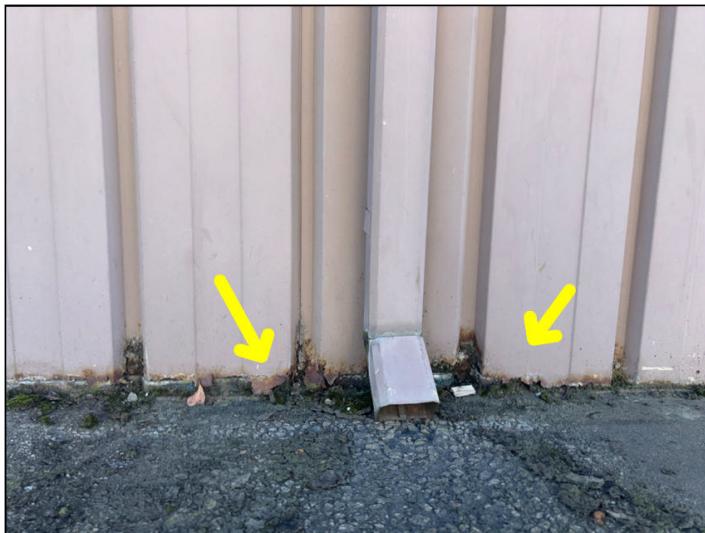
corrosion was noted in various places at the base of the rear exterior metal siding.

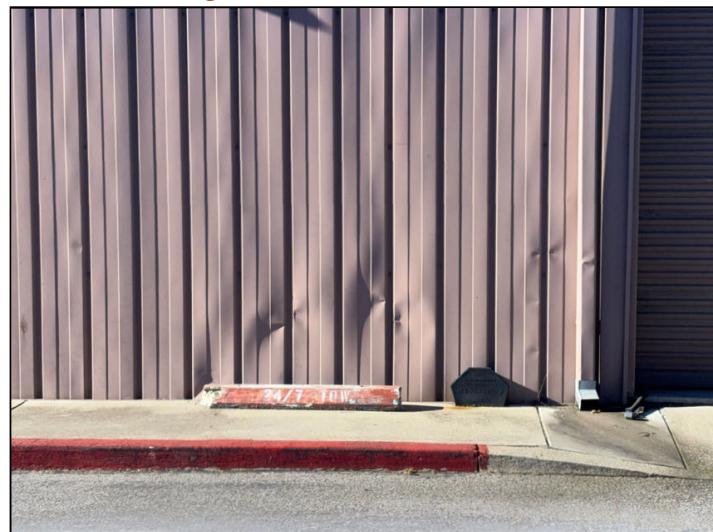
Damaged metal siding was noted at the rear of 12334.

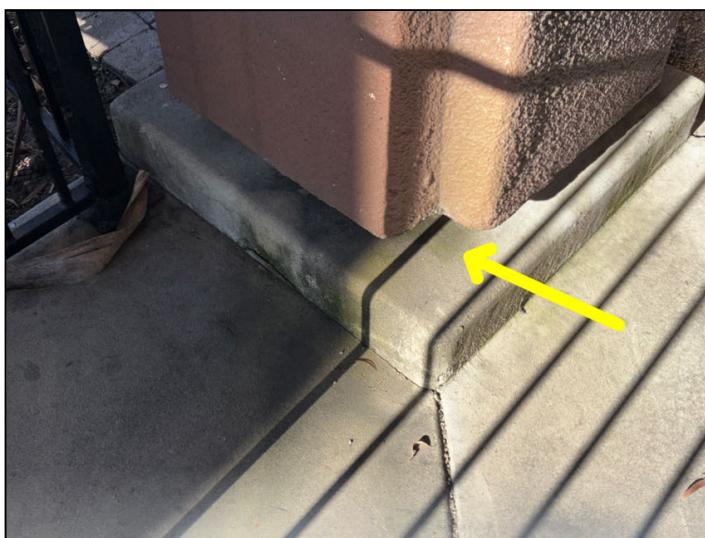
It has been disclosed that water pours out of the bottom of a column adjacent to 12300 during rainfall.

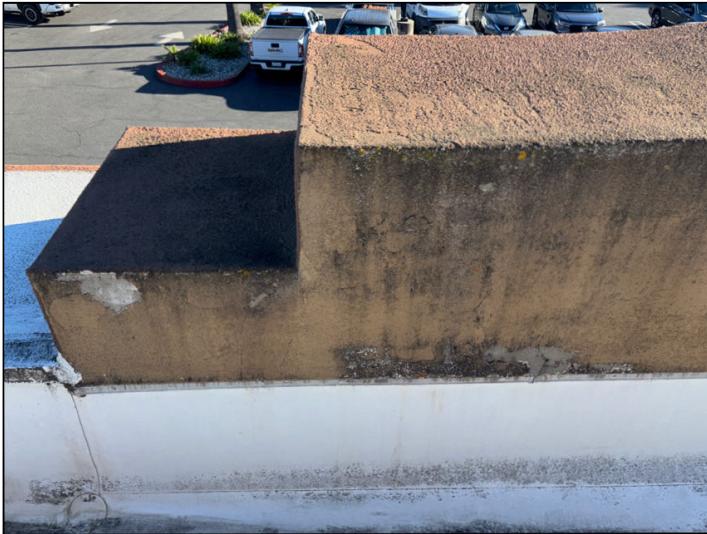
Damaged and flaking stucco color coat was noted in various places at the stucco arch detail over 12328.

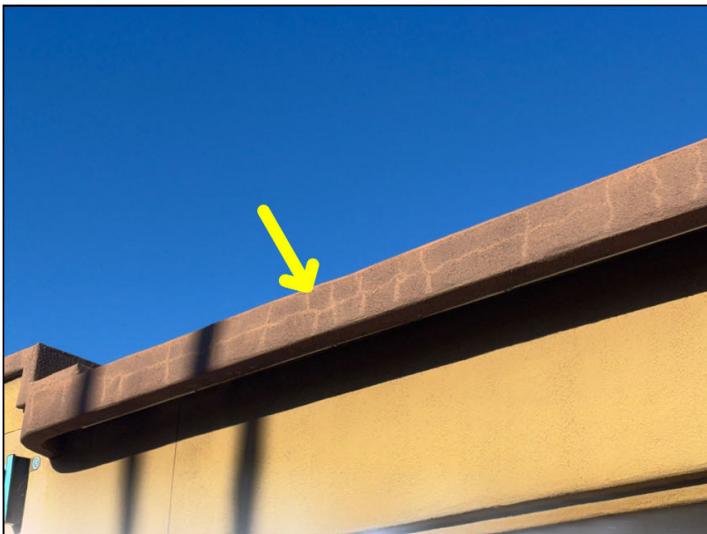
Patched cracks were noted in many places at the stucco trim and eave details.

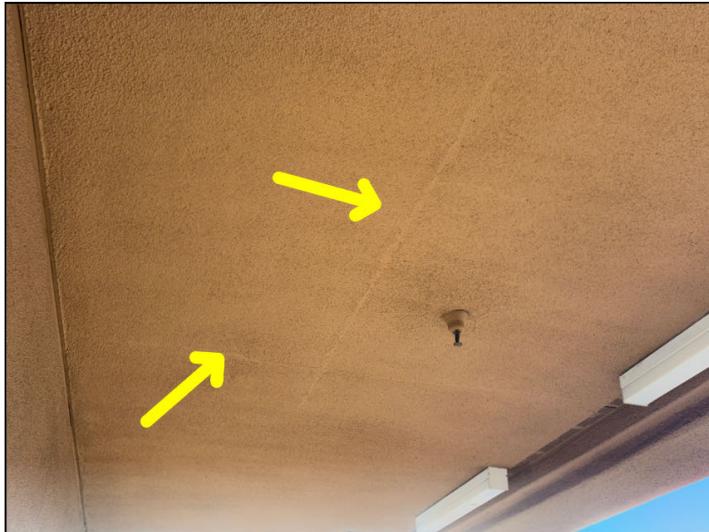
Patched cracks were noted in many places at the stucco trim and eave details.

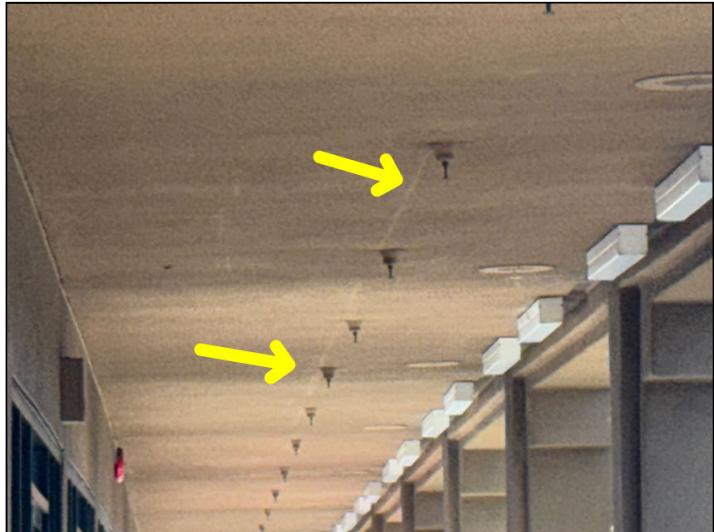
Patched cracks were noted in many places at the stucco trim and eave details.

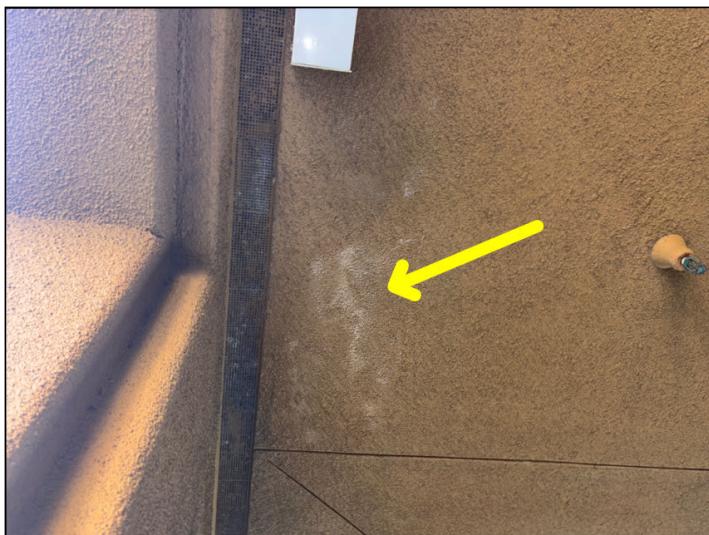
Efflorescence was noted at the underside of the eaves adjacent to the common restrooms.

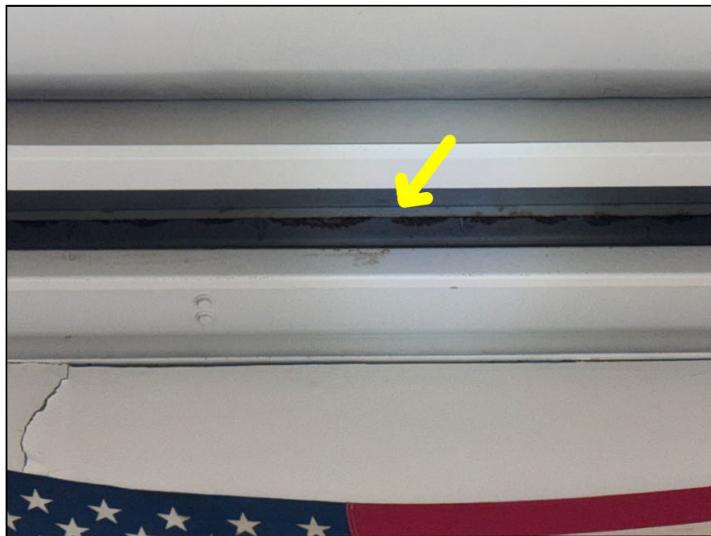
Corrosion and evidence of moisture intrusion were noted at the metal framing below the roof over the entry door of 12334.

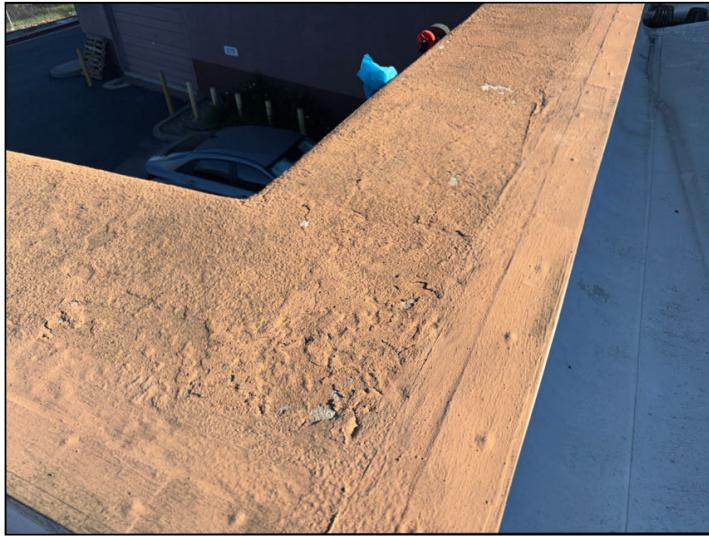
Peeling paint and deteriorated stucco was noted in many places at the horizontal surfaces of the parapet walls.

Peeling paint and deteriorated stucco were noted in many places at the horizontal surfaces of the parapet walls. Recommend all of the horizontal stucco surfaces on the parapet walls be evaluated and improved or resealed as needed to help prevent water intrusion and moisture damage.

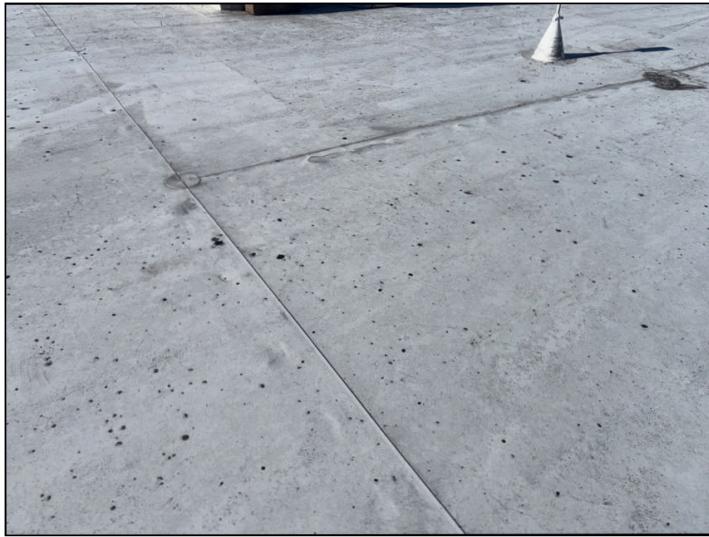
The roof is due for cleaning at various places.

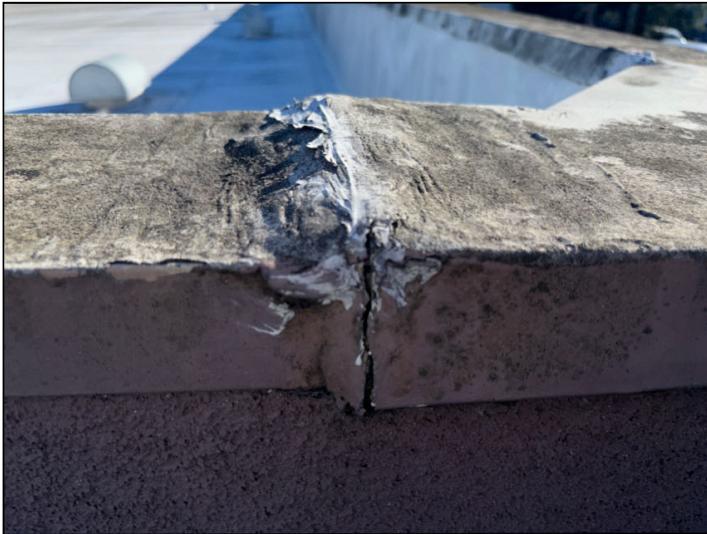
Cracked sealants and added sealants were noted in many places at the parapet cap flashings on the upper portion of the roof.

Cracked sealants and added sealants were noted in many places at the parapet cap flashings on the upper portion of the roofs. Recommend improving or resealing as needed.

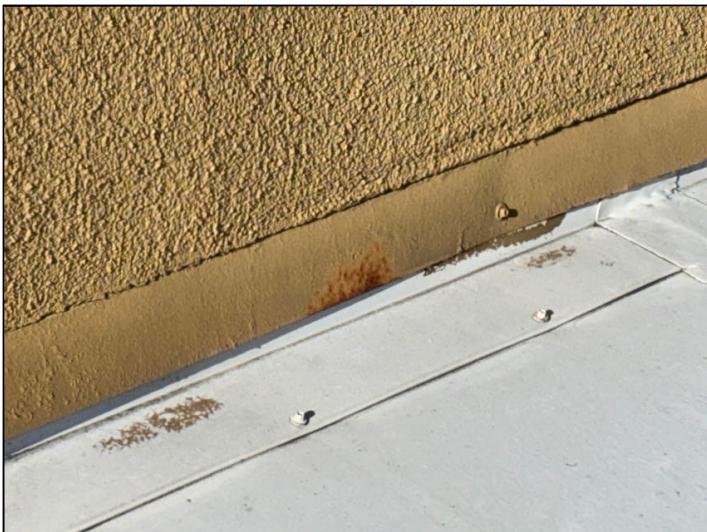
Corroded flashings were noted in various places on the roofs.

Corroded flashings were noted in various places on the roofs. Recommend cleaning and coating with a rust preventative material to help prevent further corrosion.

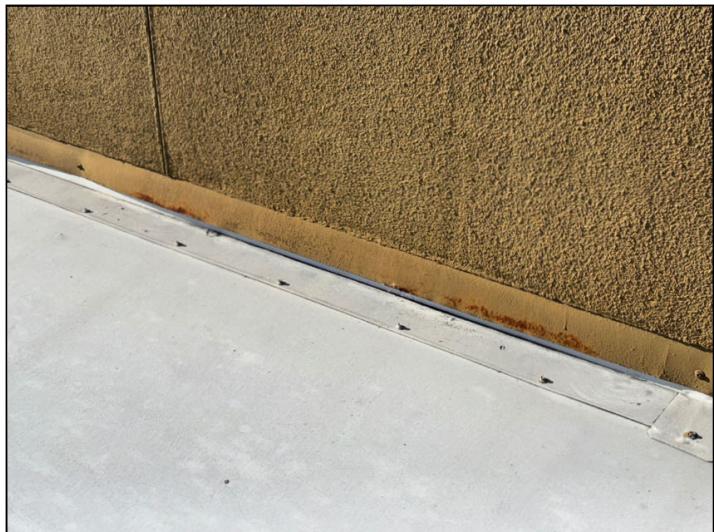
Corroded flashings were noted in various places on the roofs.

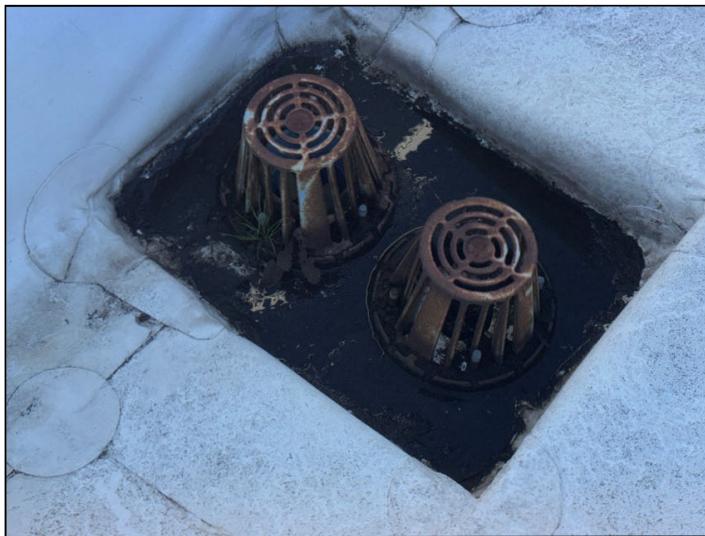
Recommend removing tree debris from the roof drains to help maintain proper drainage.

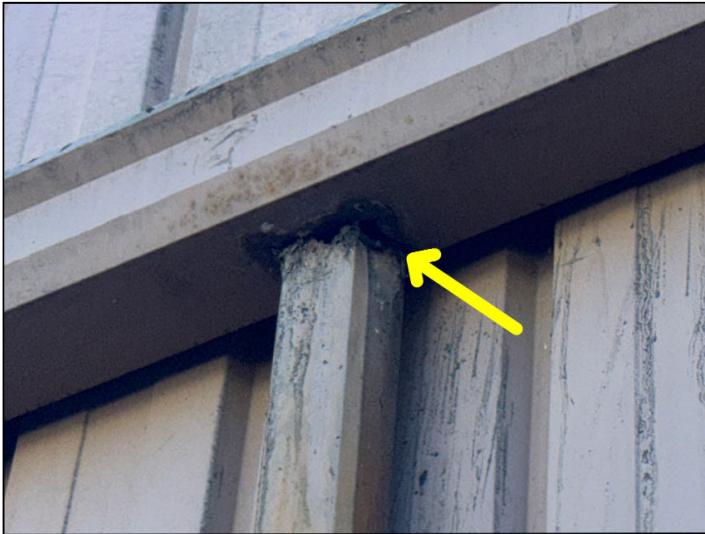
Corrosion was noted where a downspout is connected to the gutter at the rear of 12308.

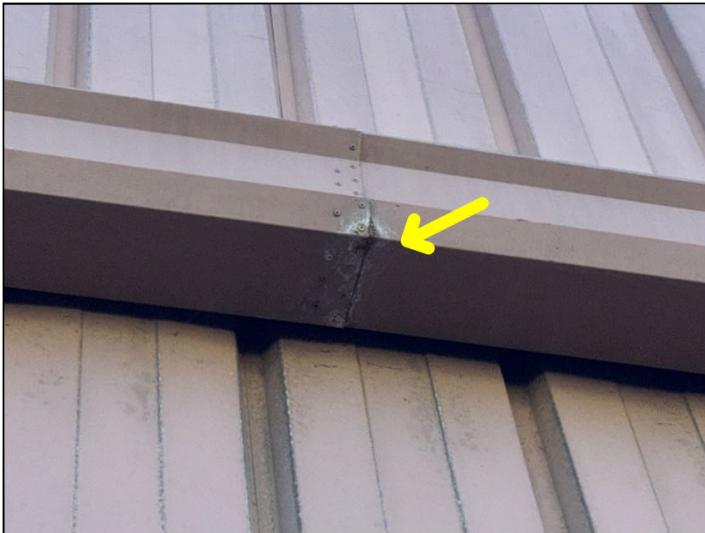
Stains and evidence of leakage were noted in many places at gutter seams.

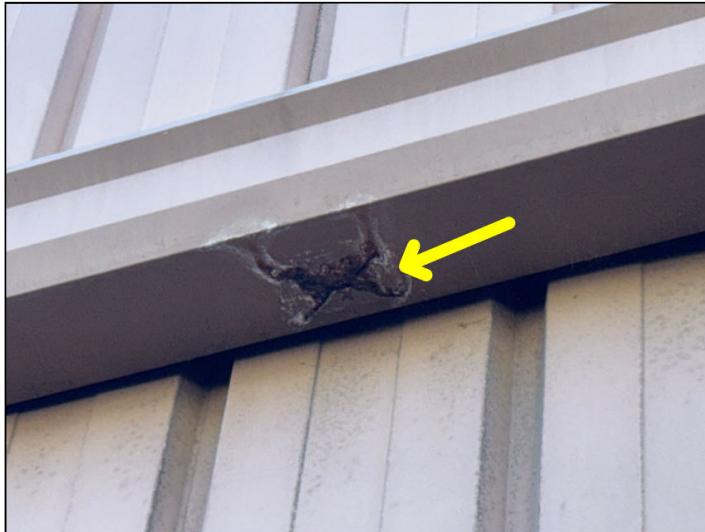
Corrosion was noted at the gutter in various places at the rear of 12320 and 12322.

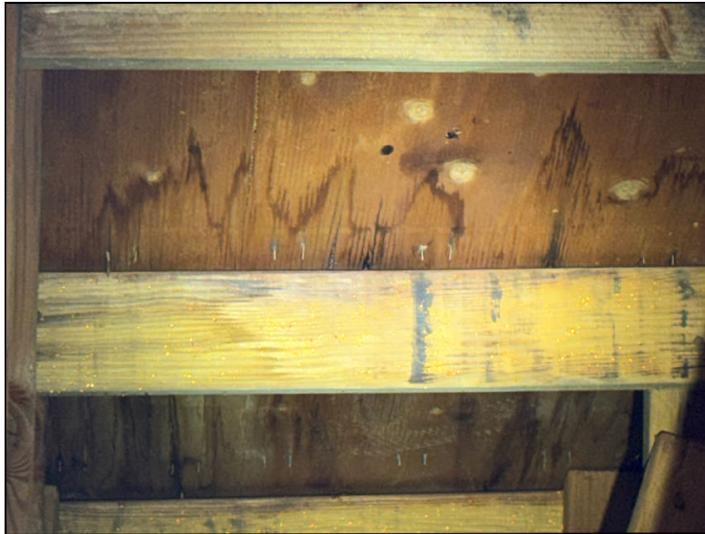
Moisture stains were noted in the attic of the stucco arch detail over 12338. The stains were dry at the time of the inspection.

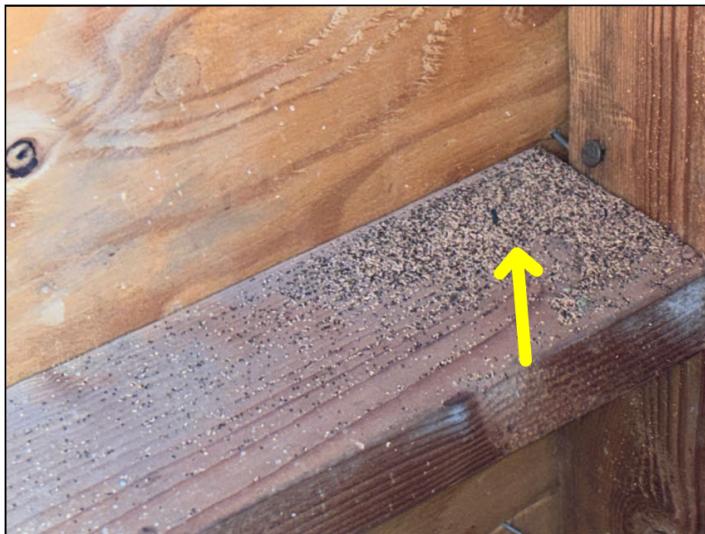
Apparent insect droppings were noted at various places in the attics of the stucco arch details on the roof.

Recommend the entire property be evaluated by a licensed structural pest control operator. See wood destroying organism (WDO) report for more information. Recommend all damaged wood at the exterior of the building be improved or replaced as needed by a qualified licensed contractor. Recommend all areas of repair be painted as needed by a licensed painting contractor.

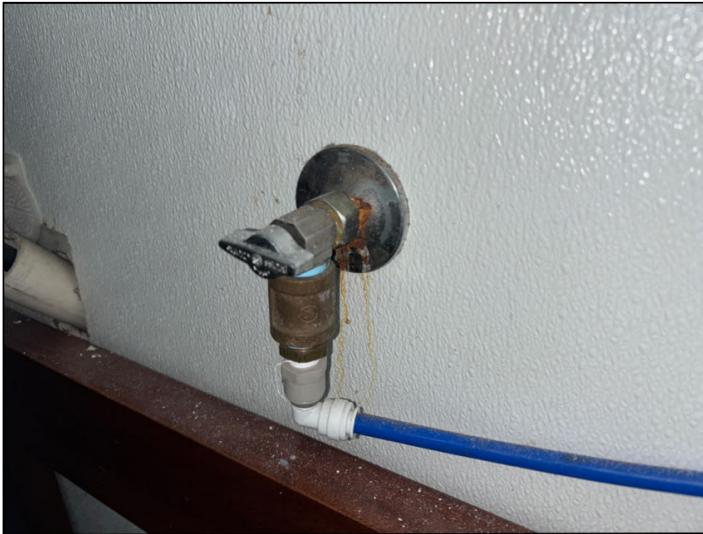
Stains and evidence of leakage were noted at a supply valve in the rear interior of 12300 adjacent to the water softener.

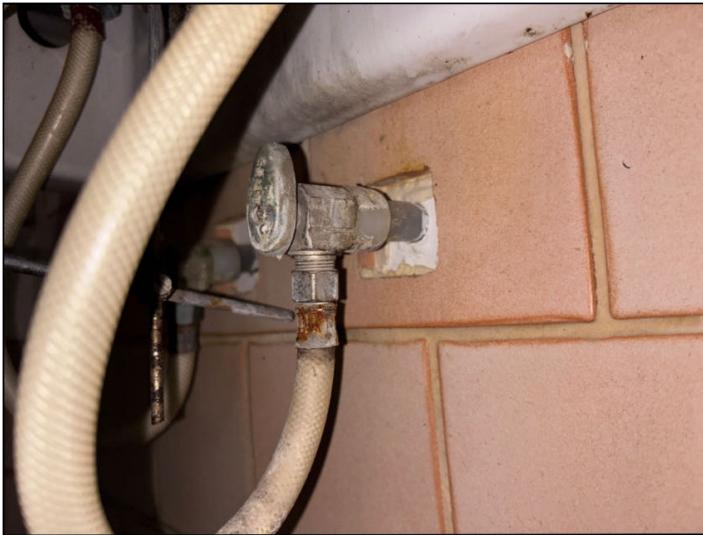
Corrosion was noted at the supply valves and adjacent connectors in the restroom of 12306.

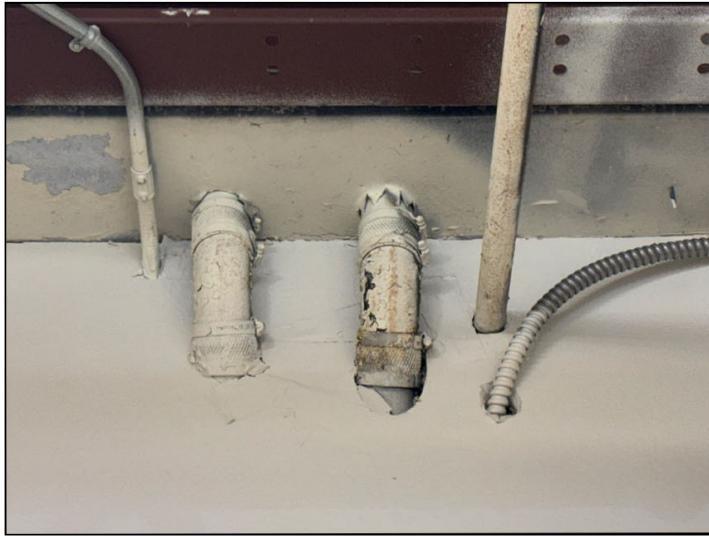
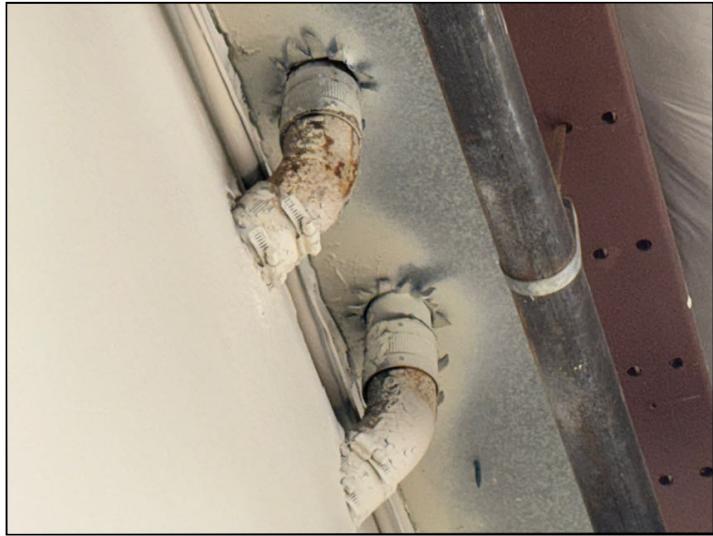
Corrosion and evidence of leakage were noted at the cast iron drain pipes where visible adjacent to the ceiling of 12340.

Corrosion and evidence of leakage were noted at the cast iron drain pipes where visible adjacent to the ceiling of 12340. Recommend further evaluation and improvements be made as needed by a licensed plumbing contractor.

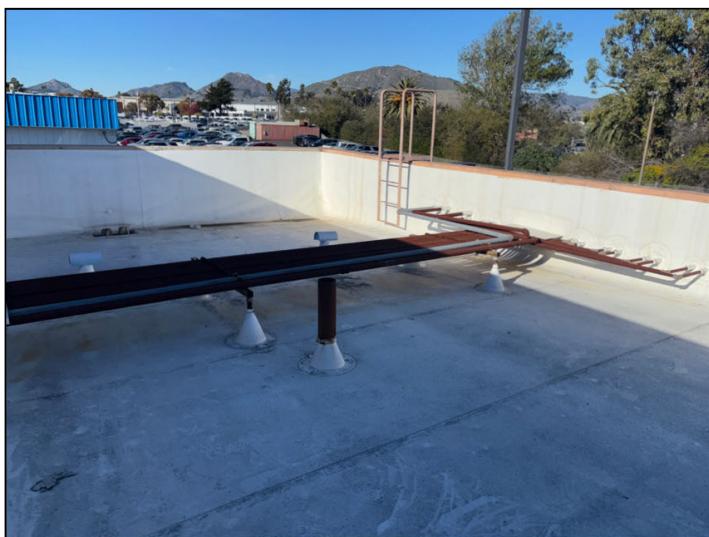
Corrosion was noted in many places at the gas lines on the roof.

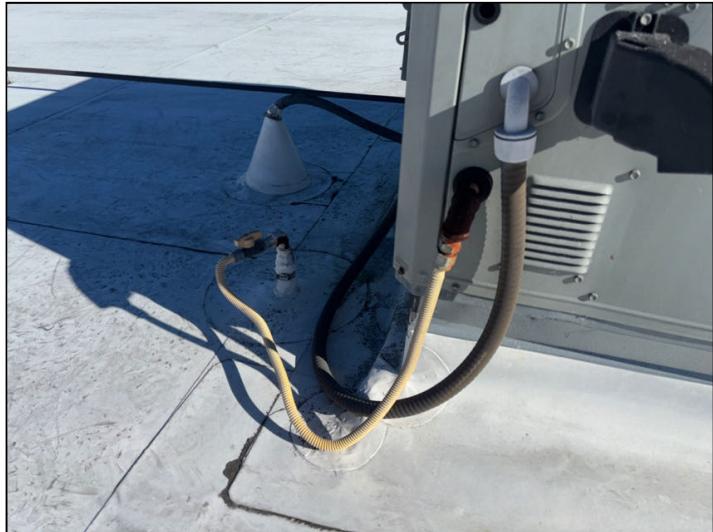
Rusted gas pipes and worn CSST gas connectors were noted in various places on the roof.

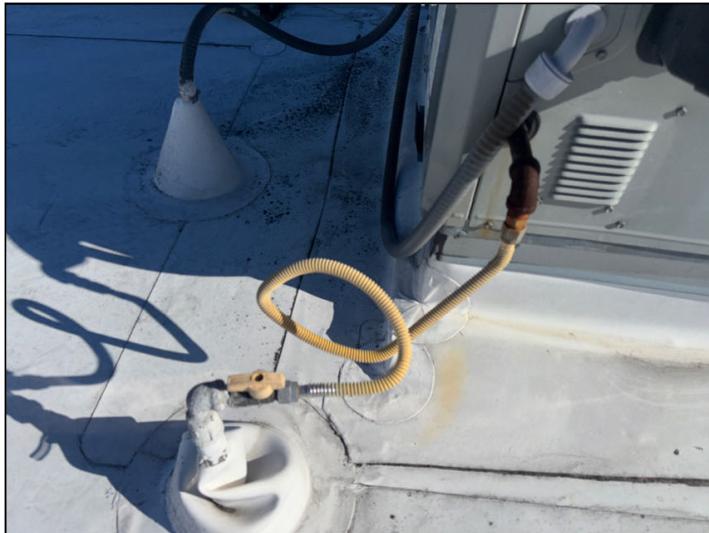
Rusted gas pipes and worn CSST gas connectors were noted at various places on the roof.

Recommend further evaluation and improvements of the fuel system by a licensed plumbing contractor.

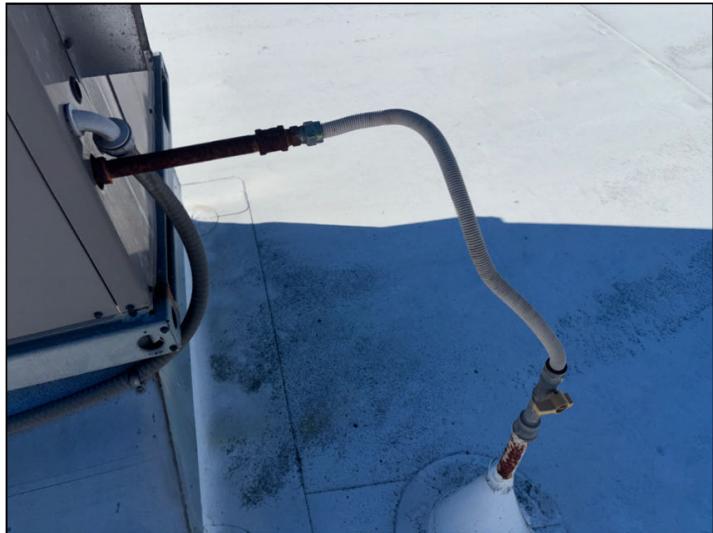
Rusted gas pipes and worn CSST gas connectors were noted in various places on the roof.

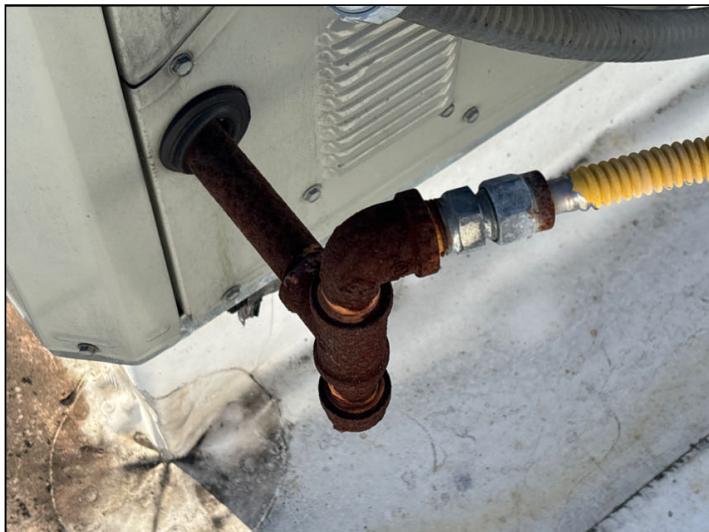
Rusted gas pipes and worn CSST gas connectors were noted in various places on the roof.

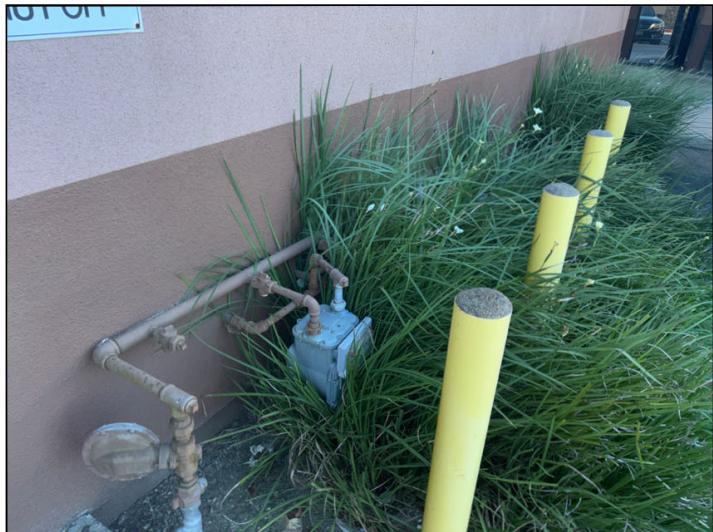
Rusted gas pipes were noted adjacent to various heating and cooling units on the roof.

Rusted gas pipes were noted adjacent to various heating and cooling units on the roof. Recommend cleaning and coating with a rust preventative material to help prevent corrosion.

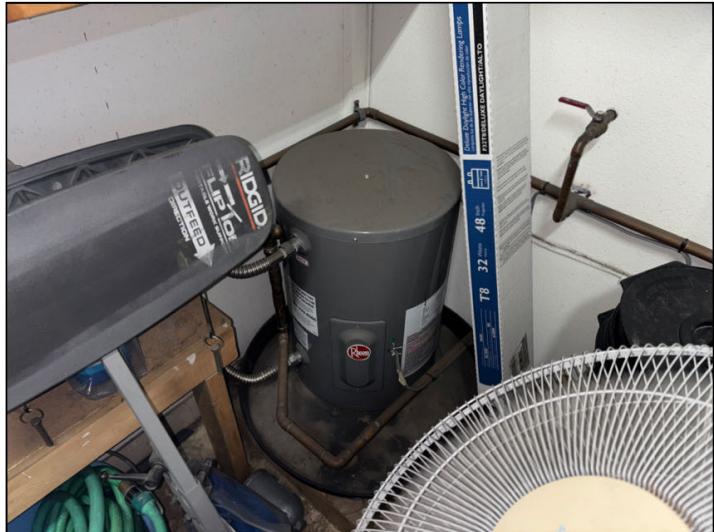
There is no seismic bracing at the water heater in 12322.

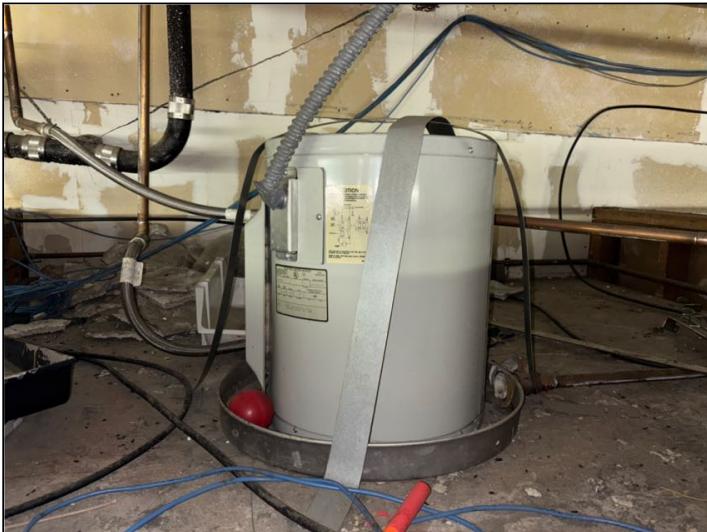
Inadequate seismic bracing was noted at the water heater in 12310.

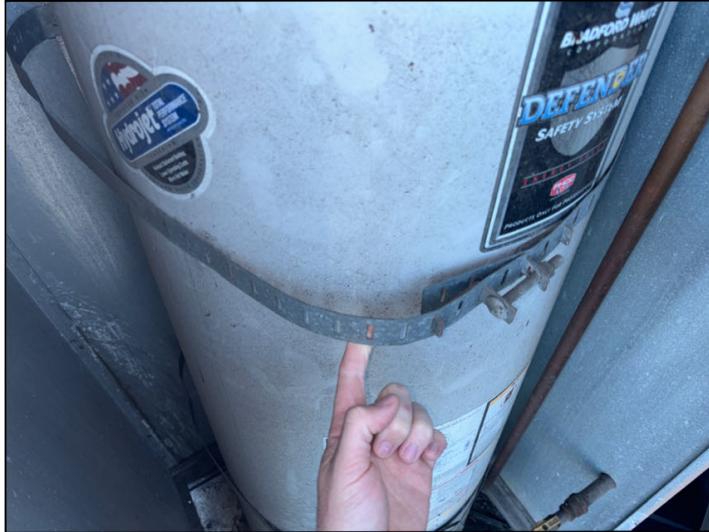
Loose seismic bracing was noted at the water heater at the rear exterior of 12304/06.

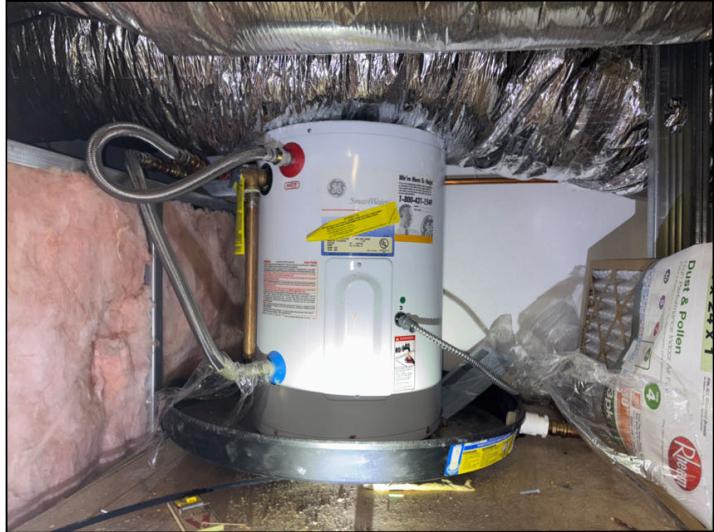
There is no seismic bracing at the water heater in 12326. Recommend installing blocking between the water heater and the wall.

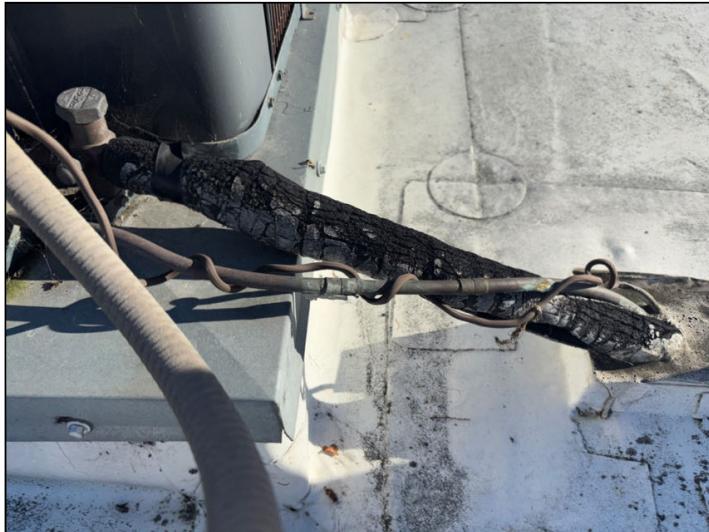
Deteriorated refrigerant line insulation was noted adjacent to the split system condenser on the roof of 12300. Recommend wrapping the refrigerant line insulation in UV resistant tape after all necessary repairs are completed.

Deteriorated refrigerant line installation was noted adjacent to the split system condenser on the roof of 12300.

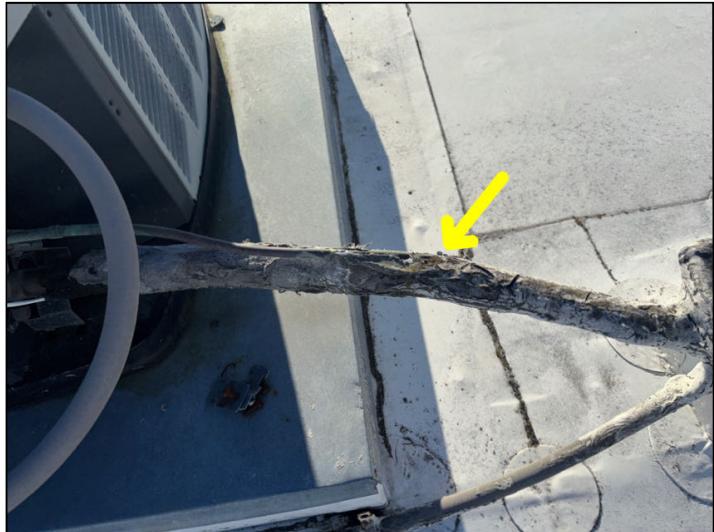
Deteriorated refrigerant line insulation and coatings were noted at the refrigerant line adjacent to the condenser over 12326.

Recommend all of the HVAC systems be cleaned, evaluated, and improved or replaced as needed by a licensed HVAC contractor.

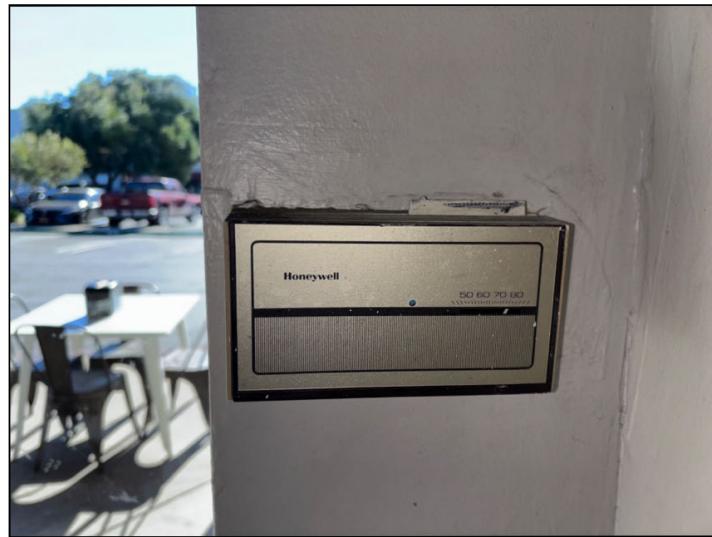
An older abandoned thermostat was noted at the front interior of 12304. Recommend replacement.

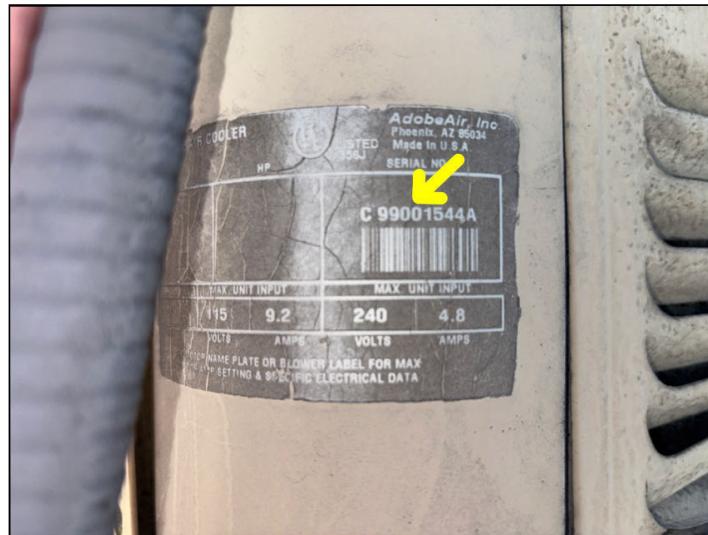
The evaporative cooler on the roof of 12304 is approximately 26 years old.

The evaporative cooler on the roof of 12304 is approximately 26 years old and is likely at the end of useful life. Recommend replacement.

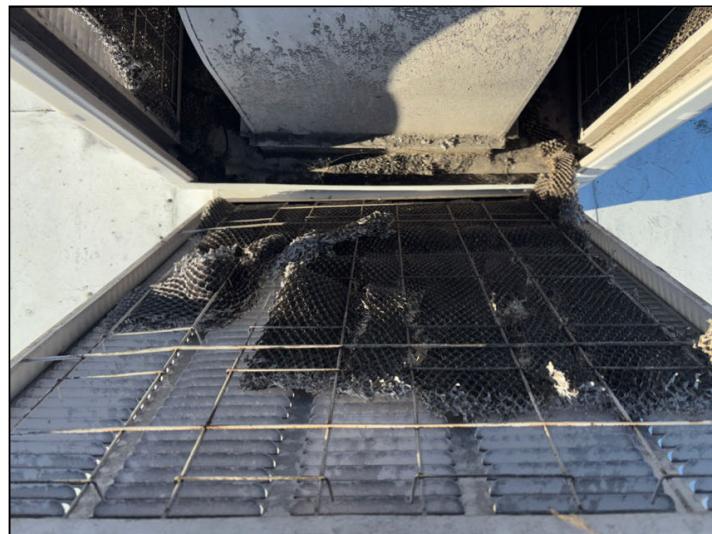
[Damaged media pads were noted at many places on the evaporative coolers.](#)

Recommend the evaporative coolers on the roof be evaluated and improved or replaced as needed by a licensed HVAC contractor.

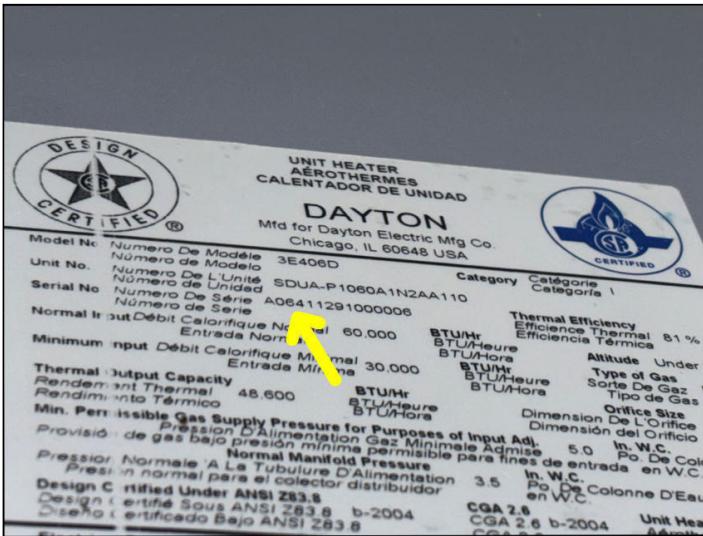
The package unit on the roof of 12322 is approximately 19 years old.

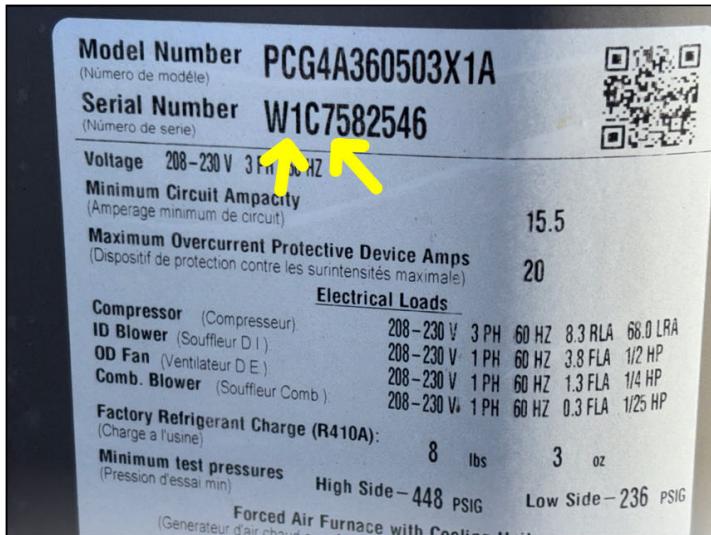
The package unit on the roof of 12318 is approximately 8 years old.

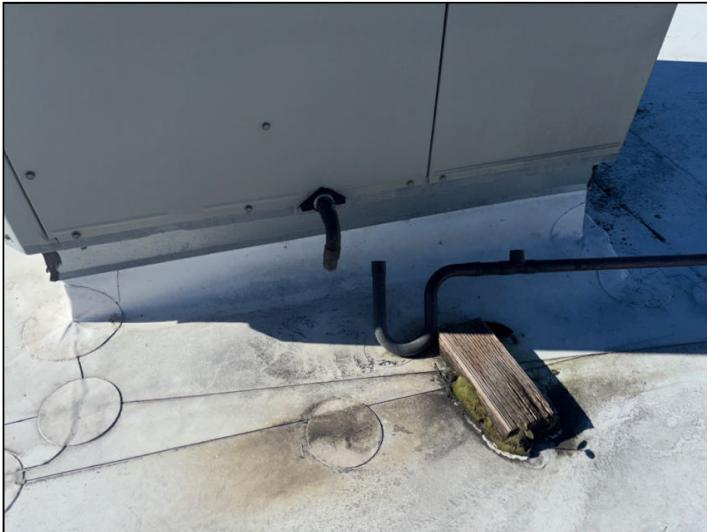
The condensate drain line for the package unit on the roof of 12310 is disconnected.

Recommend all of the package units be cleaned, evaluated, and improved or replaced as needed by a licensed HVAC contractor.

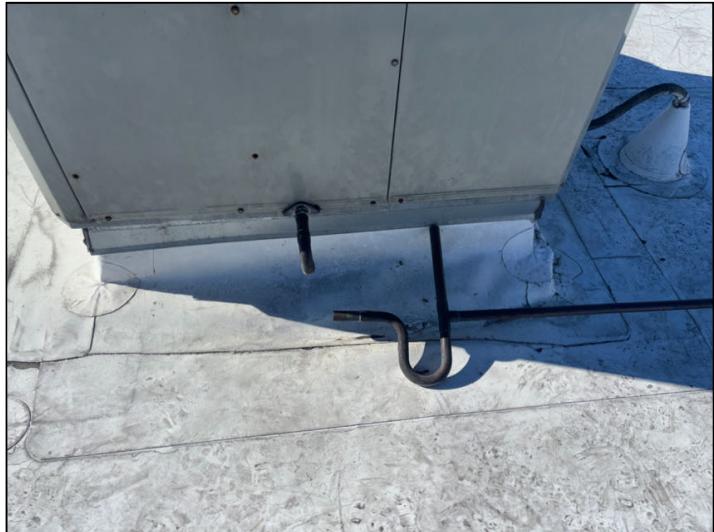
The condensate drain line for the package unit on the roof 12314 is disconnected in various places.

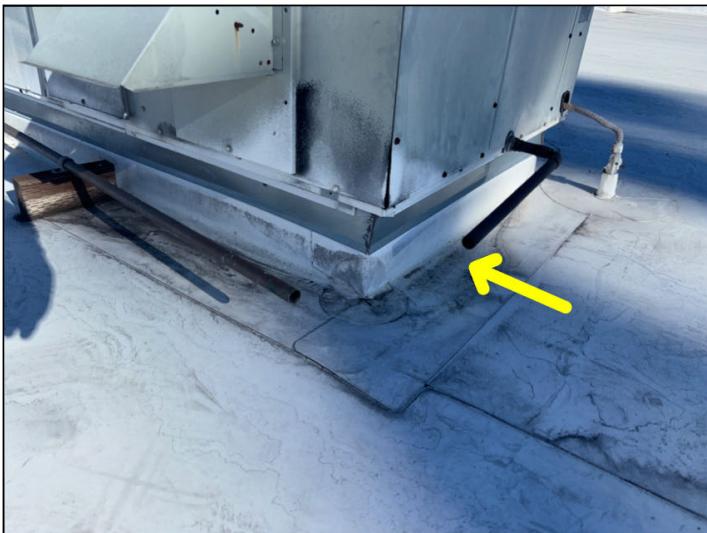
The condensate drain line for the package unit on the roof at 12324 is disconnected.

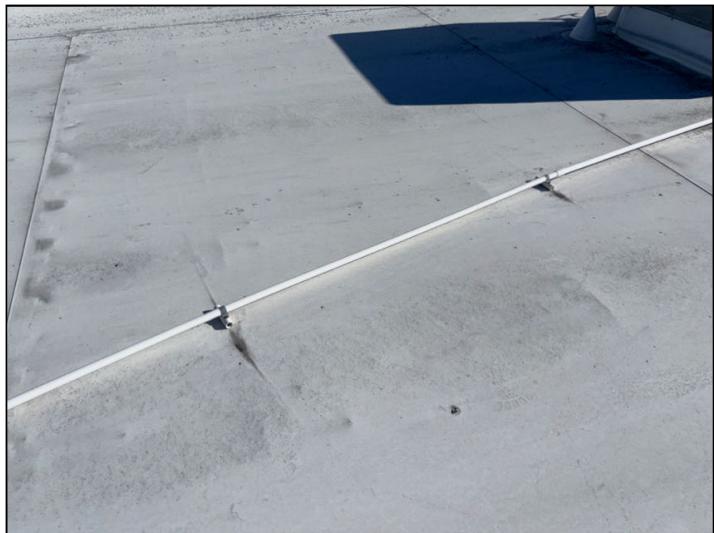
The condensate drain lines for the package units on the roof are not secured to the roof.

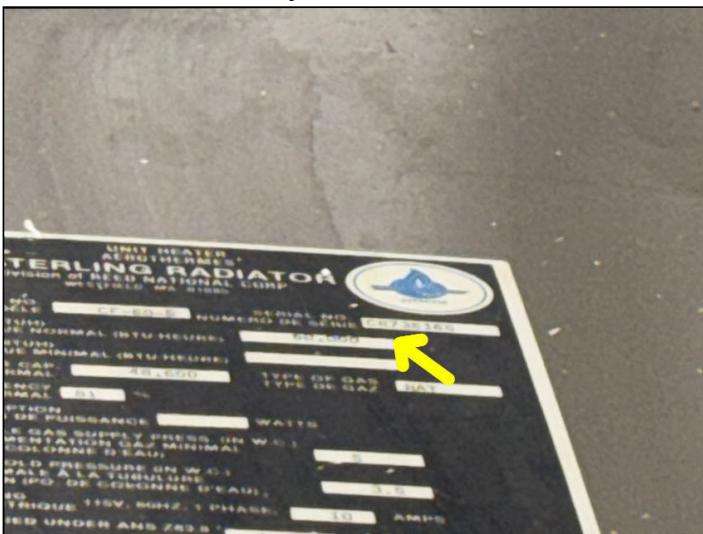
The space heater in 12334 is approximately 38 years old.

The majority of the space heaters are 38-39 years old and are likely at the end of useful life. Replacement is recommended.

Recommend all of the space heaters be evaluated and improved or replaced as needed by a licensed HVAC contractor.

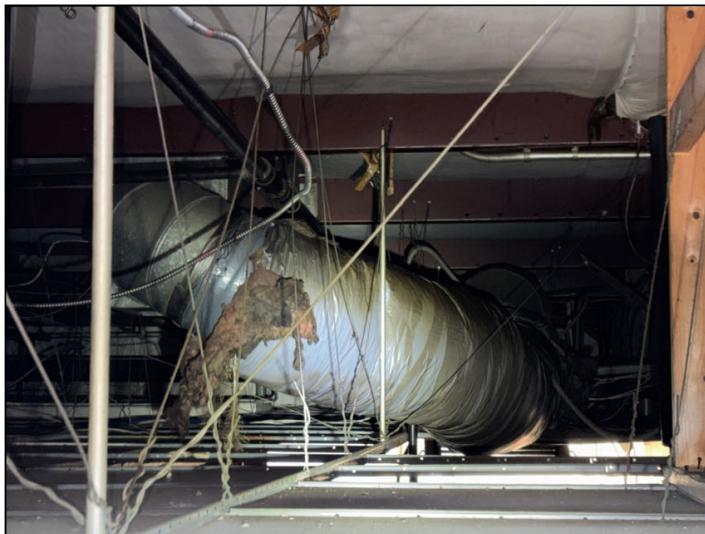
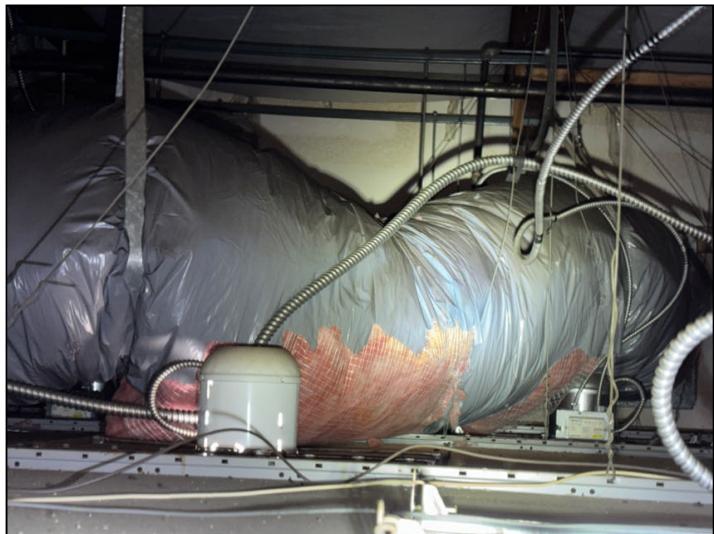
Older deteriorated gray ducting was noted in the attic over 12304. The majority of the ducting tied to older systems may be at the end of useful life. Recommend further evaluation and improvements be made as needed by a licensed HVAC contractor.

Older deteriorated gray ducting was noted in the attic over 12304.

Recommend all of the ducting be evaluated and improved or replaced as needed. Consult a licensed HVAC contractor for more information.

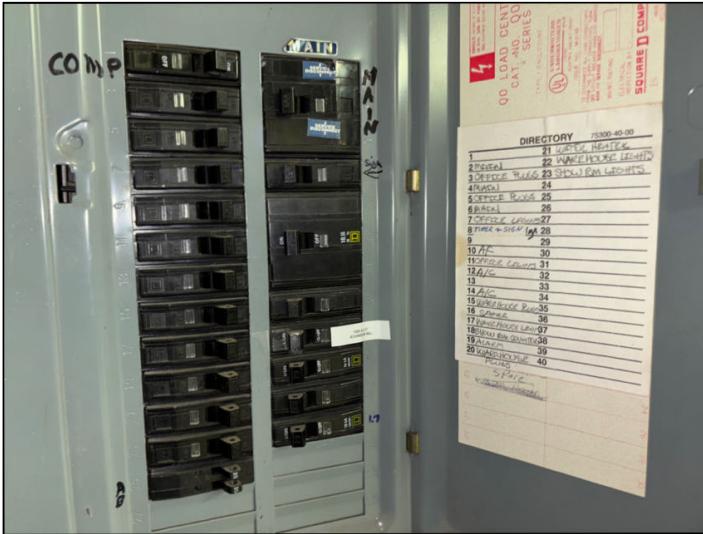
Incomplete breaker identification labeling was noted at the subpanel in the rear of 12310.

Recommend the subpanels be evaluated and improved as needed by a licensed electrician.

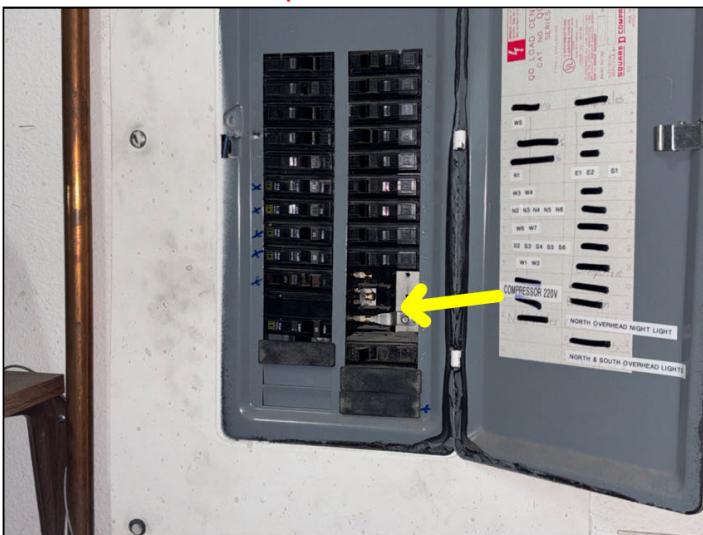
Missing filler plates were noted at the subpanel in the rear storage area of 12322.
