O'BRIEN
BUILDING INSPECTIONS INC.

SAMPLE
INSPECTION REPORT
3576 Main Street
Goleta, CA

Prepared for Island Investments LLC

12/8/2025

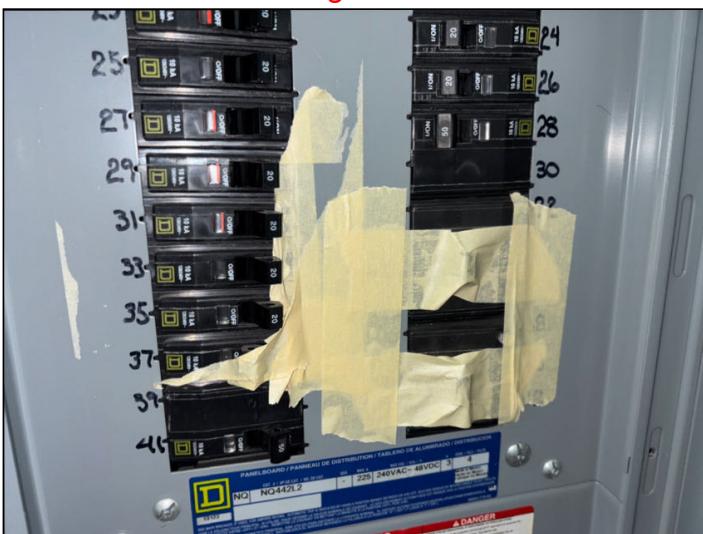
Various breakers are taped in the off position at the rear interior of 12300.

Recommend the subpanels be evaluated and improved as needed by a licensed electrician.

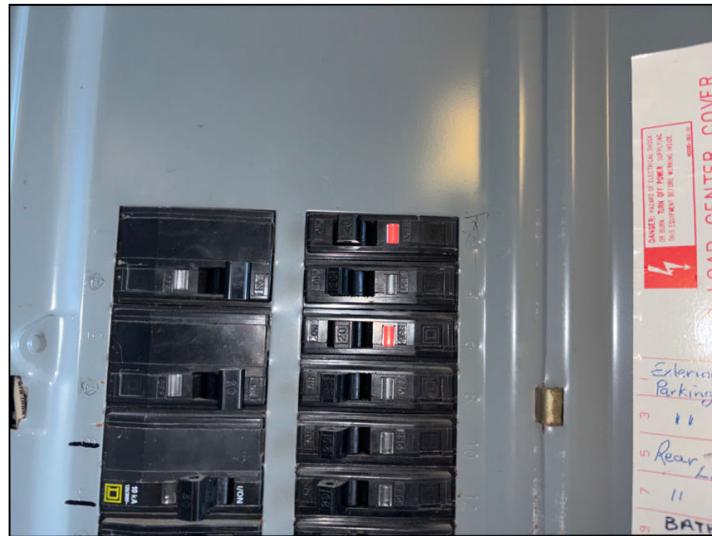
Two of the breakers in the house panel were found tripped at the time of inspection.

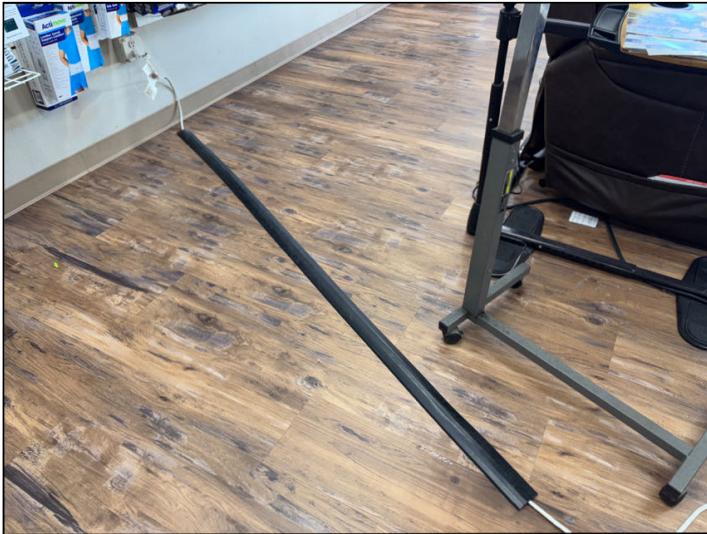
Temporary extension cords have been permanently installed at the sale room of 12310.

Recommend further evaluation and improvements be made as needed by a licensed electrician.

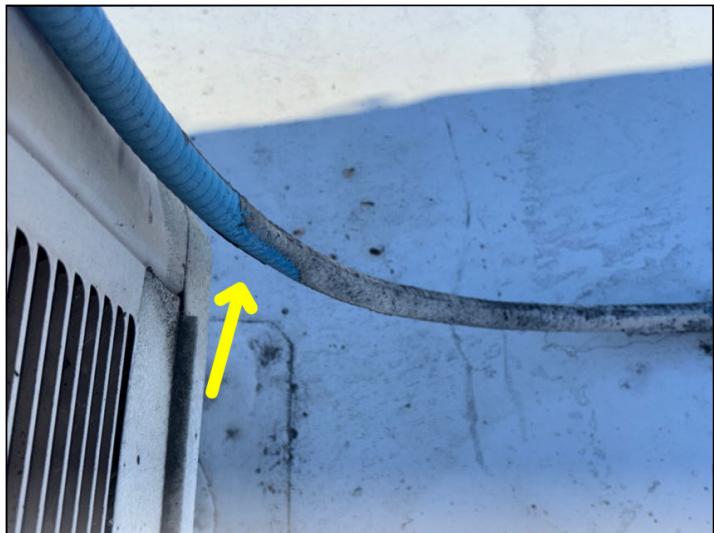
Deteriorated conduits were noted in various places on the roof of 12308.

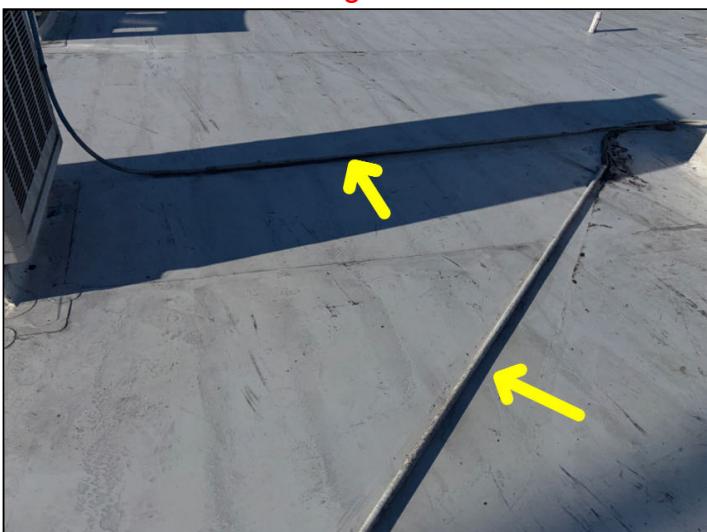
Unsecured conduits were noted in various places on the roof of 12308.

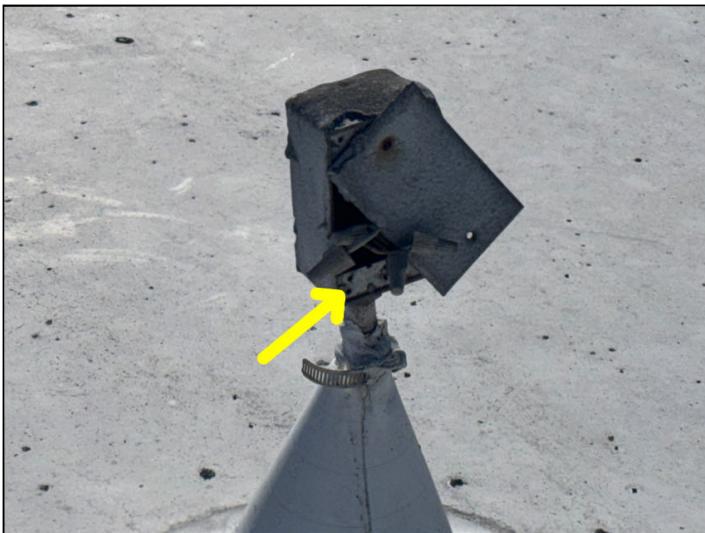
An open junction box was noted on the roof of 12308.

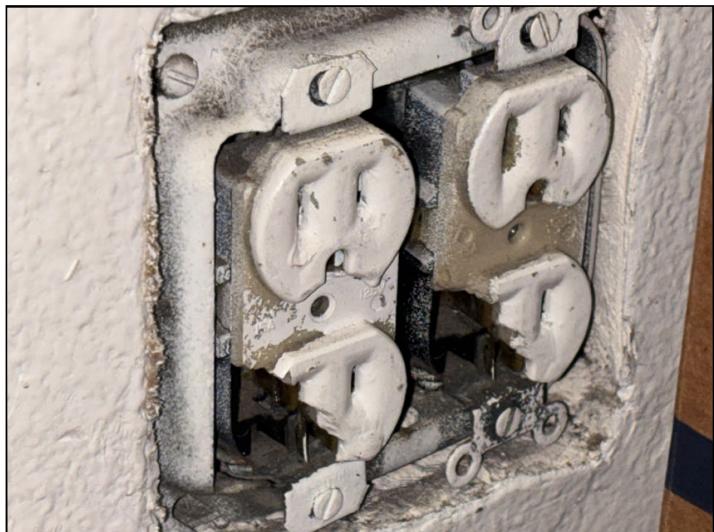
Damaged receptacles and a missing receptacle cover plate were noted at the rear interior storage area of 12308.

Recommend the lights, receptacles, and misc. devices be evaluated and improved as needed by a licensed electrician.

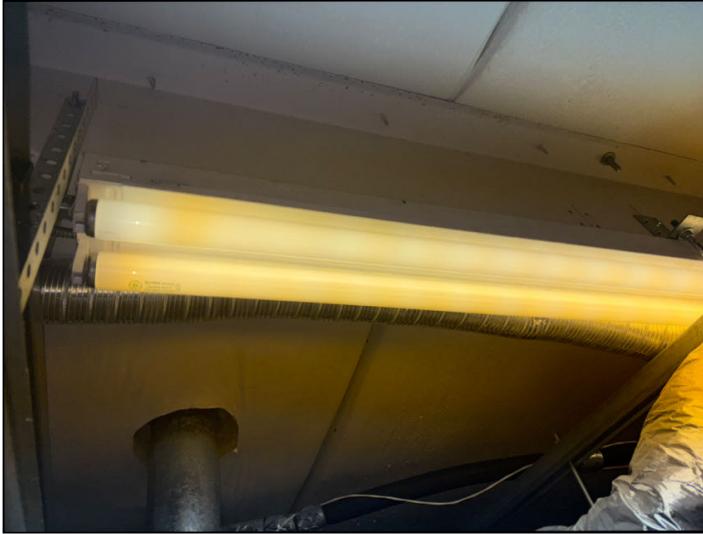
Recommend a proper light cage be installed around the light fixture in the attic over the 12326 restroom.

Recommend a proper light cage be installed around the light fixture in the attic over the 12326 restroom.

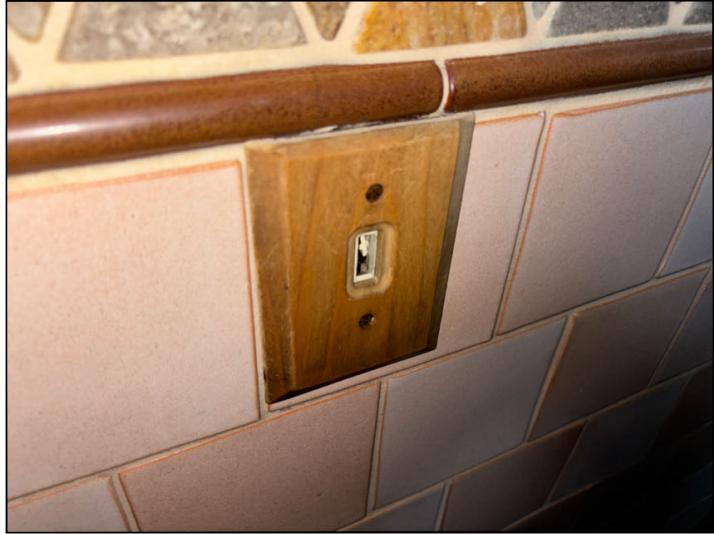
A damaged light switch was noted in the restroom of 12306.

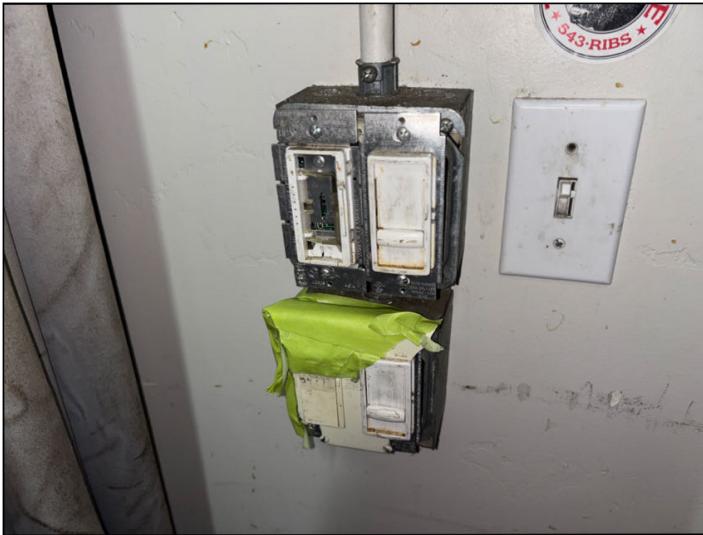
Damaged switches and switch cover plates were noted at the rear storage area of 12306.

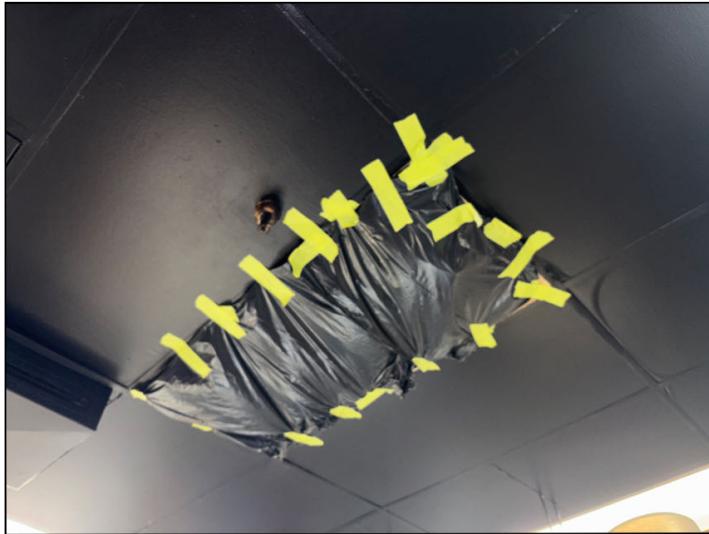
A flickering light was noted over the kitchen in 12308. This light has been covered.

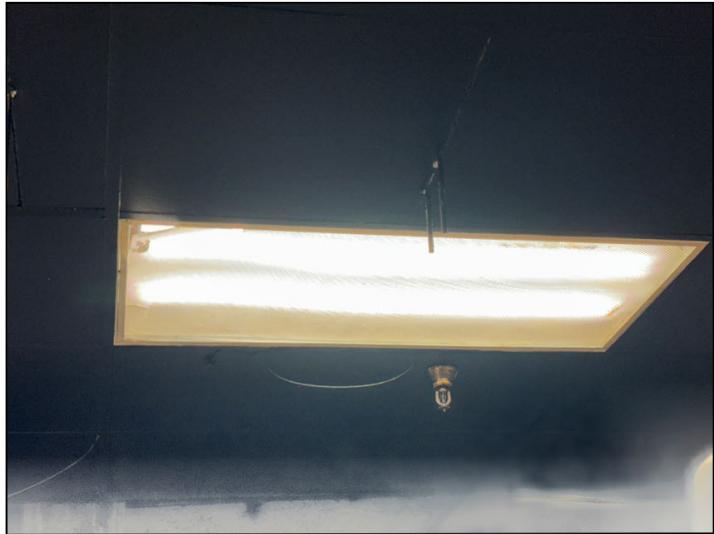
A damaged light diffuser was noted adjacent to the ventilation hood in the kitchen of 12308.

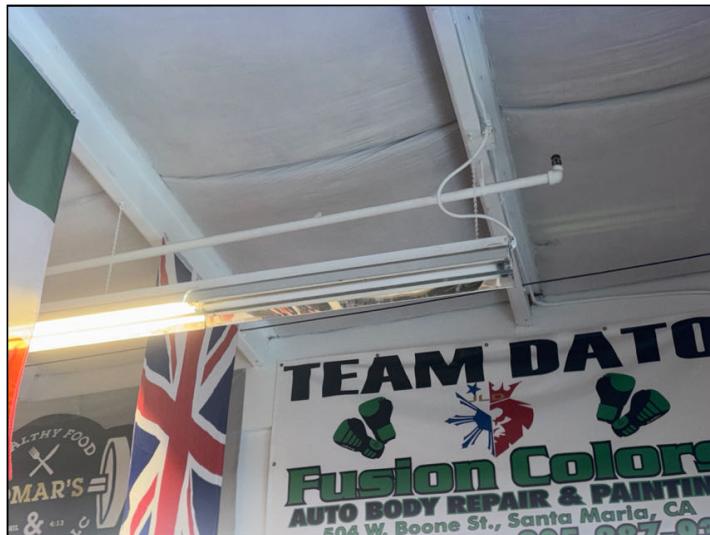
Various burnt out bulbs were noted at the front of 12338.

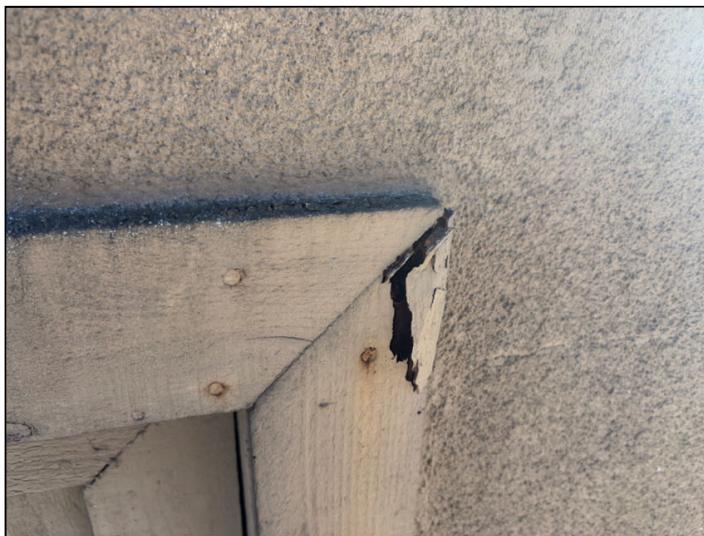
Moisture damage and apparent insect damage were noted in various places at the attic access doors and adjacent framing on the backside of the stucco arch details. See WDO report for more information.

Moisture damage and apparent insect damage were noted in various places at the attic access doors and adjacent framing on the backside of the stucco arch details.

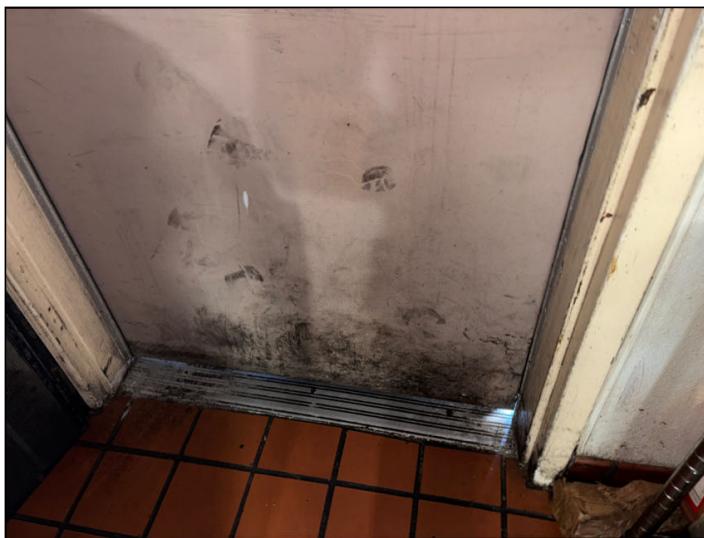
Cosmetic damage was noted at the rear exterior door of 12304. Recommend refinishing as needed.

Cosmetic damage was noted at the rear exterior door of 12304.

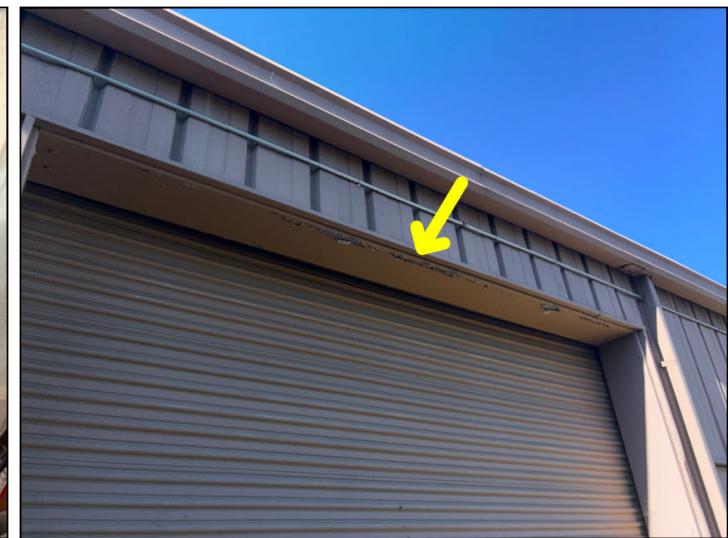
Peeling paint was noted above the rollup vehicle door on the rear of 12338. Recommend refinishing as needed.

Peeling paint was noted above the rollup vehicle door on the rear of 12338.

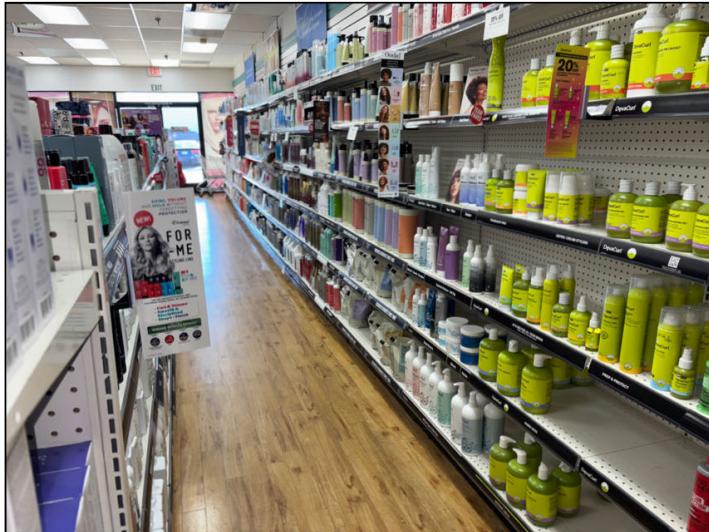
Stored items and furnishings prevent full inspection.

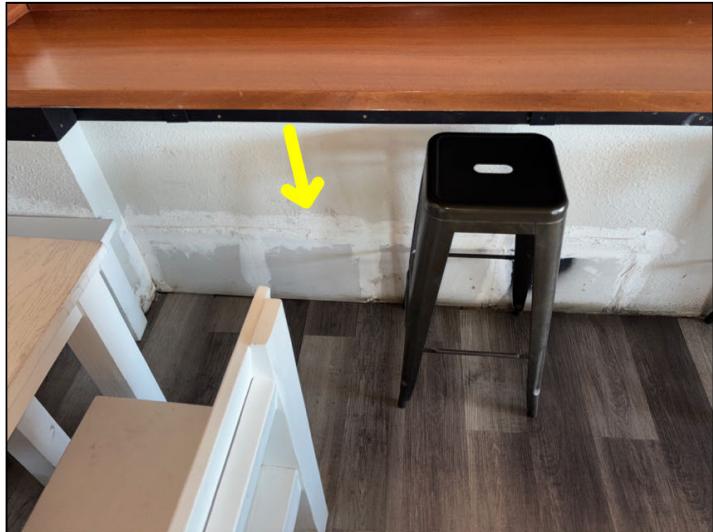
A large patch was noted at the base of the wall between 12306 and 12308. Consult the seller or tenant for more information.

A large patch was noted at the base of the wall between 12306 and 12308.

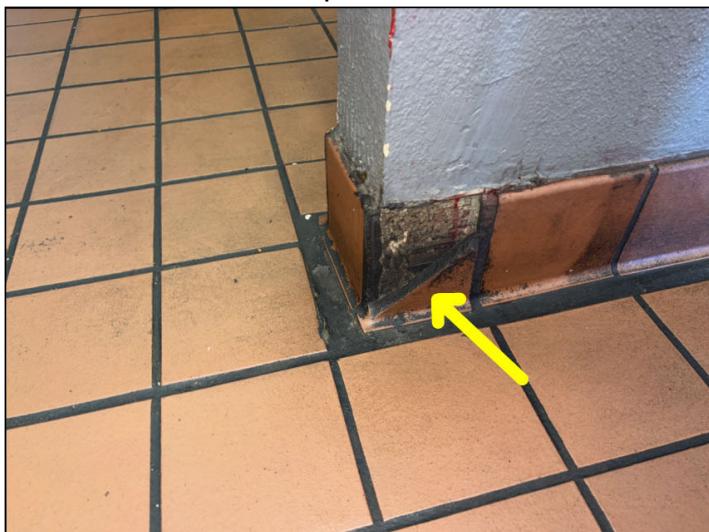
Damaged base tile was noted between the register and the kitchen at the front of 12308. Recommend improvements be made as needed by a qualified professional.

Damaged base tile was noted between the register and the kitchen at the front of 12308.

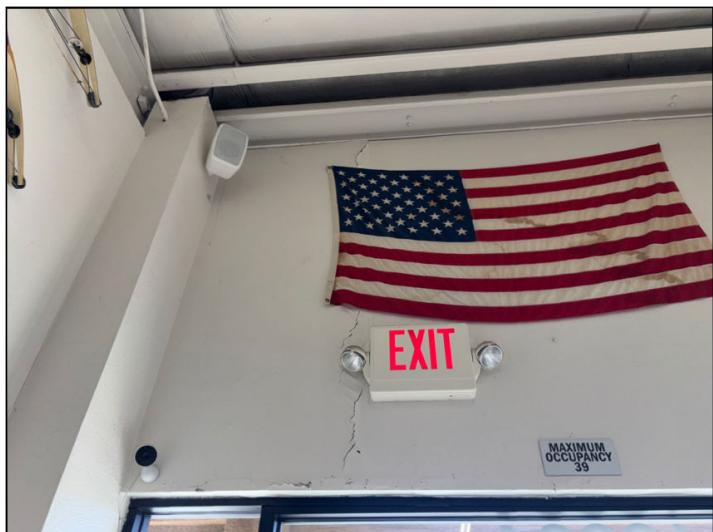
Cracked and peeling paint and evidence of water intrusion were noted at the wall over the entry door to 12334. Hidden damage may be present. Recommend further evaluation and improvements be made as needed by a qualified licensed contractor.

Cracked and peeling paint and evidence of water intrusion were noted at the wall over the entry door to 12334. Hidden damage may be present.

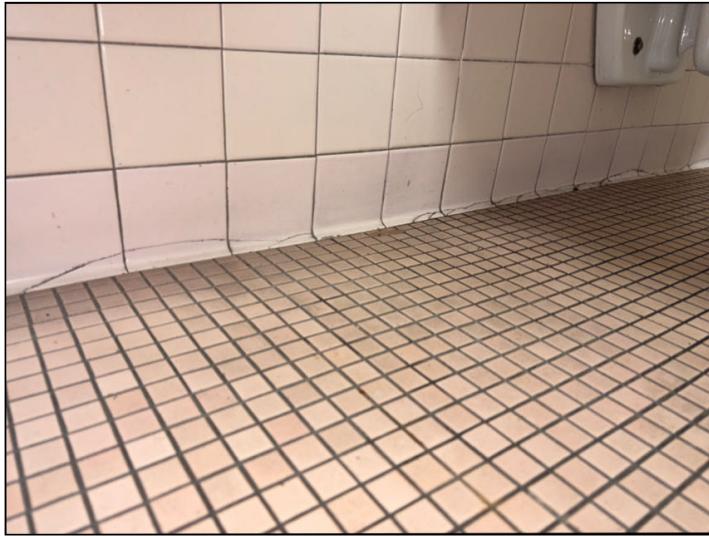
Cracked and damaged tiles were noted at many places where the walls meet the floors in the men's common restroom. Recommend further evaluation and improvements be made as needed by a qualified licensed contractor.

Cracked and damaged tiles were noted at many places where the walls meet the floors in the men's common restroom.

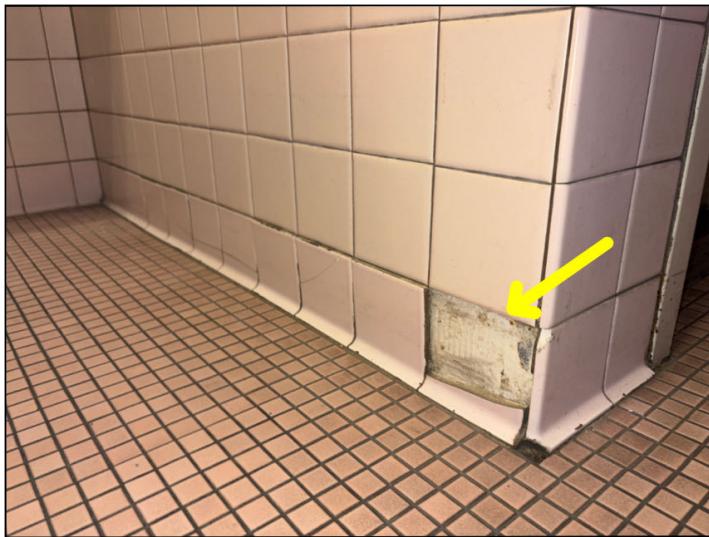
Damaged tiles were noted at the wall adjacent to the common women's restroom sinks. Recommend further evaluation and improvements be made as needed by a qualified licensed contractor.

Damaged tiles were noted at the wall adjacent to the common women's restroom sinks.

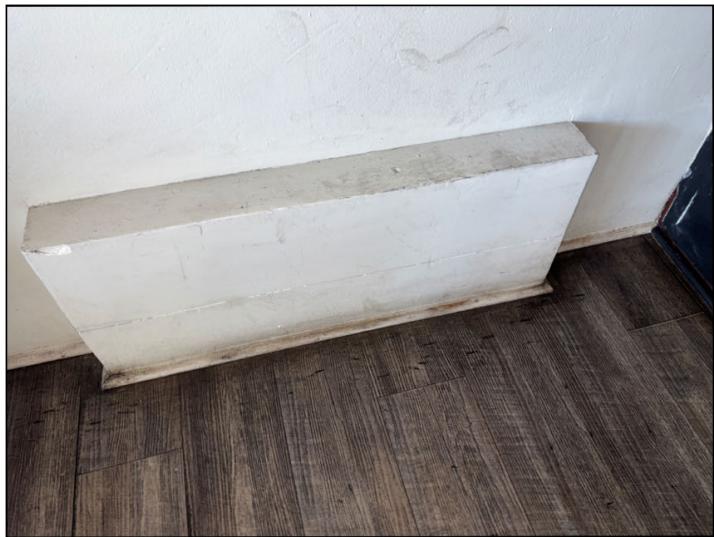
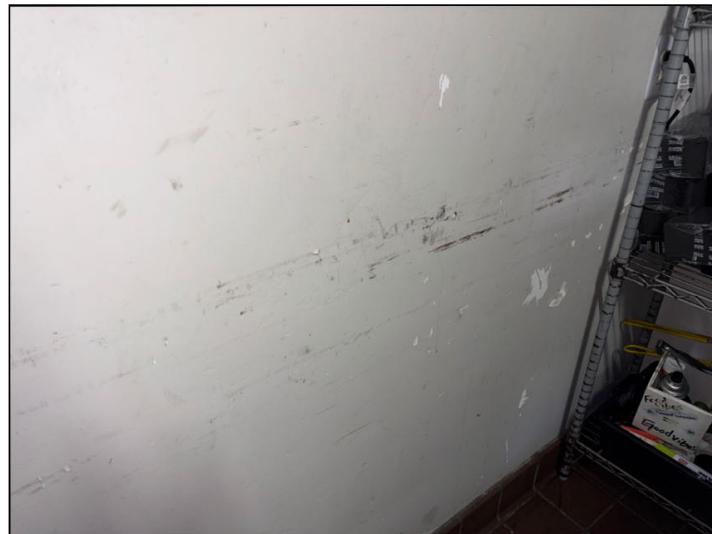
Cosmetic damage was noted in various places at the interior walls. Recommend cleaning and refinishing as needed.

Cosmetic damage was noted in various places at the interior walls.

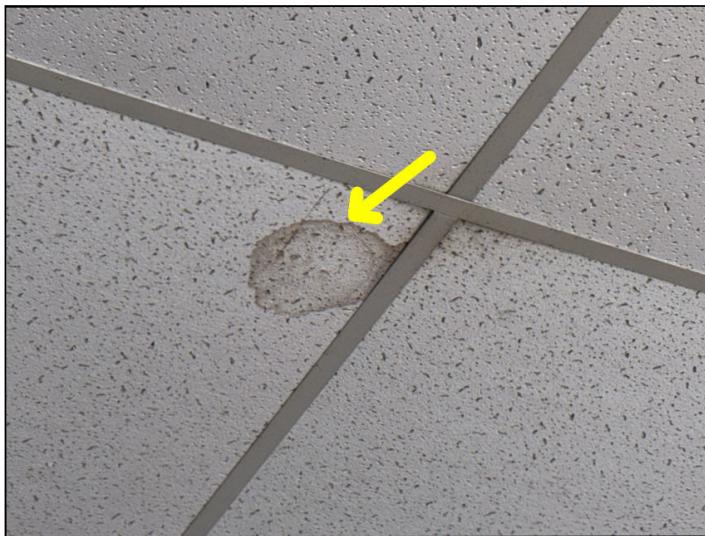
A moisture stain and evidence of water intrusion were noted at a ceiling tile at the front of 12308. Recommend further evaluation and improvements be made as needed by a qualified licensed contractor.

A moisture stain and evidence of water intrusion were noted at a ceiling tile at the front of 12308.

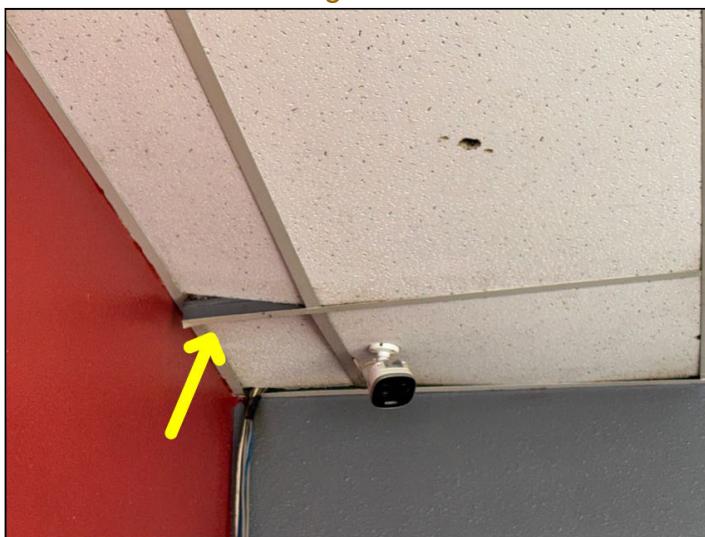
Damaged and displaced ceiling tiles were noted in various places at the front of 12308. Recommend improvements be made as needed by a qualified professional.

Damaged and displaced ceiling tiles were noted in various places at the front of 12308.

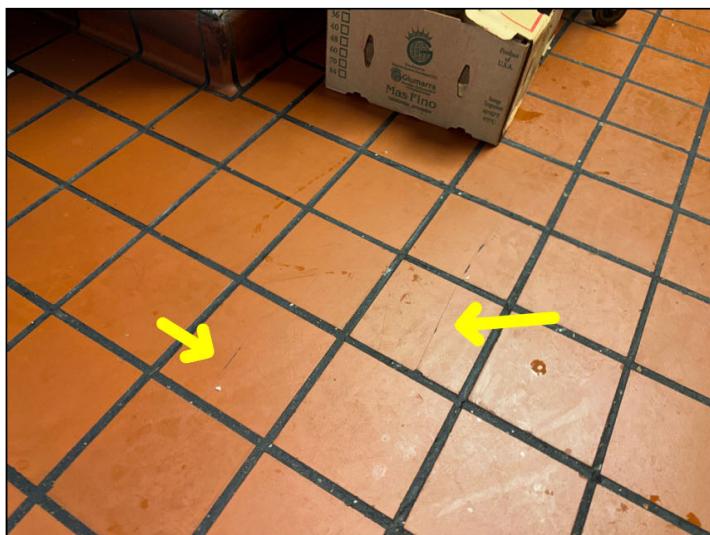
Various cracked floor tiles were noted in the kitchen of 12304.

Recommend all damaged flooring be evaluated and improved as needed by a qualified licensed contractor.

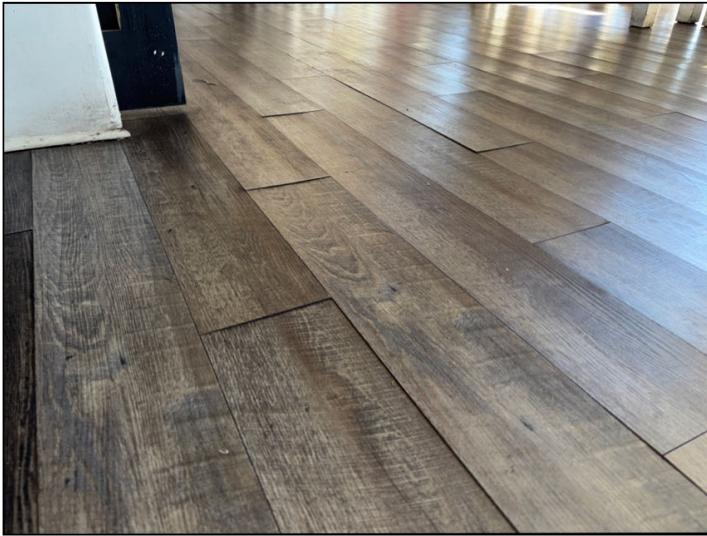
Damaged and uplifted vinyl planks were noted at many places in 12304.

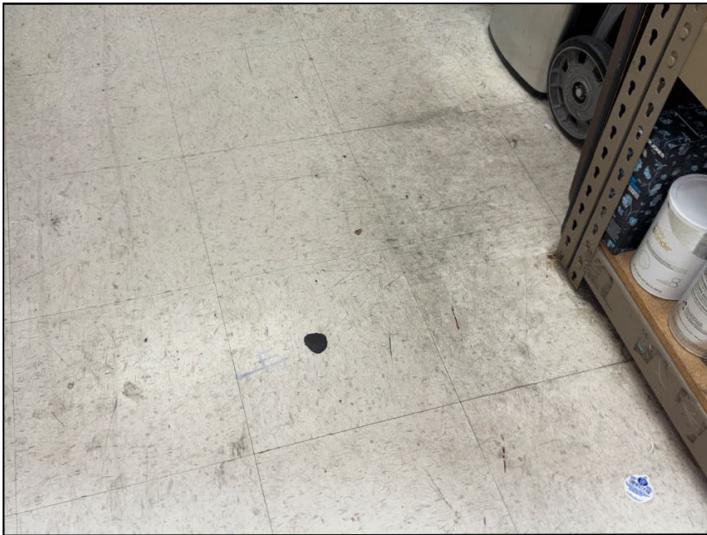
Damaged floor material was noted at various places in the rear storage room of 12314.

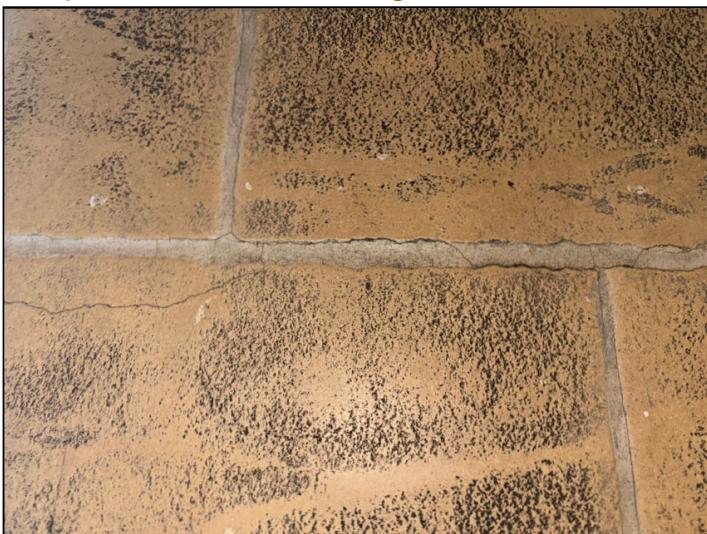
Cracked tiles were noted in various places at the hallway in 12324.

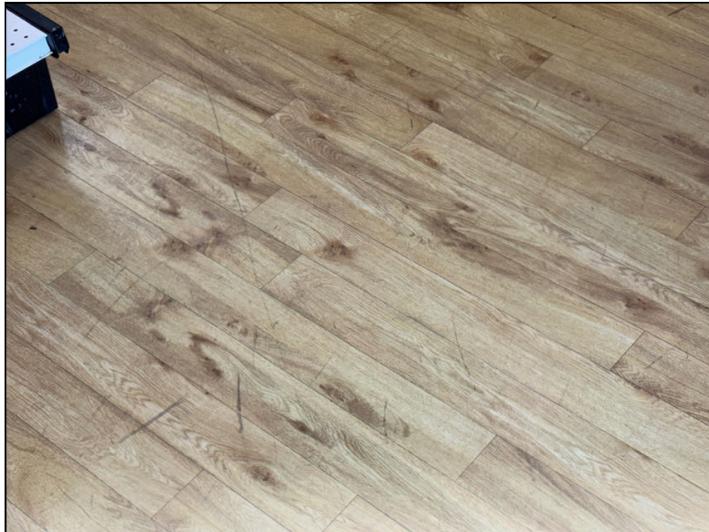
Cosmetic damage was noted in many places at the floor in 12314.

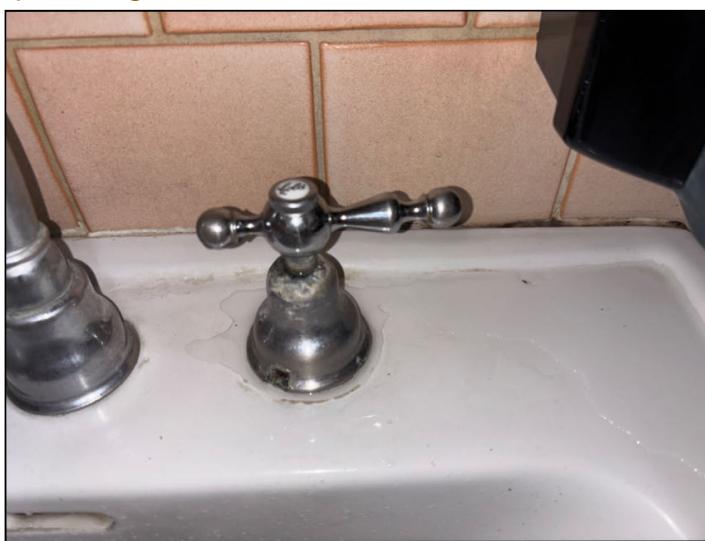
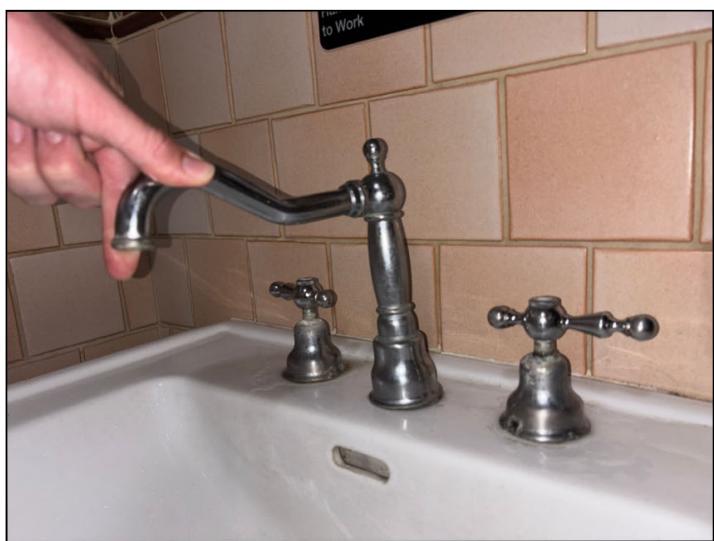
An active leak was noted at the cold water faucet in the restroom of 12306.

The sink faucet is loose in the restroom of 12306.

An active leak was noted at the cold water faucet in the restroom of 12306. The sink faucet is loose in the restroom of 12306.

Recommend the restroom sinks and faucets be evaluated and improved as needed by a licensed plumbing contractor.

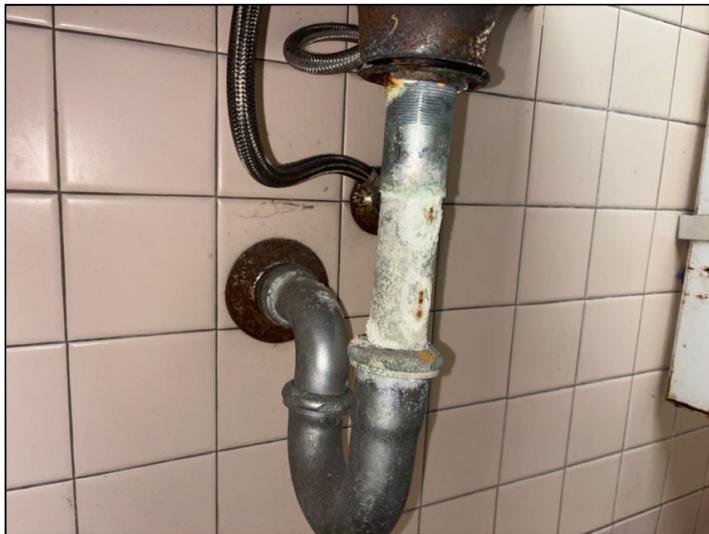
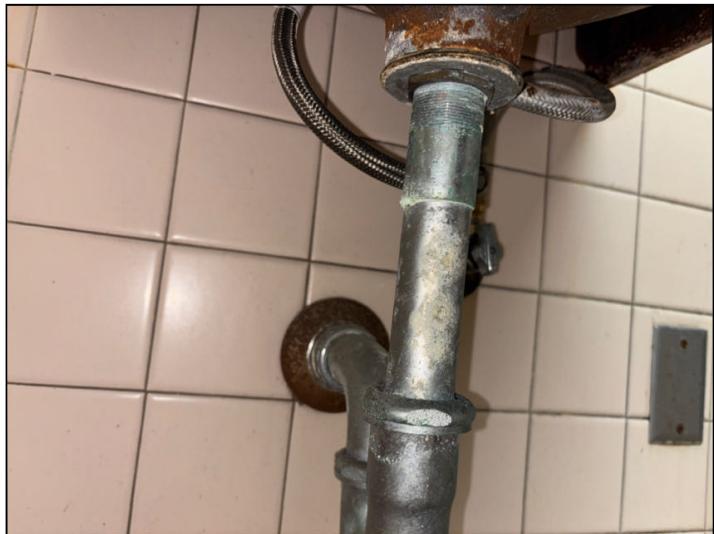
Heavy mineralization was noted at the drain lines below the men's common restroom sinks.

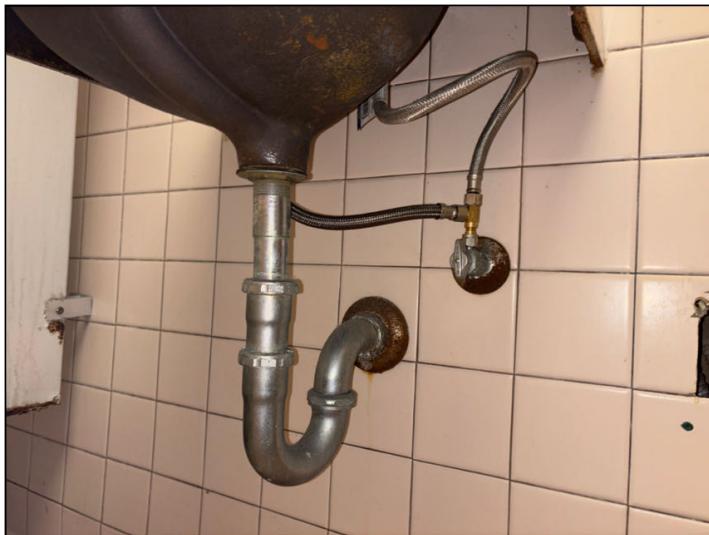
Corrosion was noted at various components below the men and women's restroom sinks.

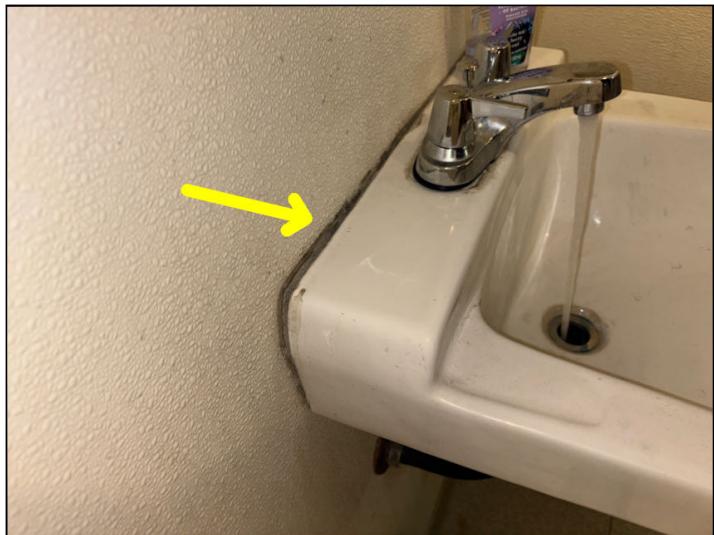
The sink is loose at the wall in the restroom at 12310.

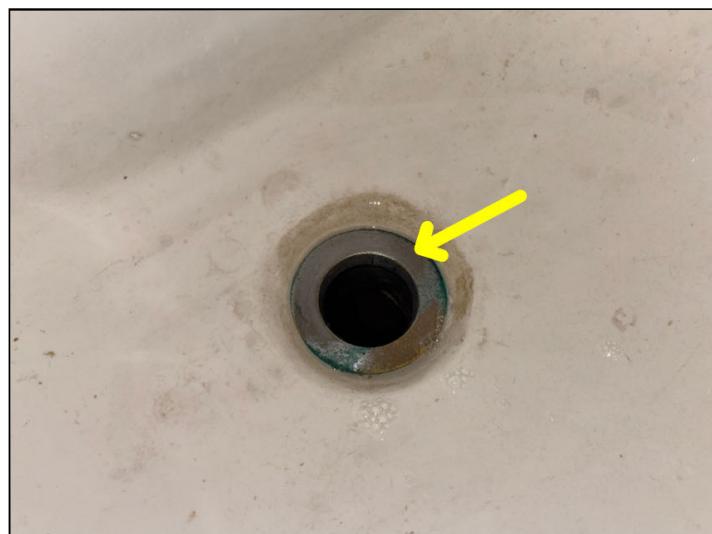
A missing sink drain stopper was noted in the restroom of 12310.

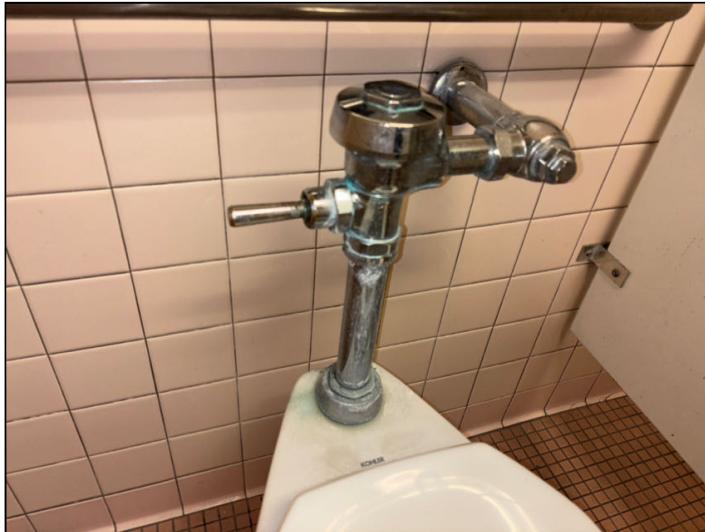
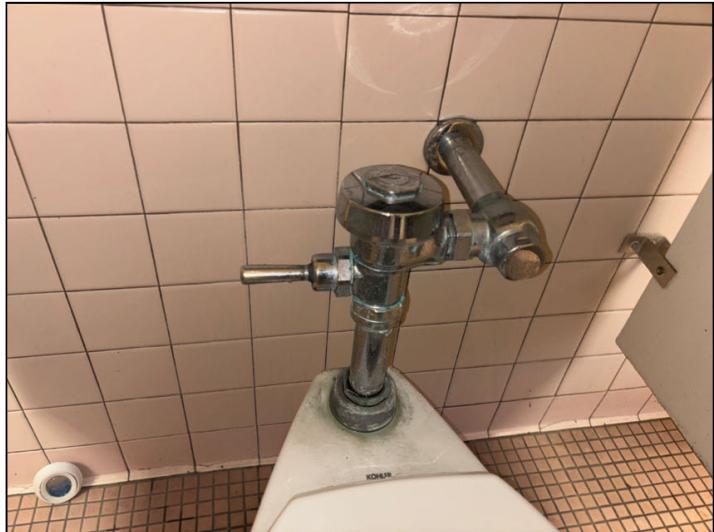
Mineral deposits and evidence of leakage were noted in many places at the common restroom toilets. Recommend further evaluation and improvements be made as needed by a licensed plumbing contractor.

Mineral deposits and evidence of leakage were noted in many places at the common restroom toilets.

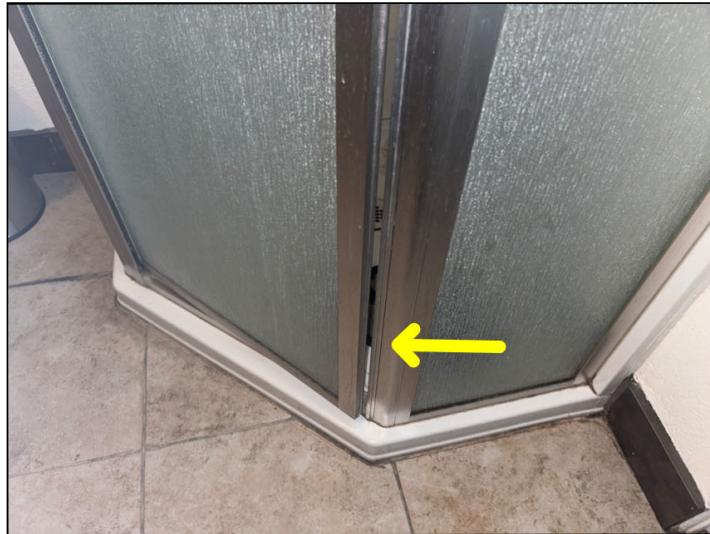
The shower door does not fully close in 12324. Recommend improvements be made as needed by a qualified professional.

The shower door does not fully close in 12324.

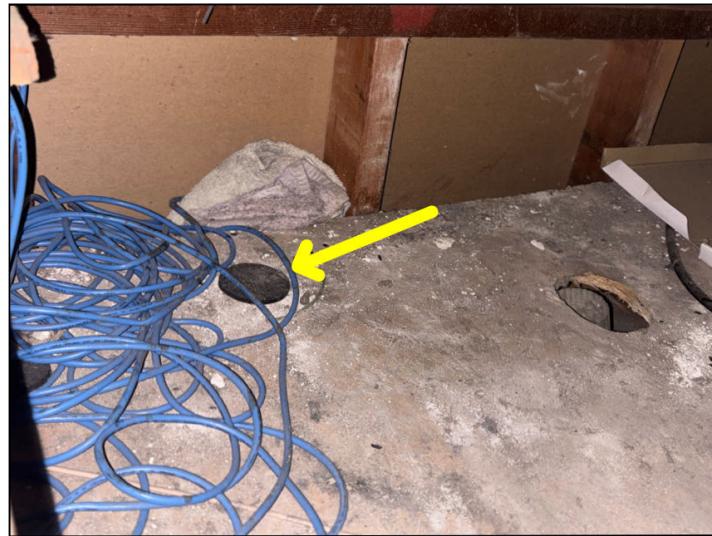
The restroom ventilation fan in 12310 terminates above the ceiling into the storage room. This is improper. Recommend the ventilation fan be ducted to the exterior of the building.

The restroom ventilation fan in 12310 terminates above the ceiling.

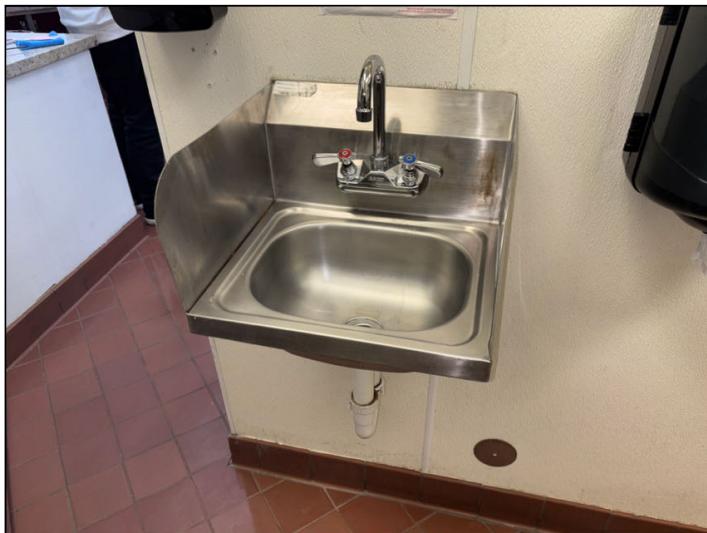
Water supply was found off at the time of inspection at the hand washing sink in 12300.

Recommend all of the kitchen and wet bar sinks be evaluated and improved as needed by a qualified licensed contractor.

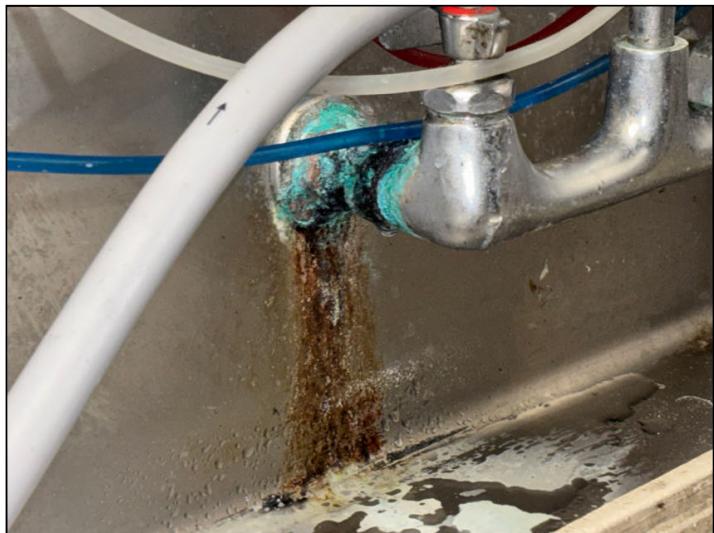
Active leakage was noted at a hot water supply pipe at a sink in 12304.

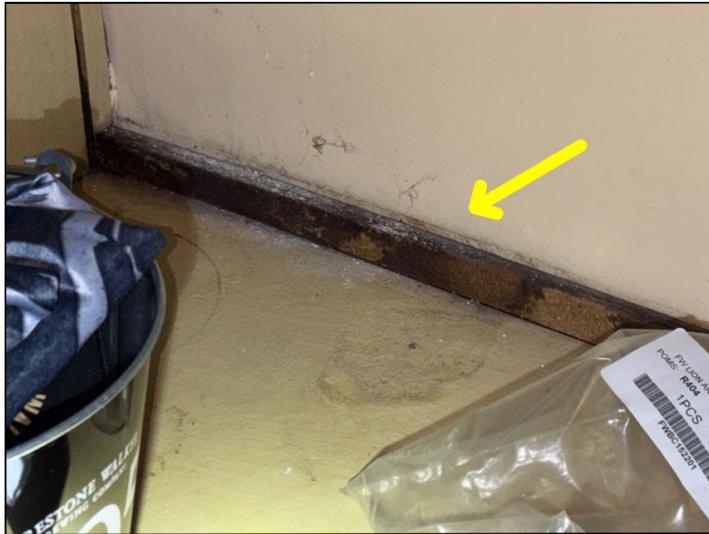
Moisture stains and evidence of past leakage were noted below the bar sink in 12306.

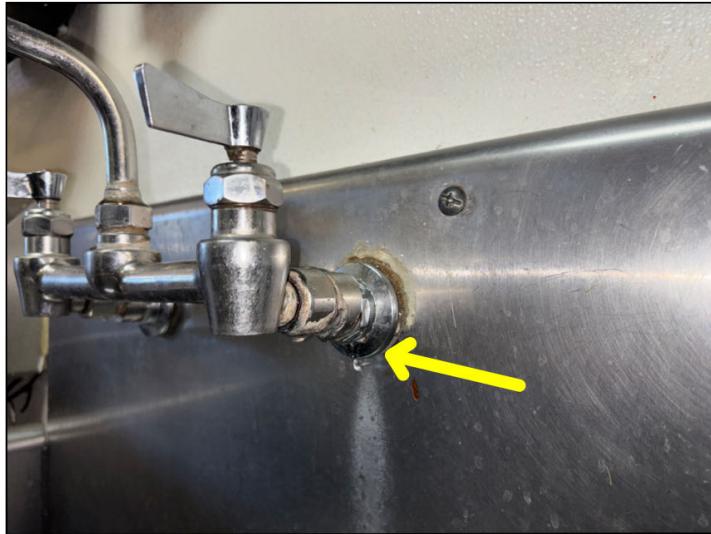
Active leakage was noted at a cold water sink handle in the kitchen of 12308.

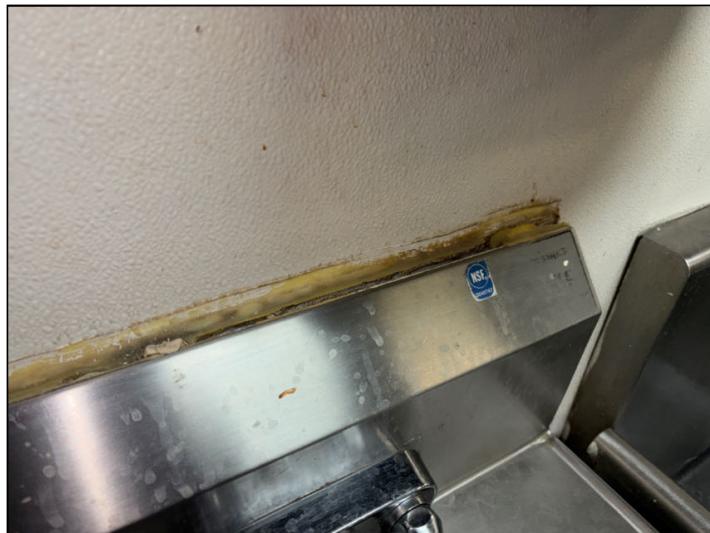
Cracked sealant was noted where a hand washing sink has separated from the wall in the kitchen of 12308.

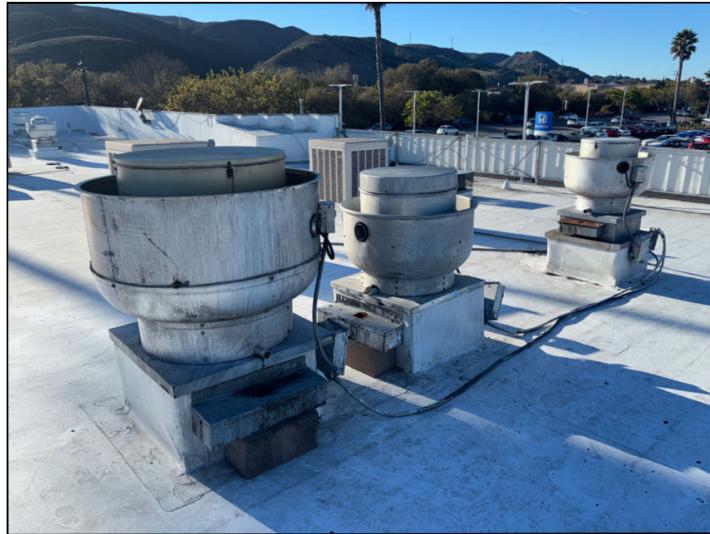
The kitchen ventilation systems on the roof over 12308 appear to be due for cleaning and servicing.

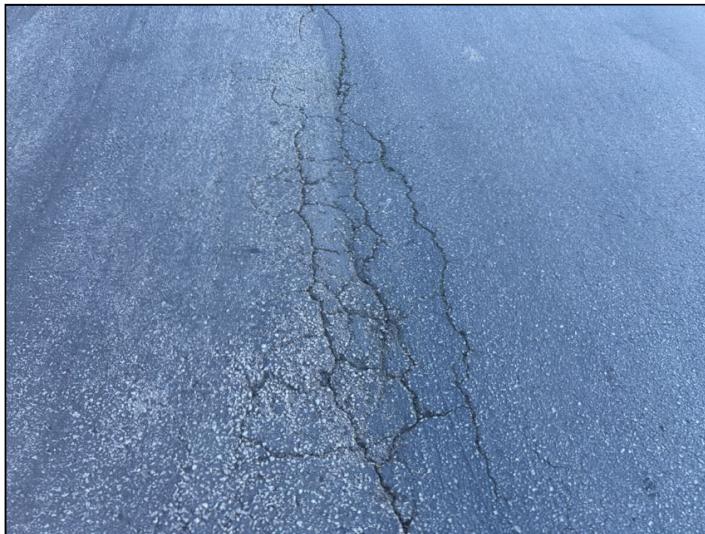
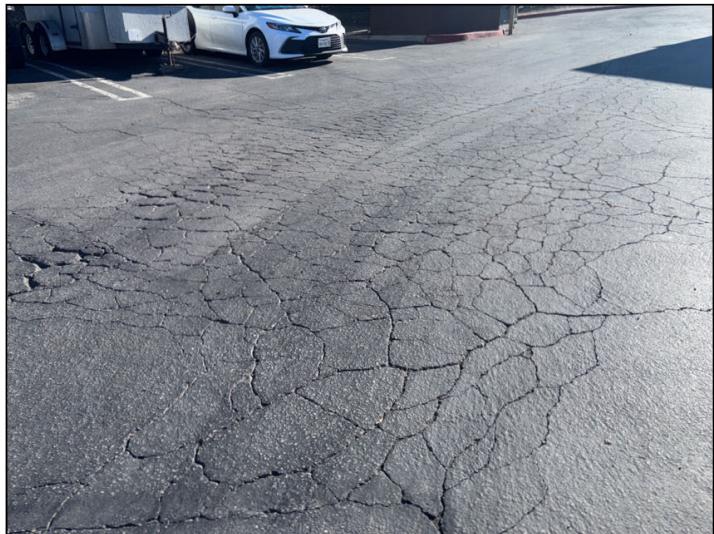
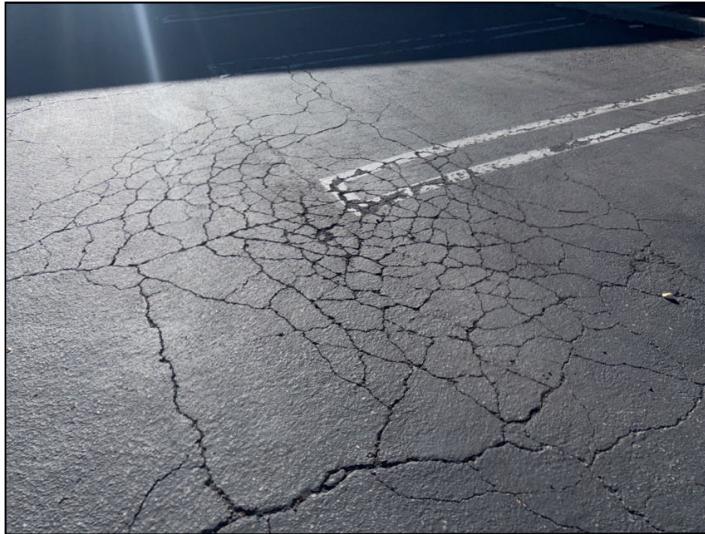
Cracked and fragmented asphalt was noted in many places at the driveway and parking areas.

Recommend the paving at the driveways and parking areas be improved or replaced as needed by a licensed paving contractor.

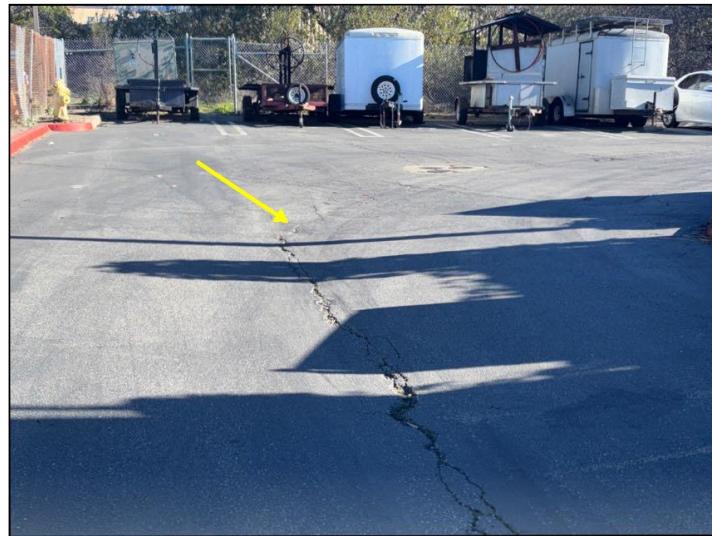
Evidence of poor drainage was noted at various places in the driveway and parking areas.

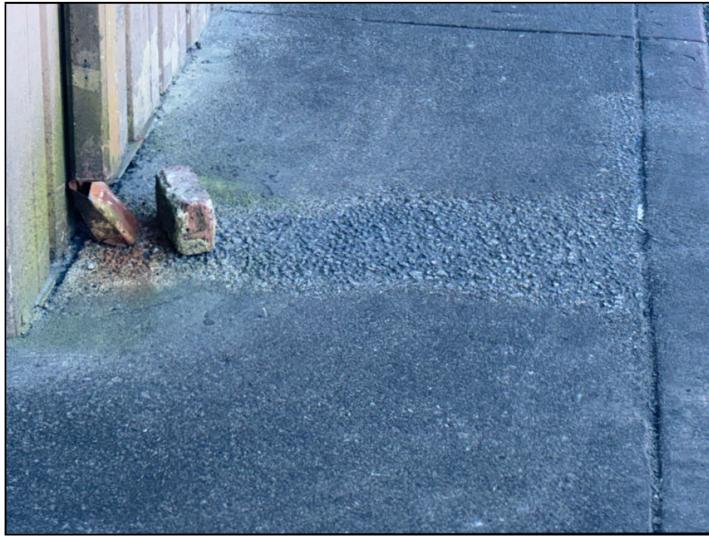
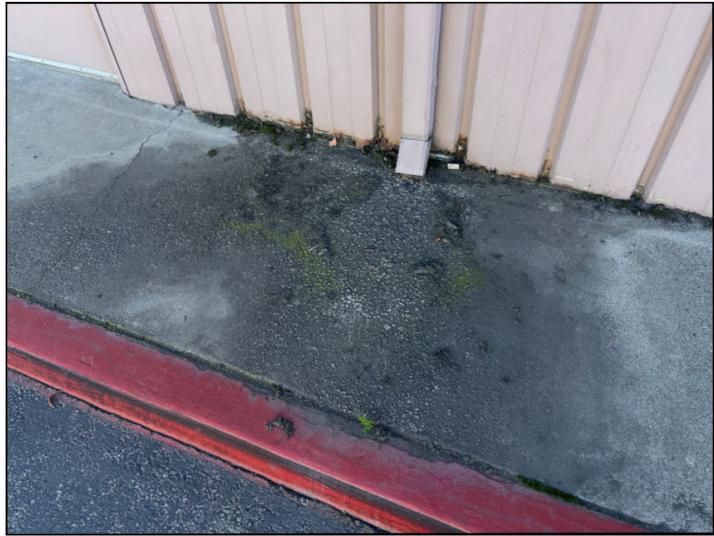
Deteriorated concrete was noted in various places adjacent to downspout terminations at the rear exterior of the units.

Deteriorated concrete was noted in various places adjacent to downspout terminations at the rear exterior of the building.

Recommend further evaluation and improvements be made to the walkways by a qualified licensed contractor.

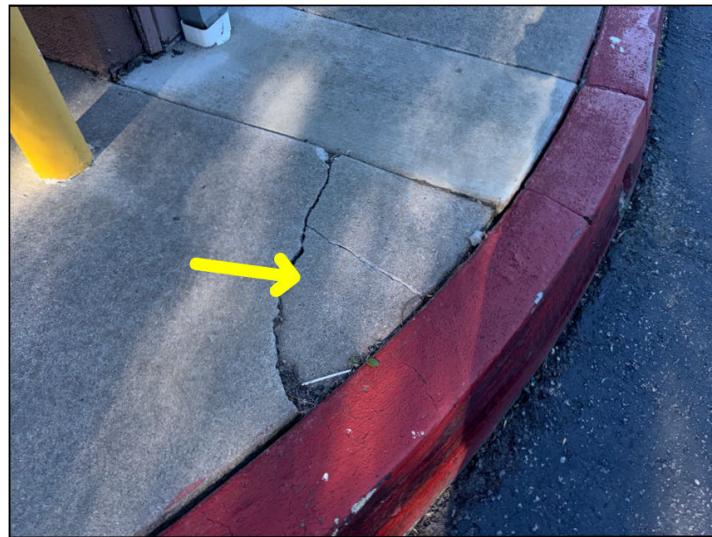
Damaged concrete was noted adjacent to the rear exterior of 12338.
