O'BRIEN
BUILDING INSPECTIONS INC.

SAMPLE
INSPECTION REPORT
3576 Main Street
Goleta, CA

Prepared for Island Investments LLC

12/8/2025

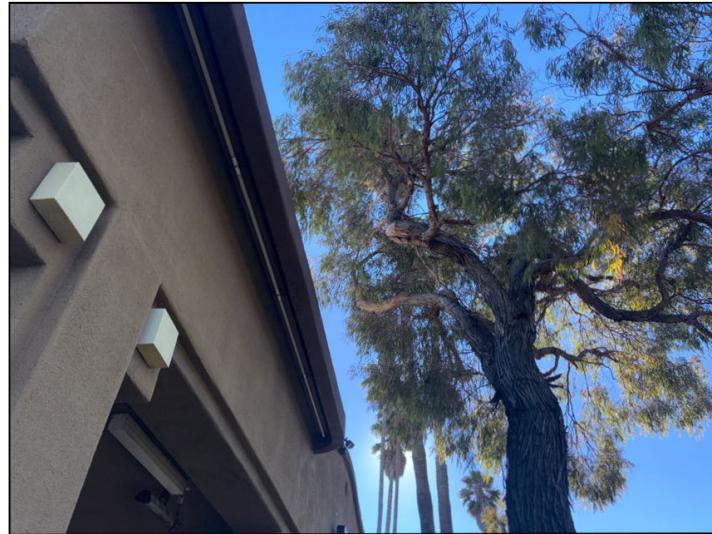
Tree branches are overhanging the building. Damage is possible. Recommend the trees be trimmed as needed by a certified arborist.

Tree branches are overhanging the building. Damage is possible.

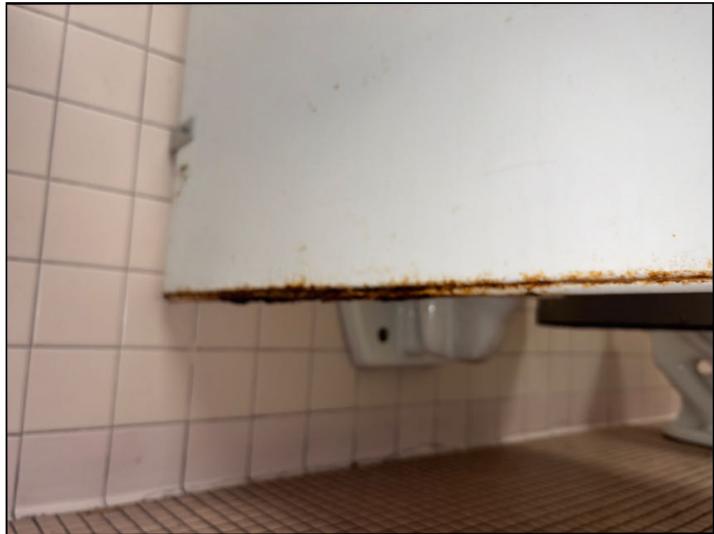
Corrosion was noted in various places at the privacy stalls in the common men's restroom. Recommend further evaluation and improvements be made as needed by a qualified specialist.

Corrosion was noted in various places at the privacy stalls in the common men's restroom.

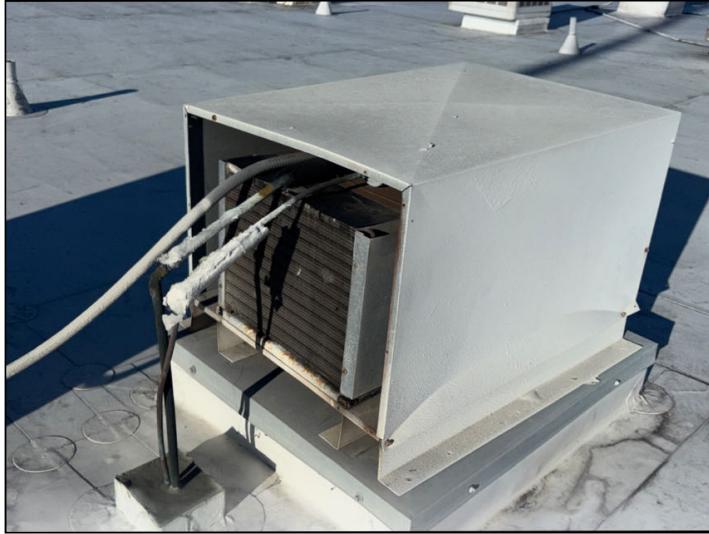
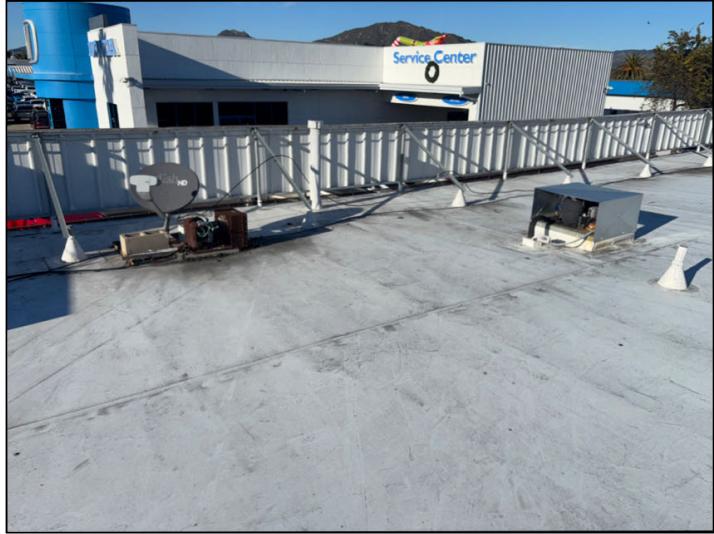
The majority of the refrigeration equipment appears to be older and may be nearing the end of useful life. Recommend further evaluation by a qualified specialist.

The majority of the refrigeration equipment appears to be older and may be nearing the end of useful life.
