SB-721 INSPECTION REPORT

1025 Olive Street
Santa Barbara, CA

10/2/2025

Inspected by Tio Turrini-Smith and Jay O'Brien

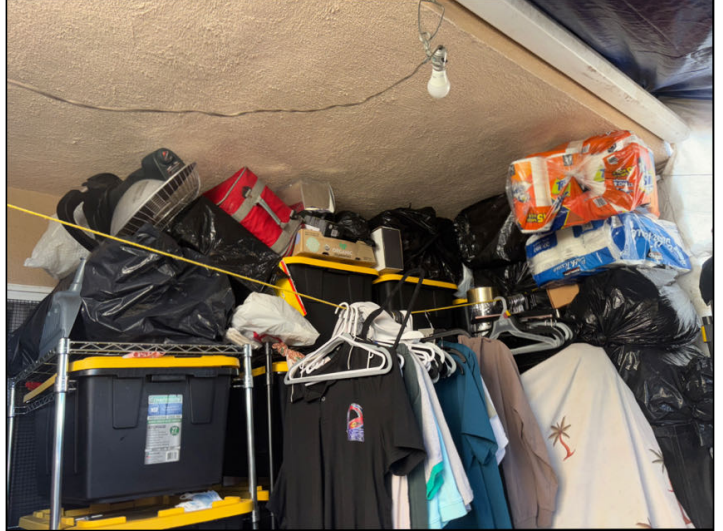
The #31 balcony soffit was not fully accessible due to storage.

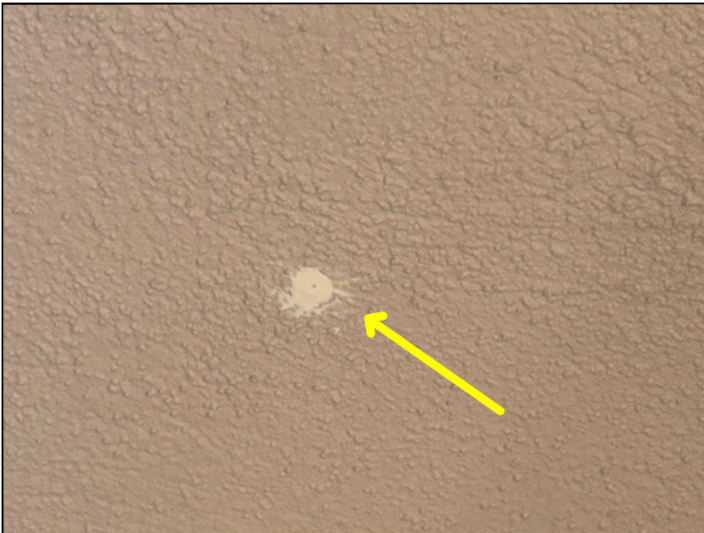
Holes were drilled in the balcony and walkway soffits that were inspected at the time of the inspection to observe the related framing components using a borescope camera.

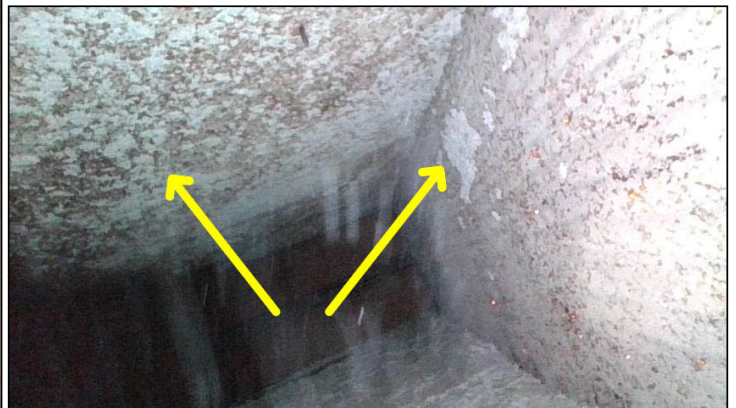
The #31 balcony framing within the soffit was mostly not visible with the borescope camera due to stucco overspray.

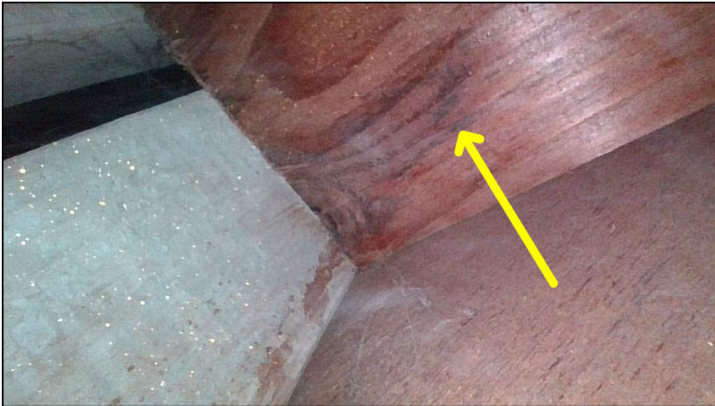
Dry water stains were observed at the #35 balcony framing with the borescope camera.

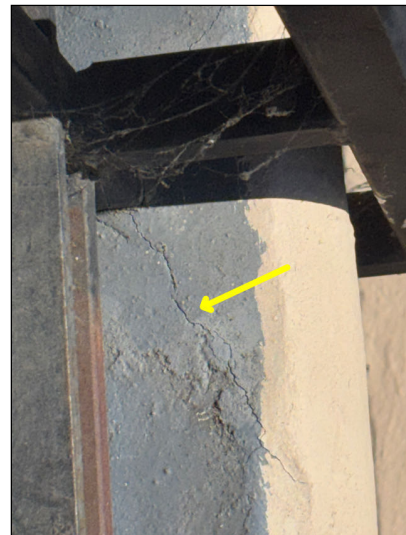
A crack was noted at an area that was patched at the #33 balcony adjacent to a railing post.

Recommend all of the balconies be evaluated and improved as needed by a qualified licensed contractor. Lack of proper repairs and maintenance can cause health and safety concerns to occur in the future.

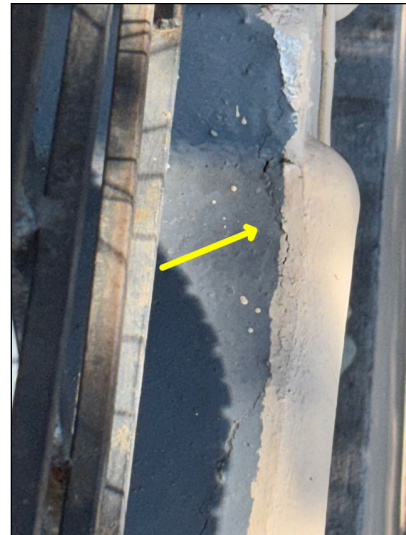
The material at the surface of the balcony is cracked in various places at the #31, #33, and #35 balconies.

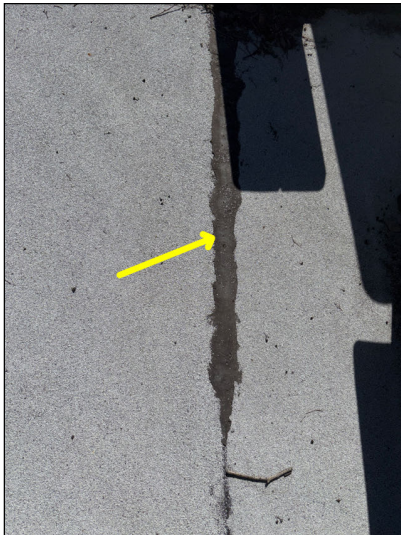
Patching was noted at the rolled composition terrace surface.

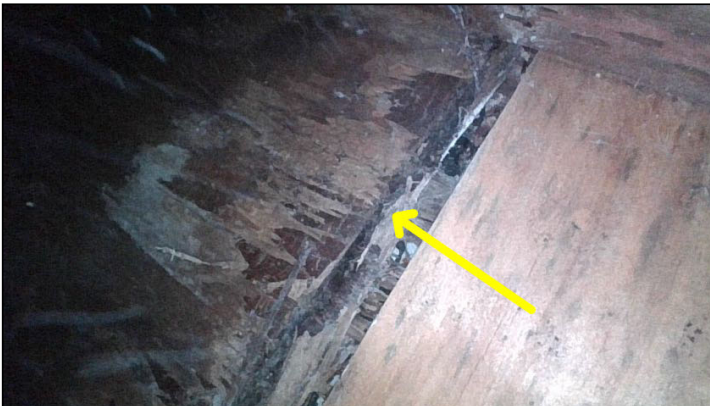
Page 22 Item: 3	WALKWAY CONDITIONS	<p>The walkway adjacent to #29 and #30 and the walkway adjacent to #25 and #28 were inspected.</p> <p>Moisture damage and possible insect damage were observed in various places at the walkway framing and sheathing with the borescope camera adjacent to #29. See WDO report for more information.</p> <p>Evidence of repairs were noted at the walkway framing in many places adjacent to #29. Damaged wood was observed next to newer wood in many places with the borescope camera. Recommend all damaged wood be replaced and removed from the soffit.</p> <p>Dry water stains were observed at the walkway framing with the borescope camera in various places including adjacent to #25 and #29.</p> <p>Possible insect droppings were observed in the walkway soffits at many places with the borescope camera. See WDO report for more information.</p> <p>Bubbled paint and efflorescence were noted at the ends of the walkway soffit adjacent to #29 and #30.</p> <p>Cracked and uplifted walkway surface material was noted adjacent to #25 and between #29 and #30 at the edge of the walkway.</p> <p>A crack with uplifted material was noted at the walkway adjacent to the #25 stairs.</p> <p>Open cracks were noted at the edge of the walkway between #29 and #30 and adjacent to #25.</p> <p>Deteriorated waterproof coating was noted at the walkway surface adjacent to the stairs and #29 in many places.</p> <p>Gaps were noted in the stucco at the edge of the walkway adjacent to #25 and #29.</p> <p>Cracked waterproof coating and rust stains were noted at the walkway surface adjacent to a guardrail post and #30.</p> <p>Cracks were noted between the walkway and the exterior wall adjacent to the stairs and #29.</p> <p>Corrosion was noted at a walkway guardrail post adjacent to #25.</p> <p>Corroded stucco lathe was observed with the borescope camera adjacent to #6.</p> <p>Recommend all of the walkways be evaluated and improved as needed by a qualified licensed contractor to help prevent moisture damage. Lack of proper repairs and maintenance can cause health and safety concerns to occur in the future.</p>

Moisture damage and possible insect damage were observed in various places at the walkway sheathing with the borescope camera adjacent to #29.

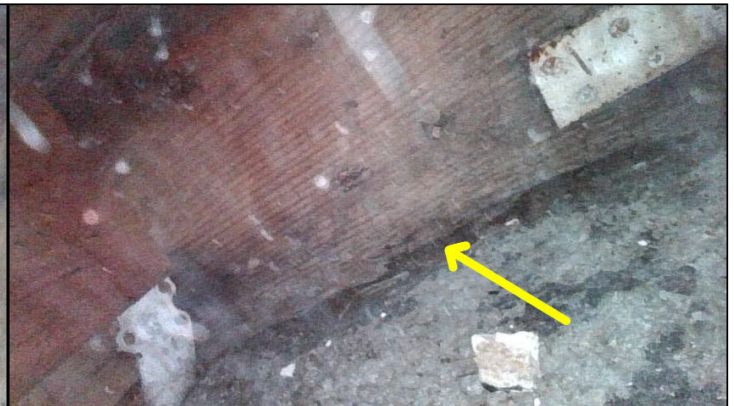
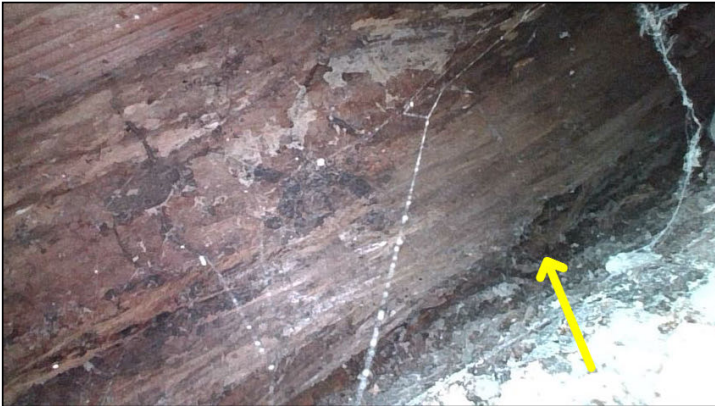
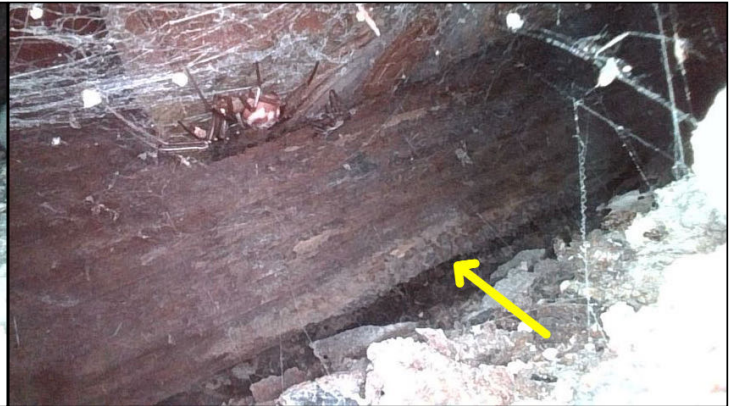
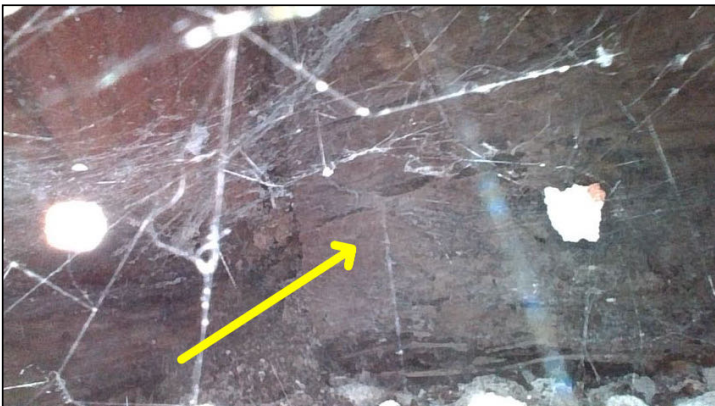
Moisture damage and possible insect damage were observed in various places at the walkway framing with the borescope camera adjacent to #29.

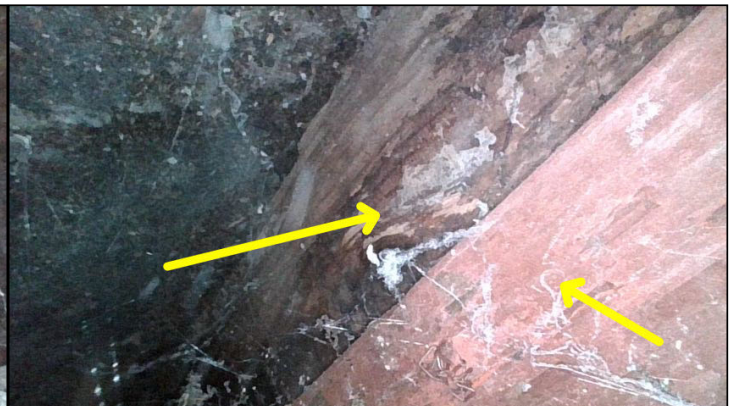
Damaged wood was observed next to newer wood in many places with the borescope camera.

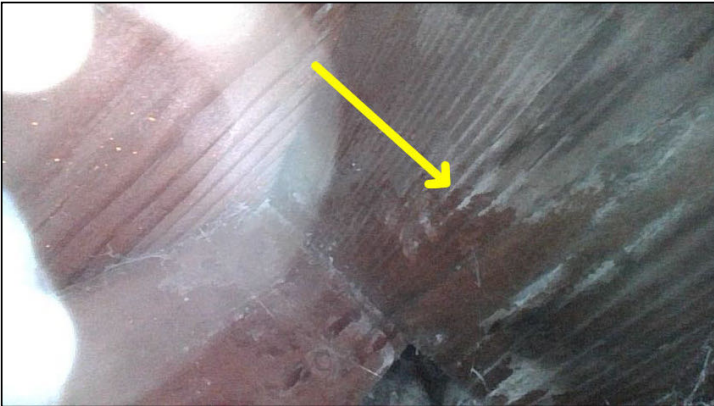
Dry water stains were observed at the walkway framing with the borescope camera in various places including adjacent to #25 and #29.

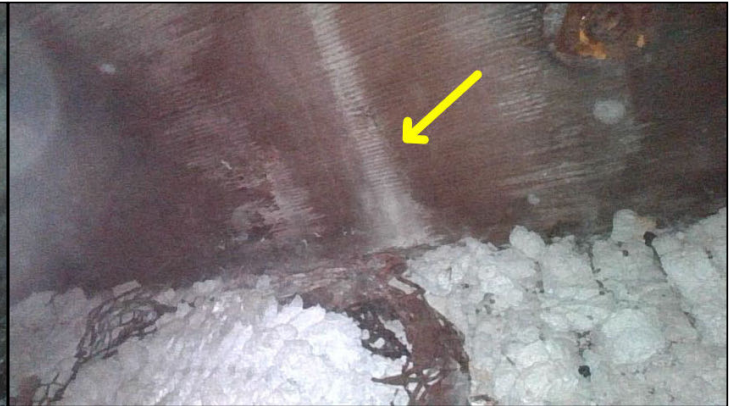
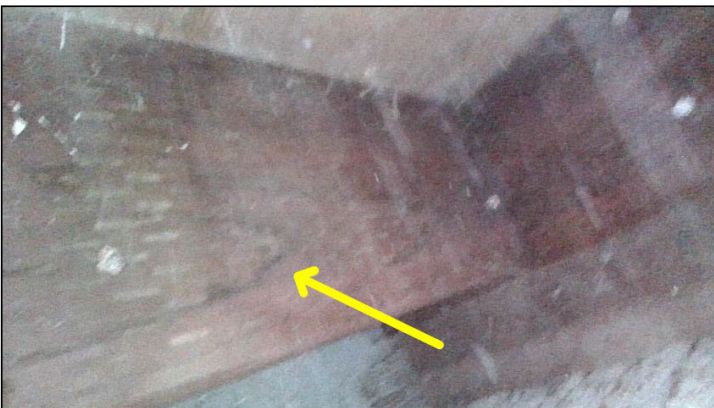
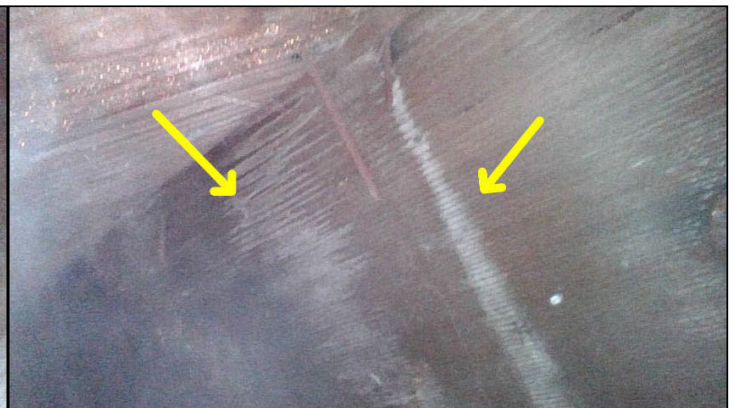
Dry water stains were observed at the walkway framing with the borescope camera in various places including adjacent to #25 and #29.

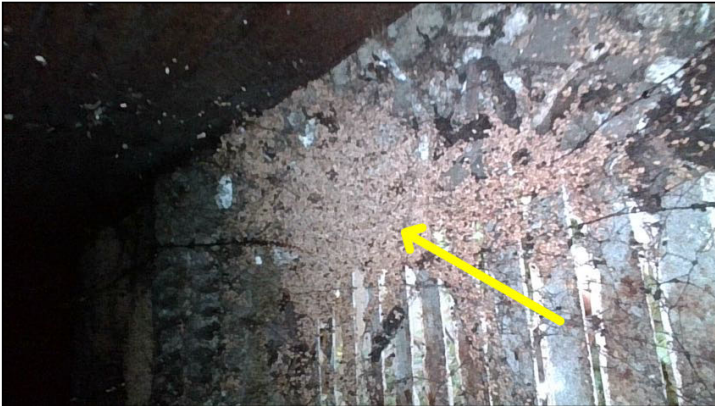
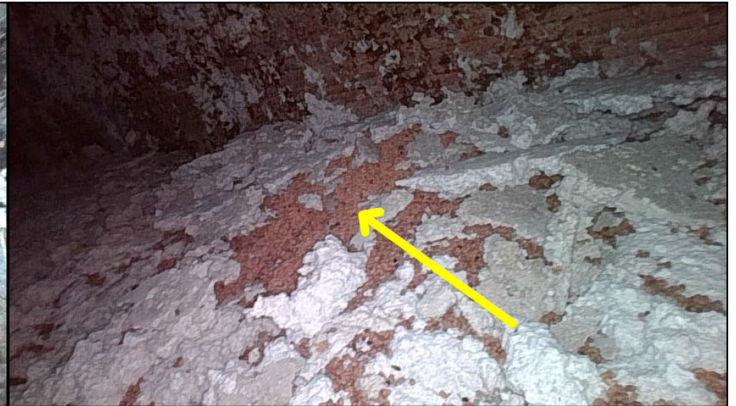
Possible insect droppings were observed in the walkway soffits at many places with the borescope camera.

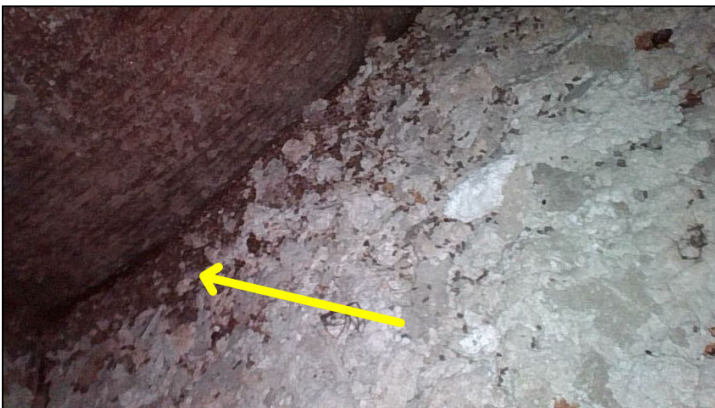
Possible insect droppings were observed in the walkway soffits at many places with the borescope camera.

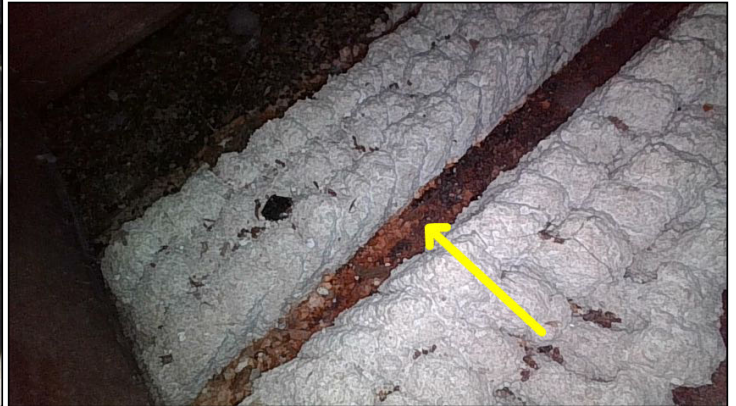
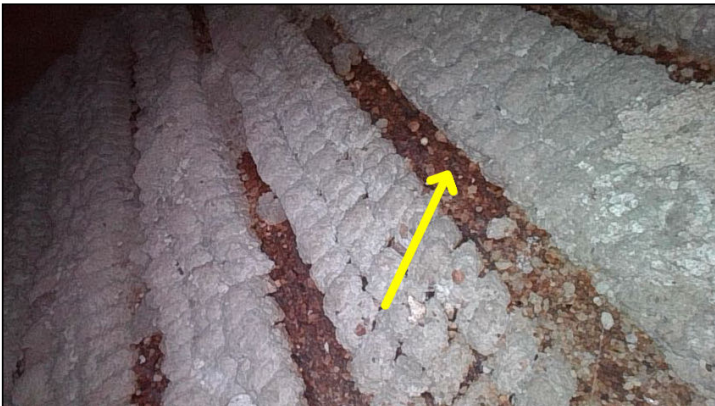
Corroded stucco lathe was observed with the borescope camera adjacent to #6.

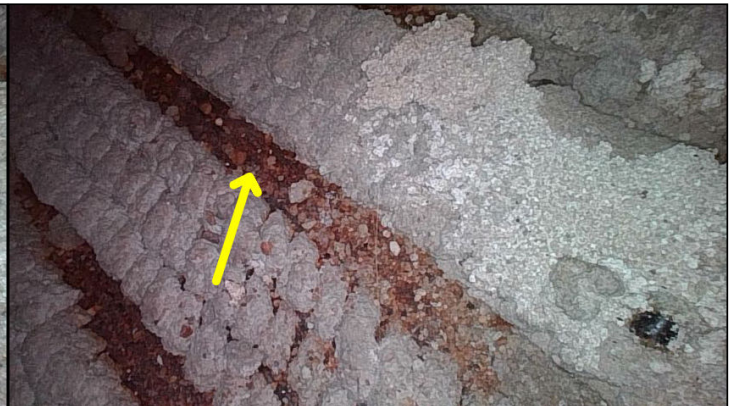
Corroded stucco lathe was observed with the borescope camera adjacent to #6.

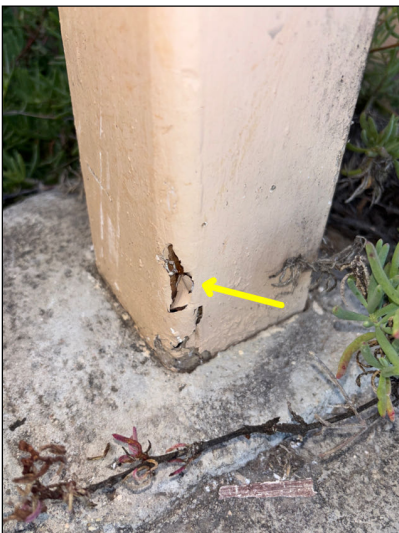
Extensive moisture damage and possible insect damage were noted at the terrace stairs.
