December 7, 2021

**RE: Forensic Engineering Report – Wind Damage  
Newnan Presbyterian Church  
38 Greenville St. S  
Newnan, GA 30263**

Per your request, Shields Engineering Group, Inc. performed a forensic engineering inspection at the Newnan Presbyterian Church at the address above. The Church purportedly sustained damage as a direct result from high winds from a tornado that passed through Newnan on March 26, 2021. This investigation was conducted on November 9<sup>th</sup>, 2021, by Martin Shields, P.E. and Ava Shields of SEG.

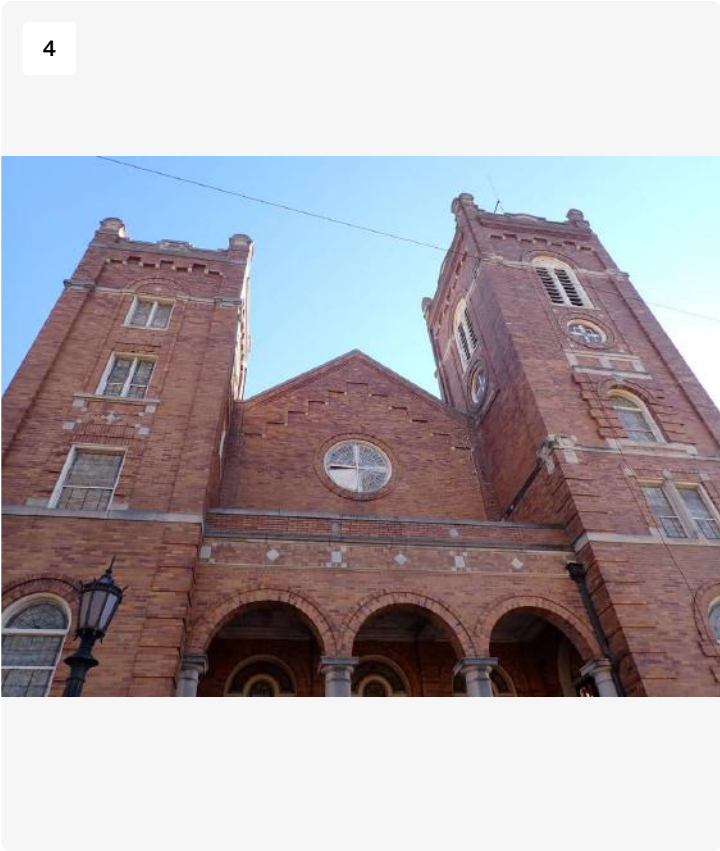
Broken window

Same

2. Remove and replace the damaged modified-bitumen flat roofing assembly on the west elevation.
3. Remove and repair the stained-glass window on the western elevation.

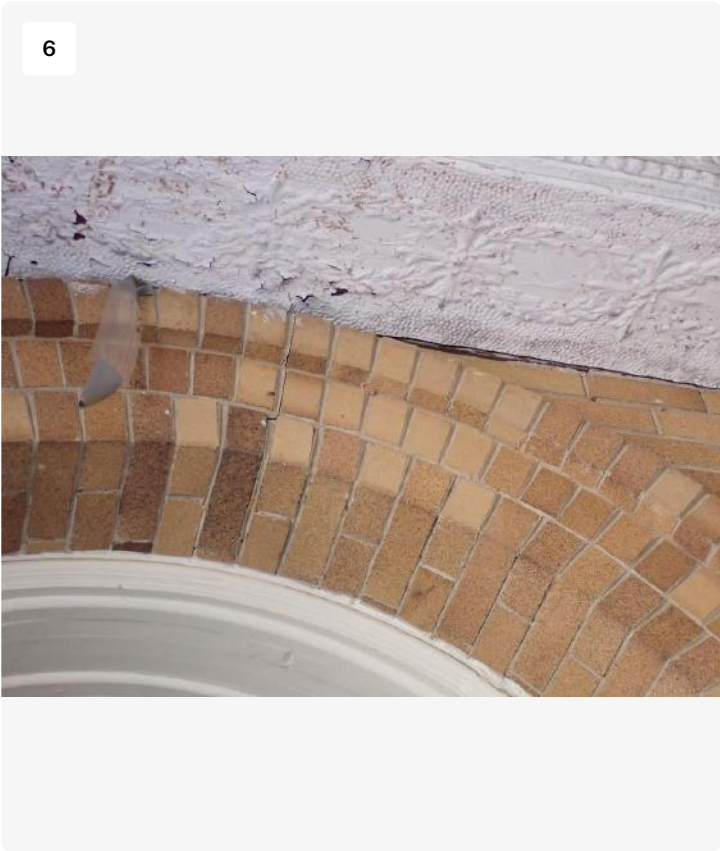
Displaced brick

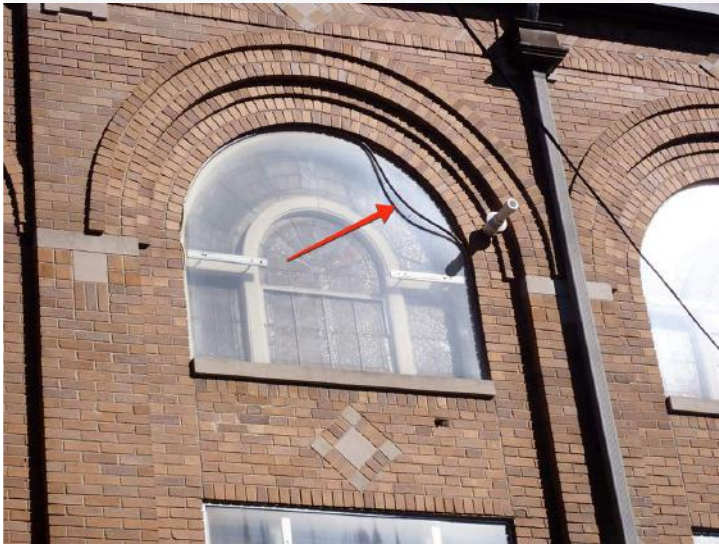
Displaced window seal

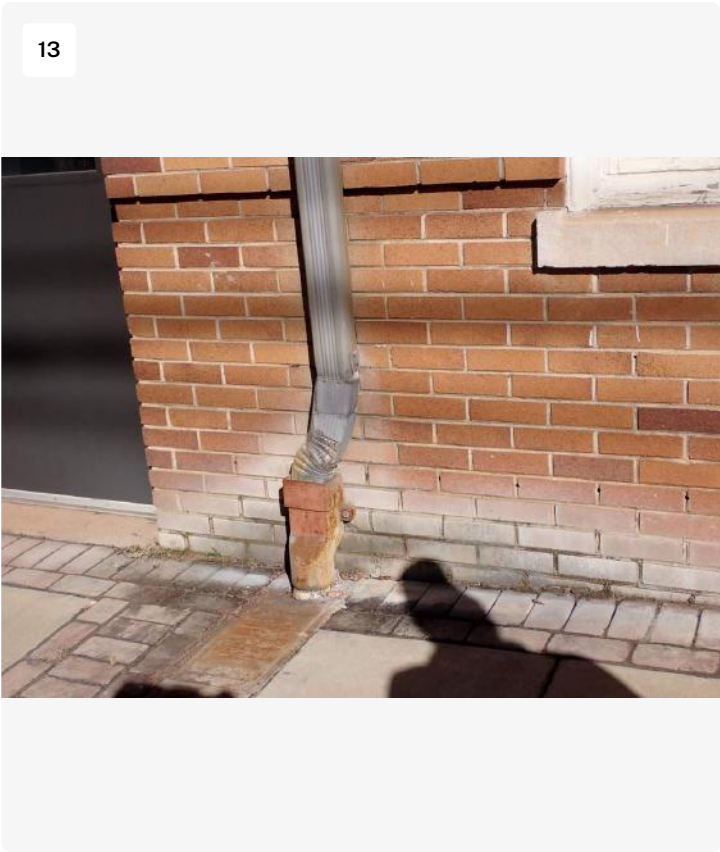
Downspout

4. Remove and replace all plexiglass storm-protection windows on the north and south elevations.
5. Remove and replace all damaged gutters and downspouts.

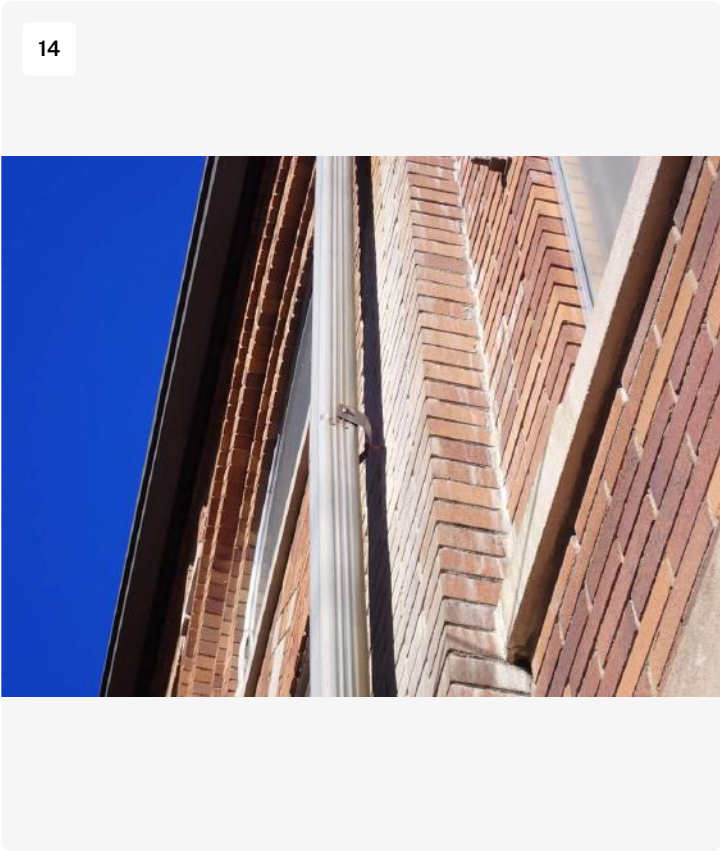
Displaced downspout

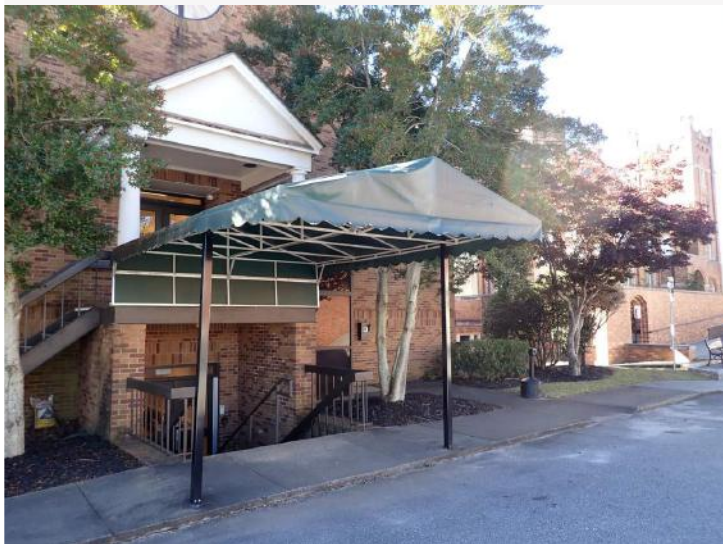
19

North-displaced awning

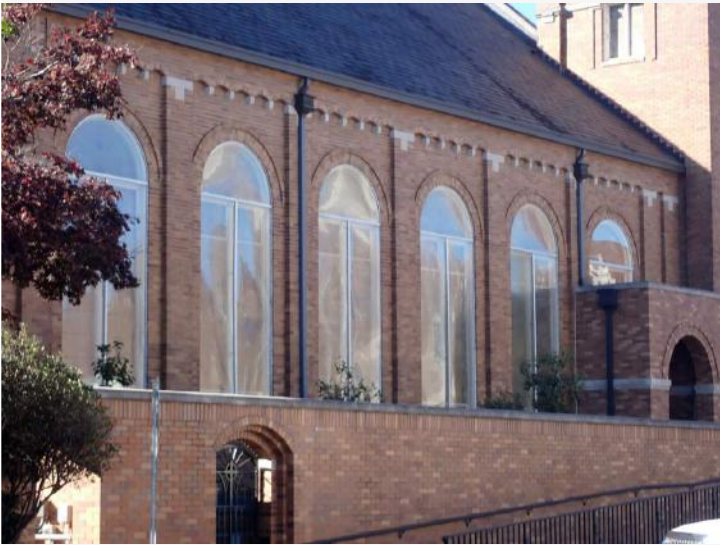
22

Bowed windows

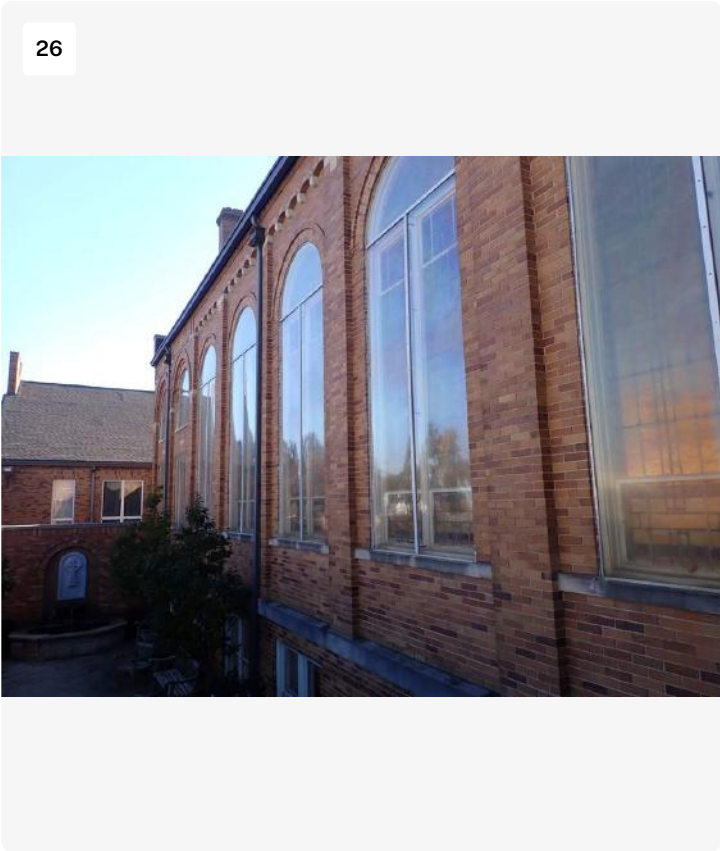
Bowed windows

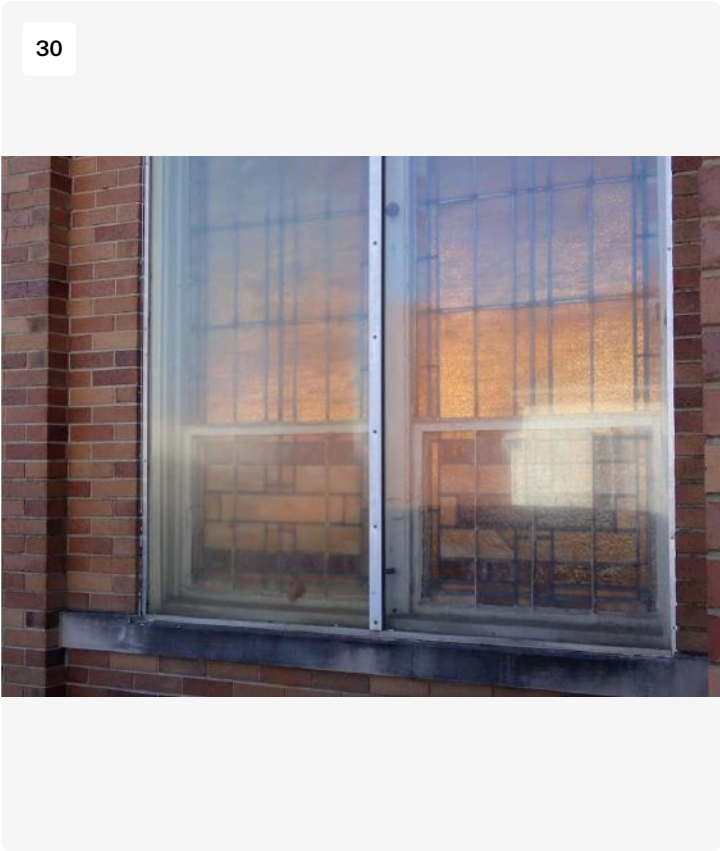
Displaced window

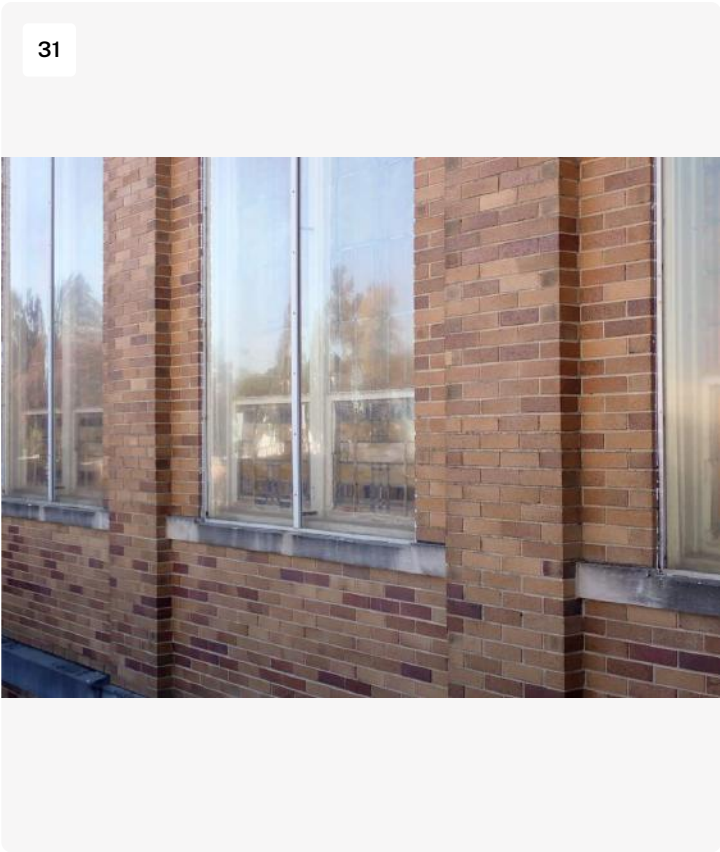
Bowed window

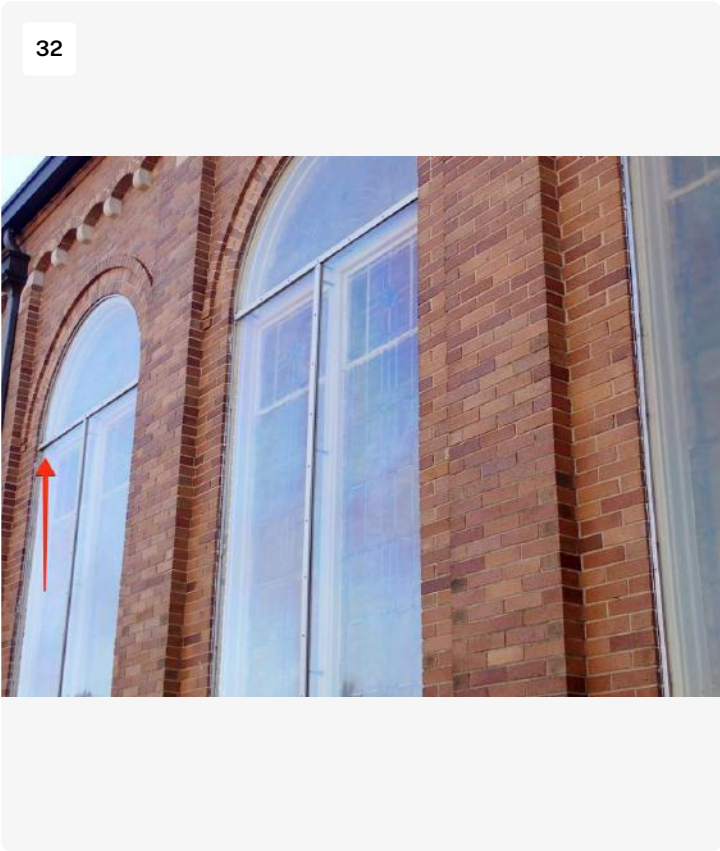
Displaced frame

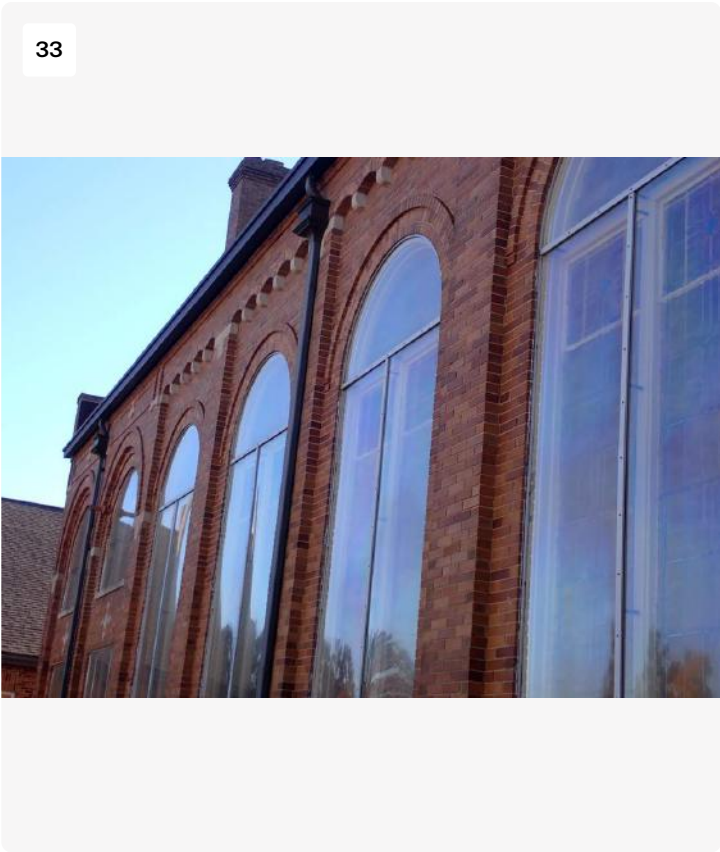
Bowed window

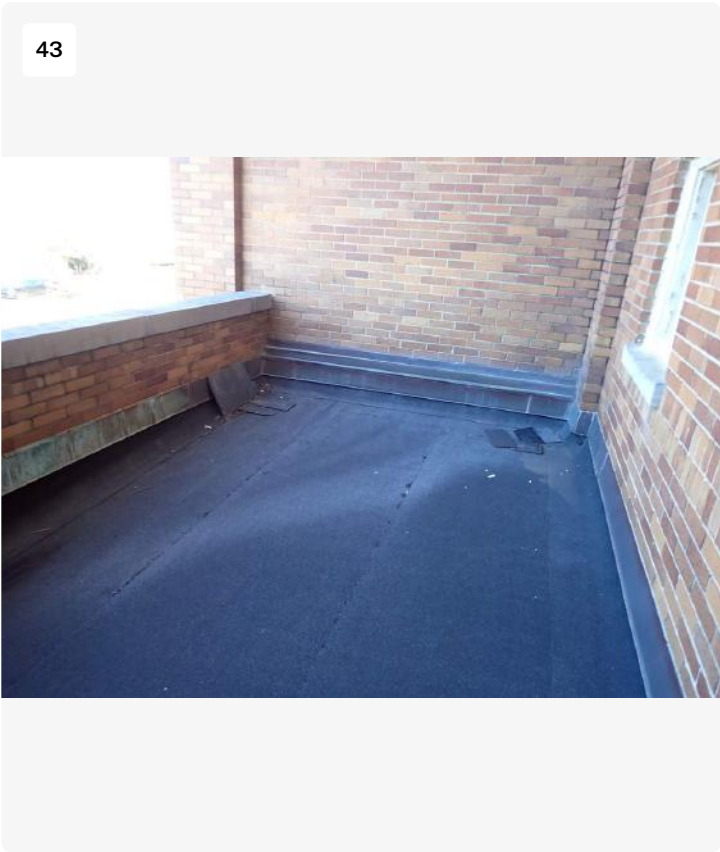
- The flat-lay modified bitumen roofing assembly was inspected for storm-related damages. SEG found several broken slate tiles on the roofing assembly that had fallen from the main roof above. Abrasions and scratches were noted throughout the roofing field due to the fallen tiles and wind-borne debris. Areas of the mod-bit lap seams were found to be unbonded and uplifted due to the high winds. Storm-related debris was noted underneath some of these lap seams, as well as throughout the roof (**Photographs 43—70**).
- Copper counter flashing was noted around the roofing assembly. A scratch was found on the copper from the adjacent broken slate tile that had fallen (**Photographs 71—73**).

**Modified Bitumen Flat Roofing Assembly**  
Over front entrance - west elevation

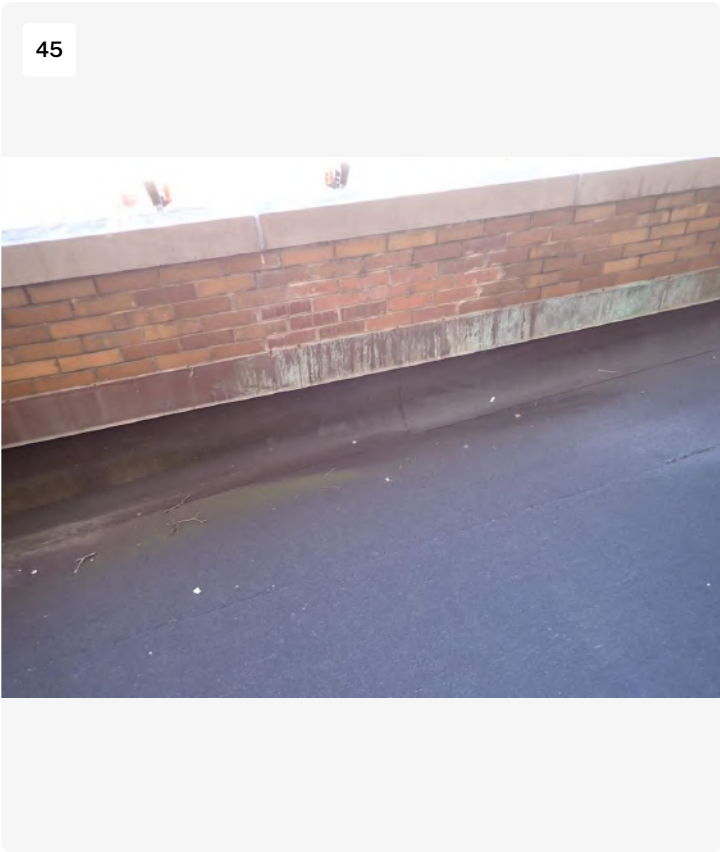
Same

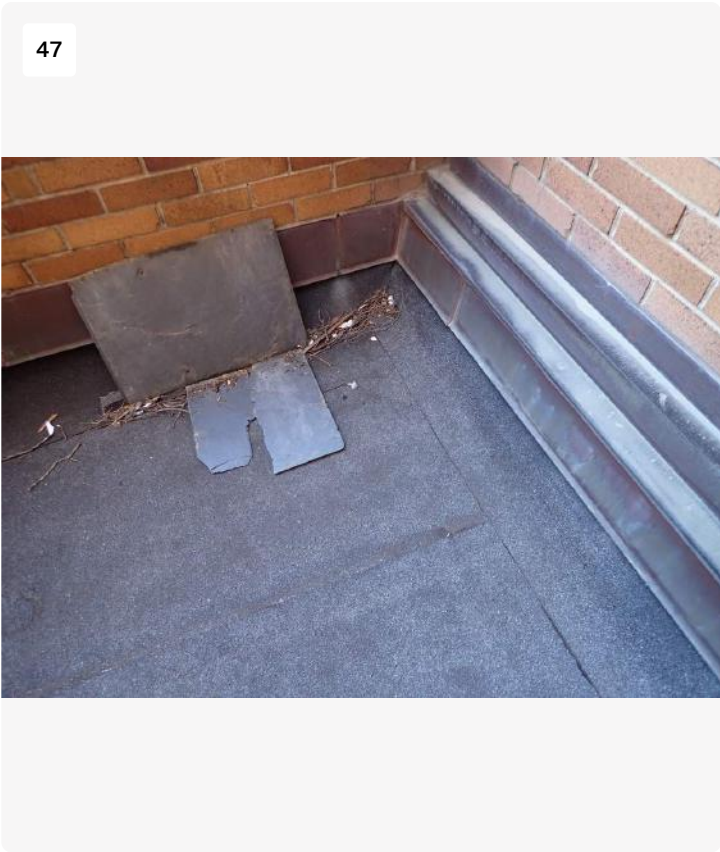
Same

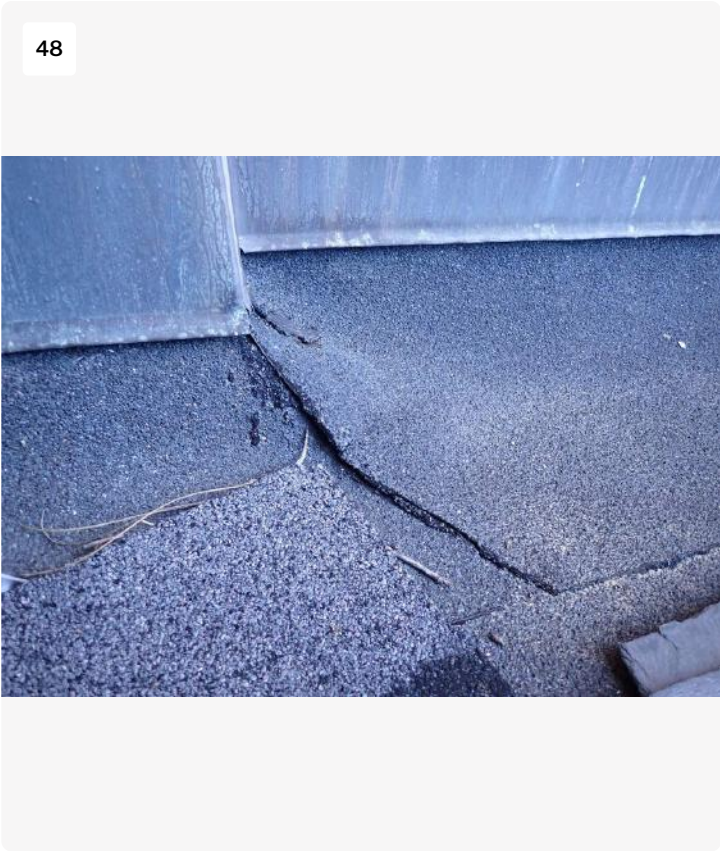
Minor uplift on lap seam

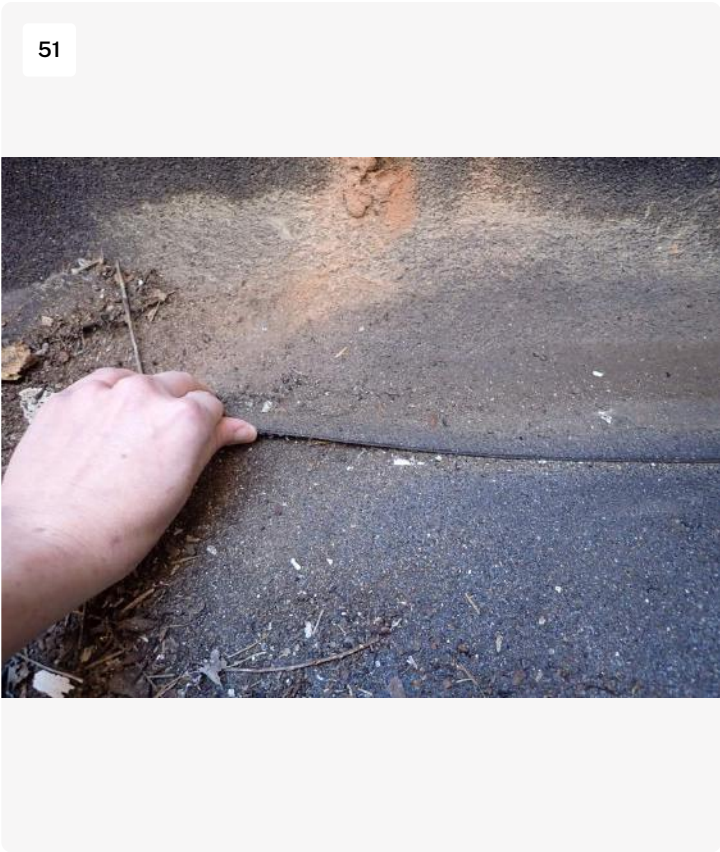
Uplifted lap seam

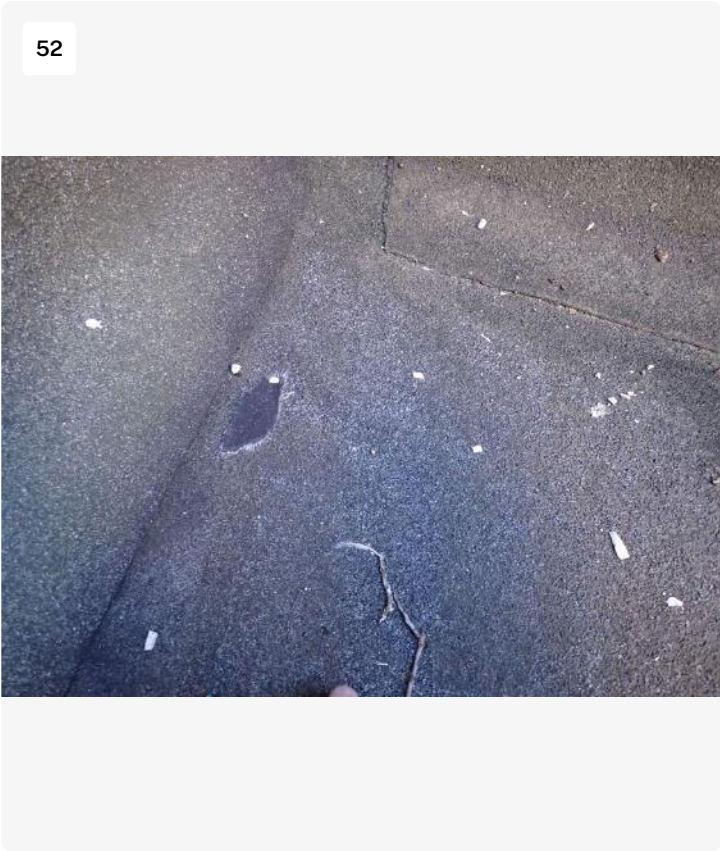
Wind-borne debris

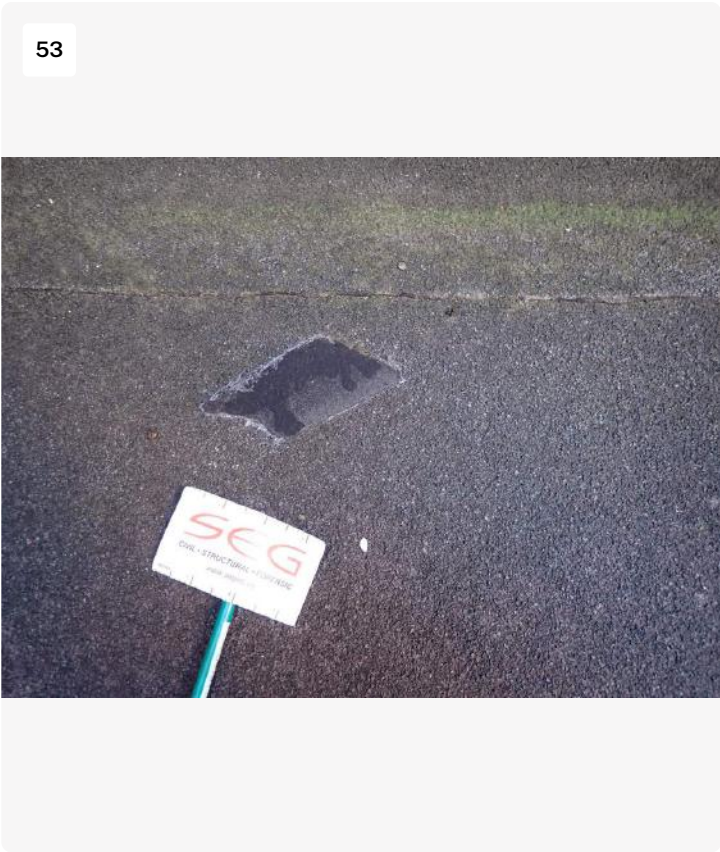
Wind-borne debris

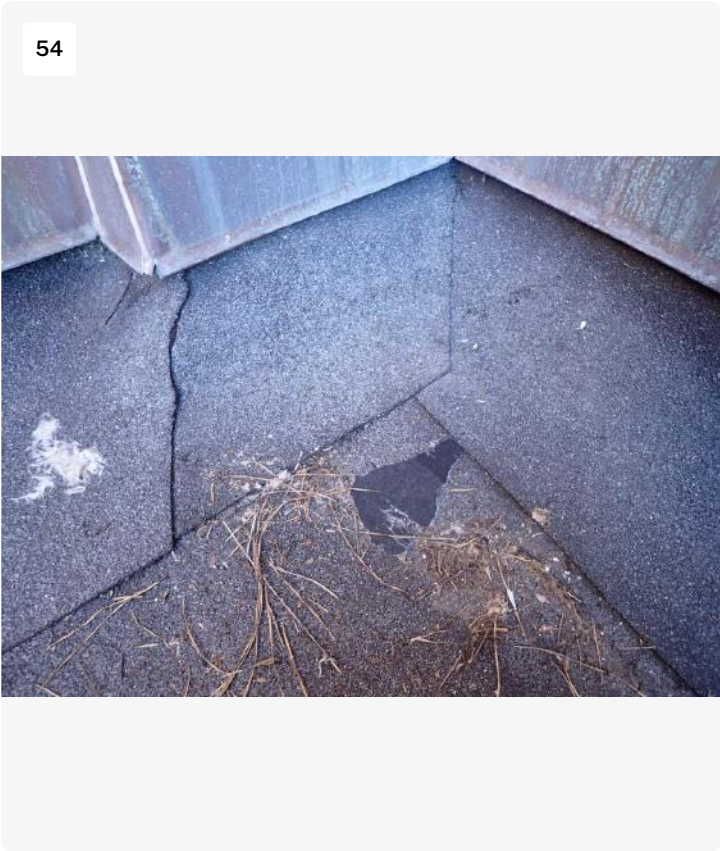
Wind-borne debris

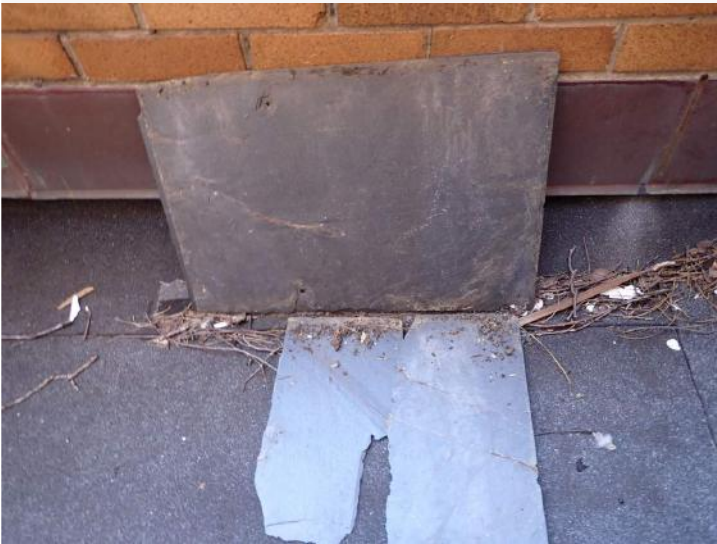
## Fallen tile

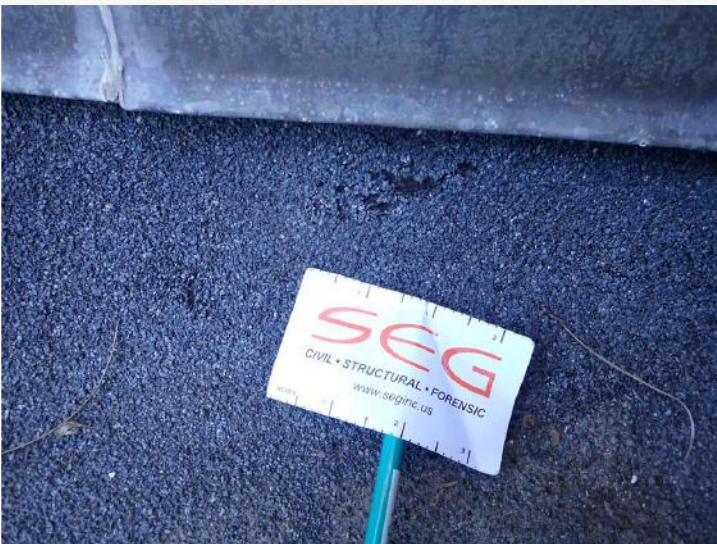
## Damage to mod-bit from fallen slate tile

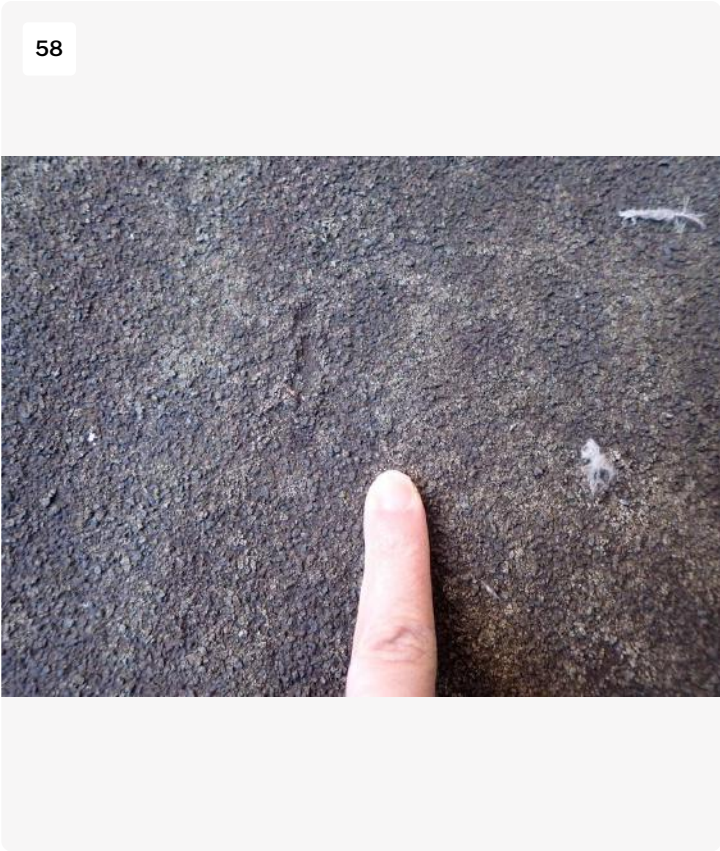
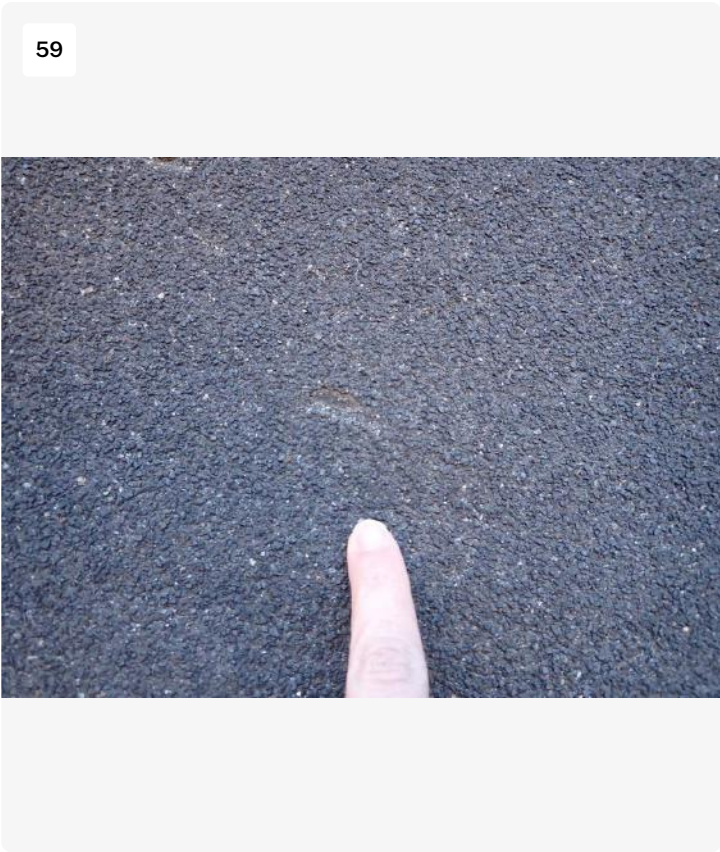
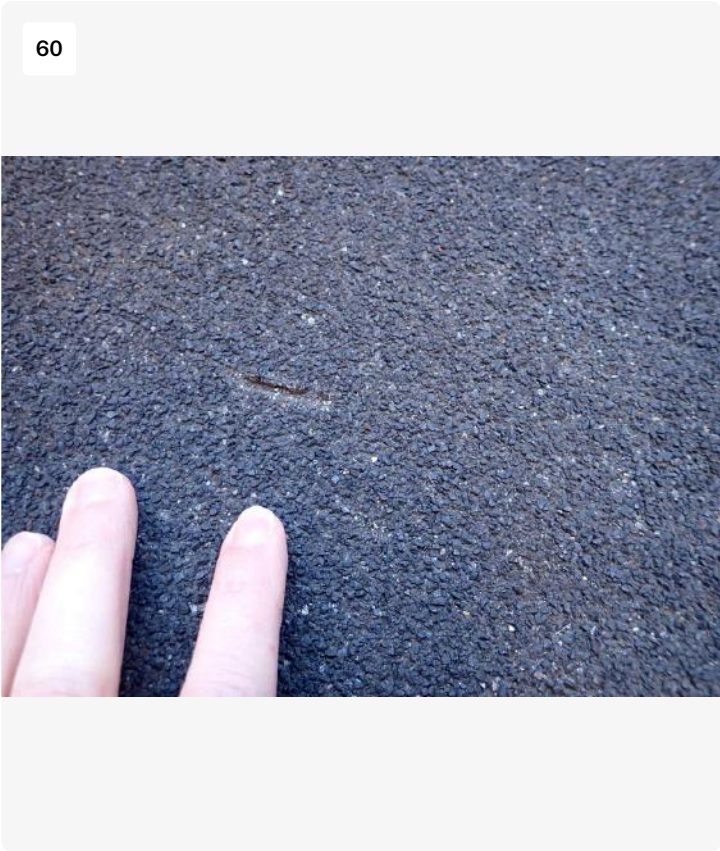
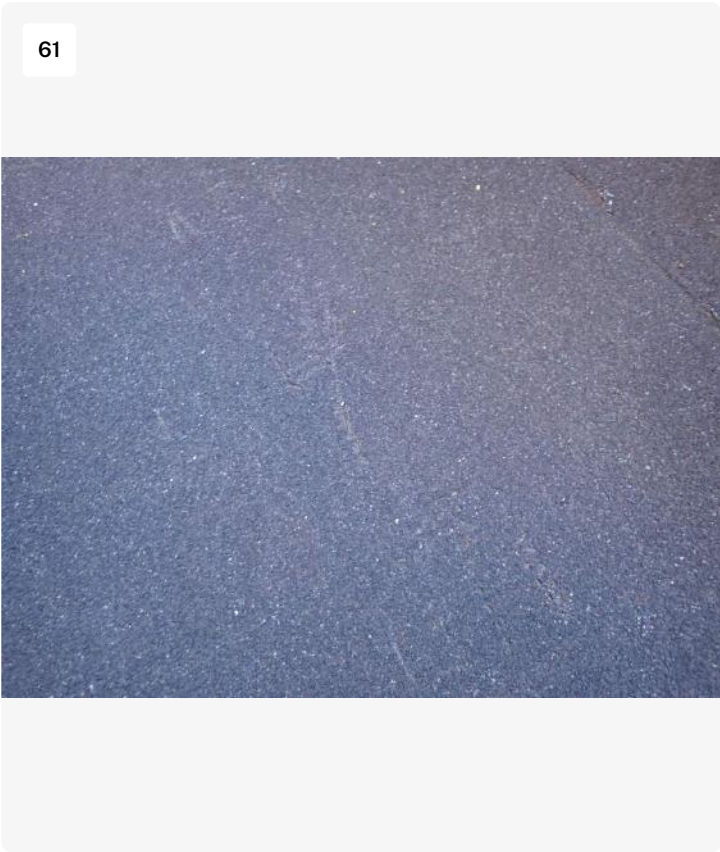
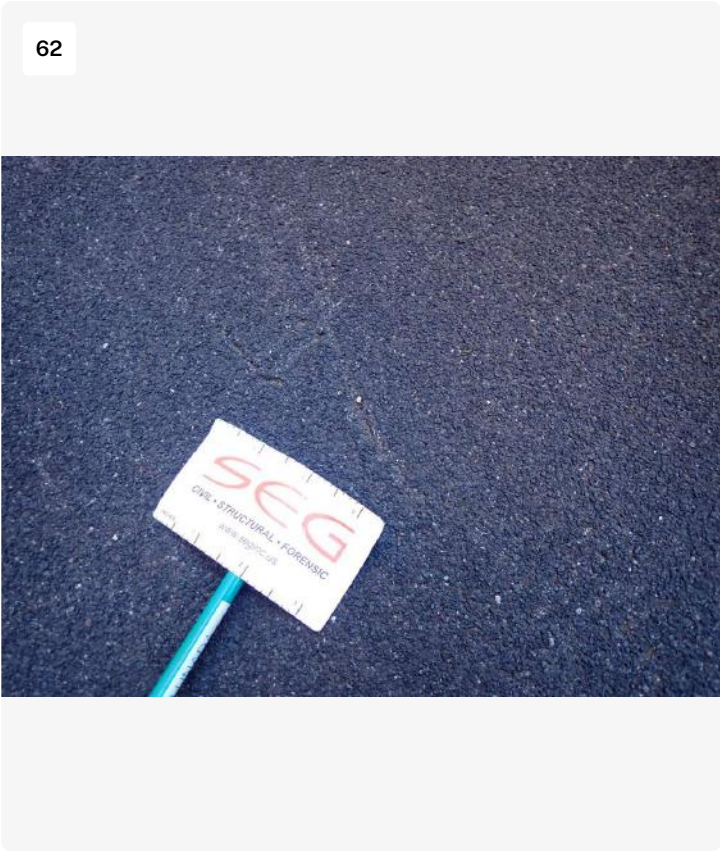
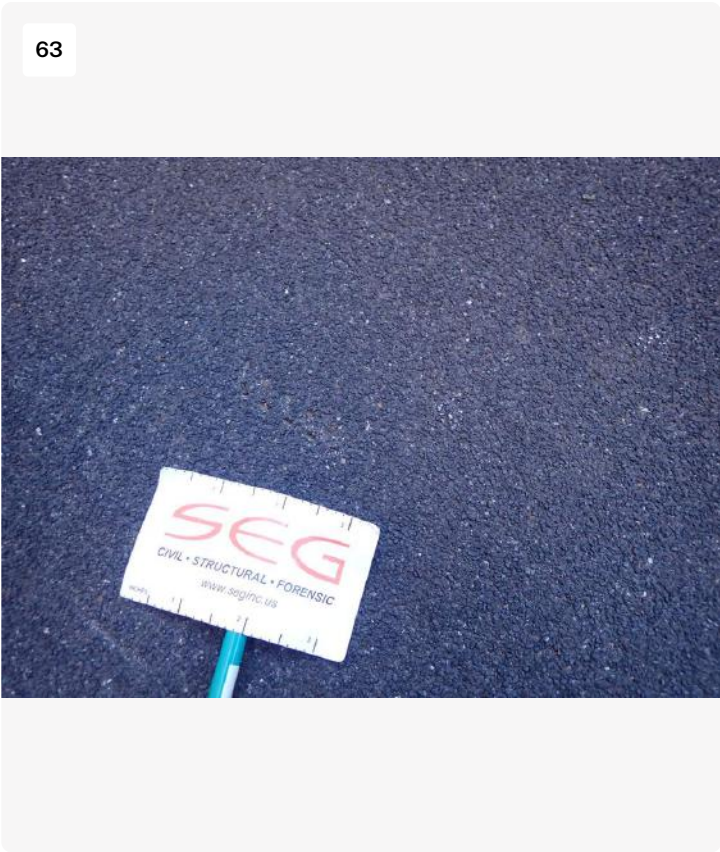
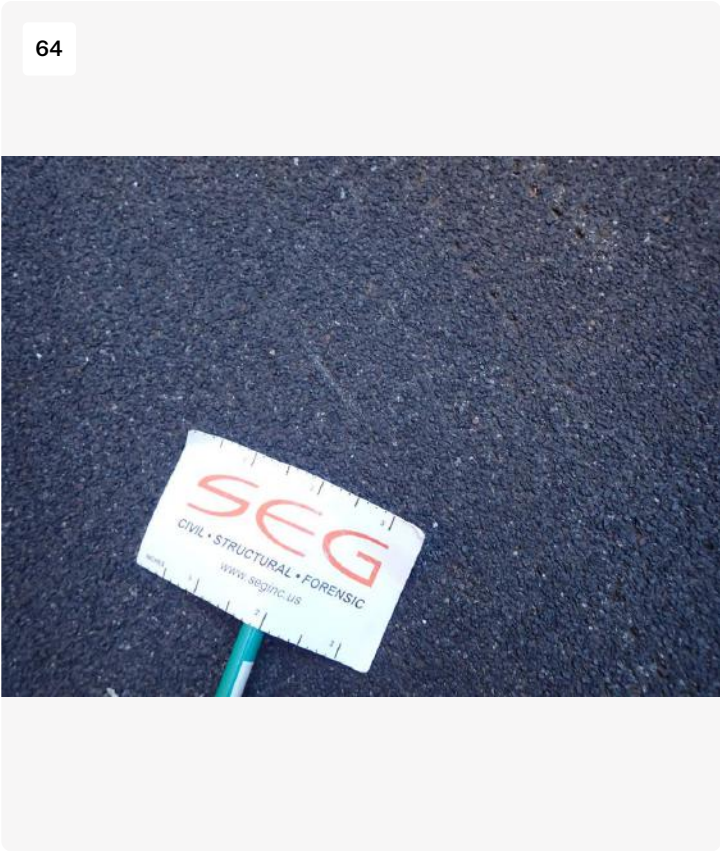
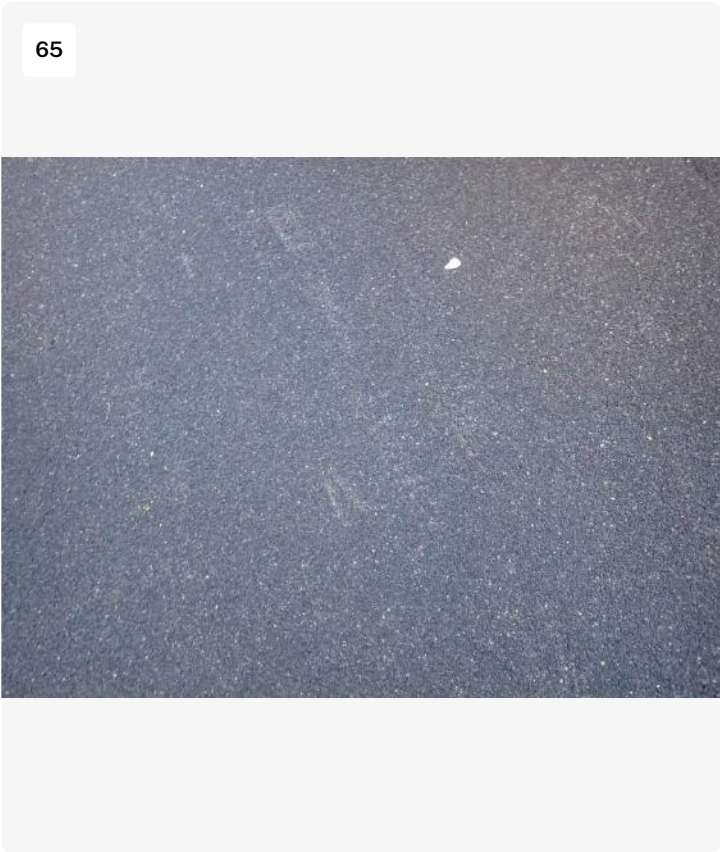
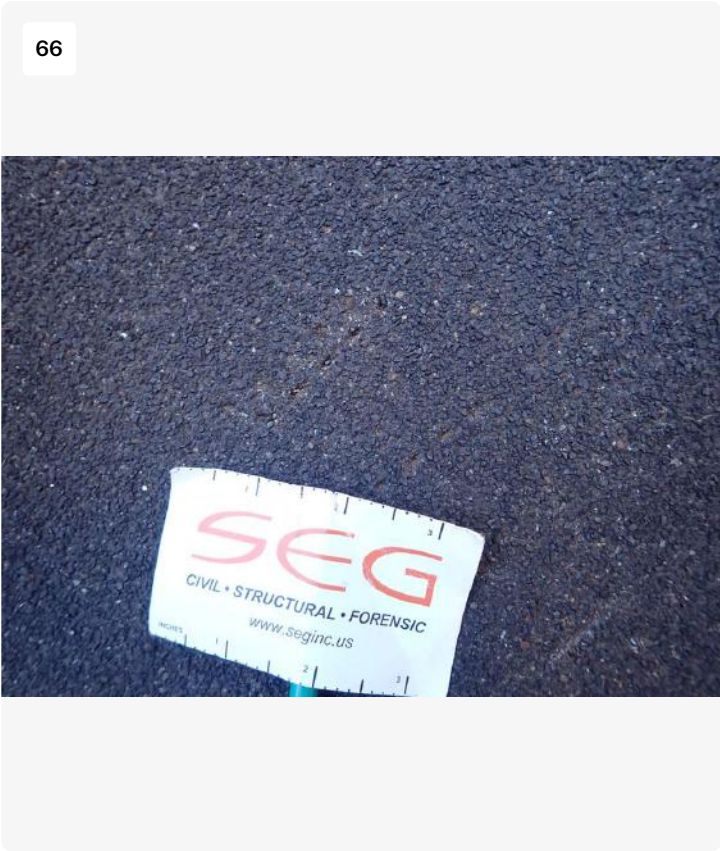
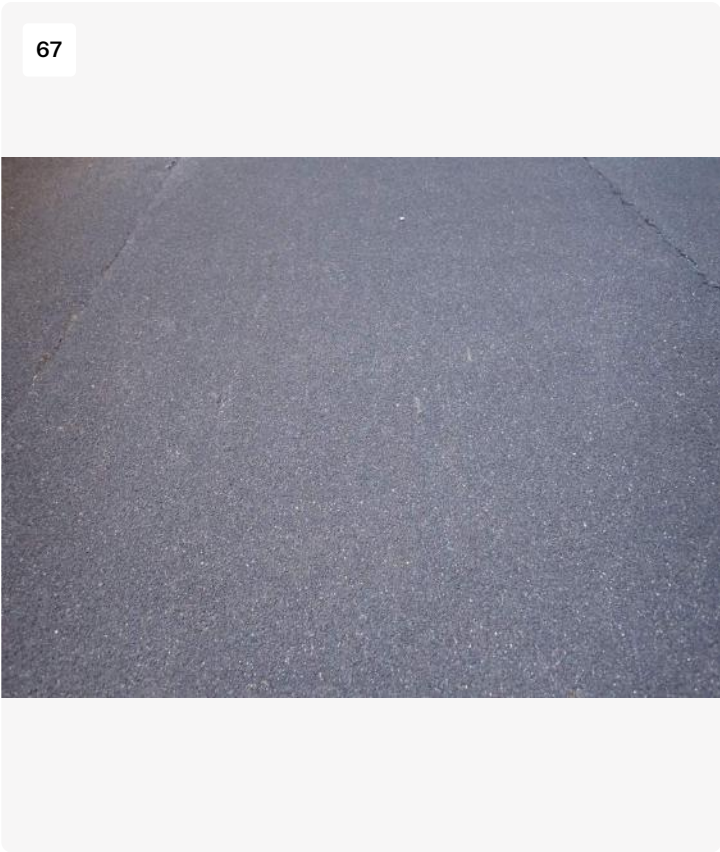
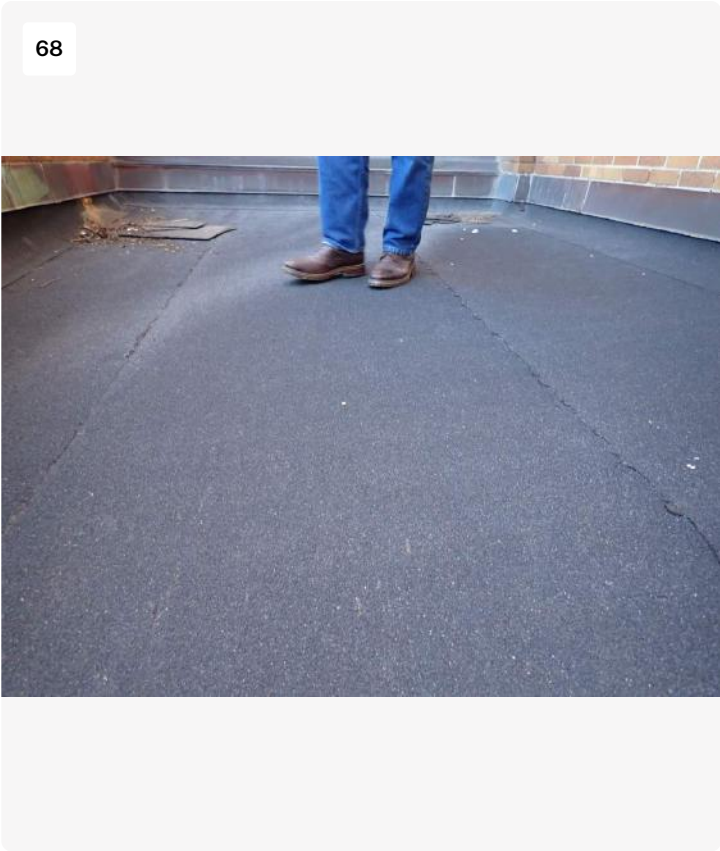
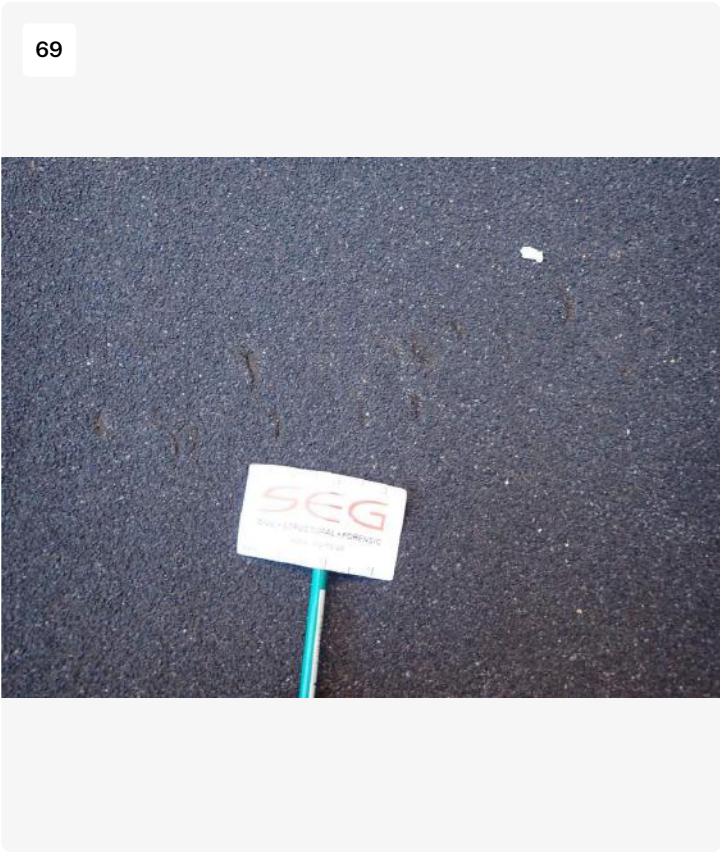
Abrasions in mod-bit from fallen tiles

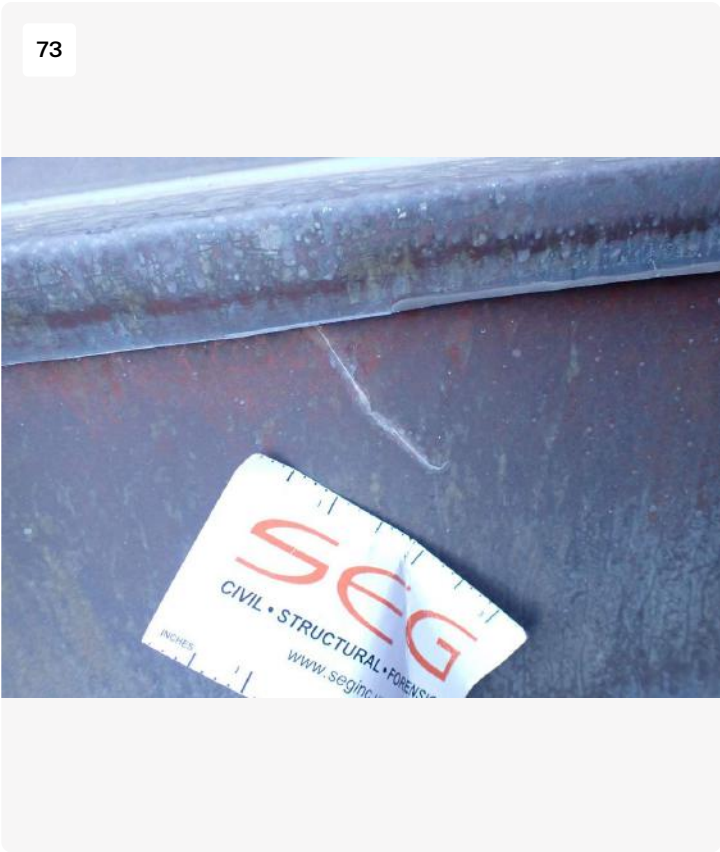
Damage to copper flashing from fallen tile

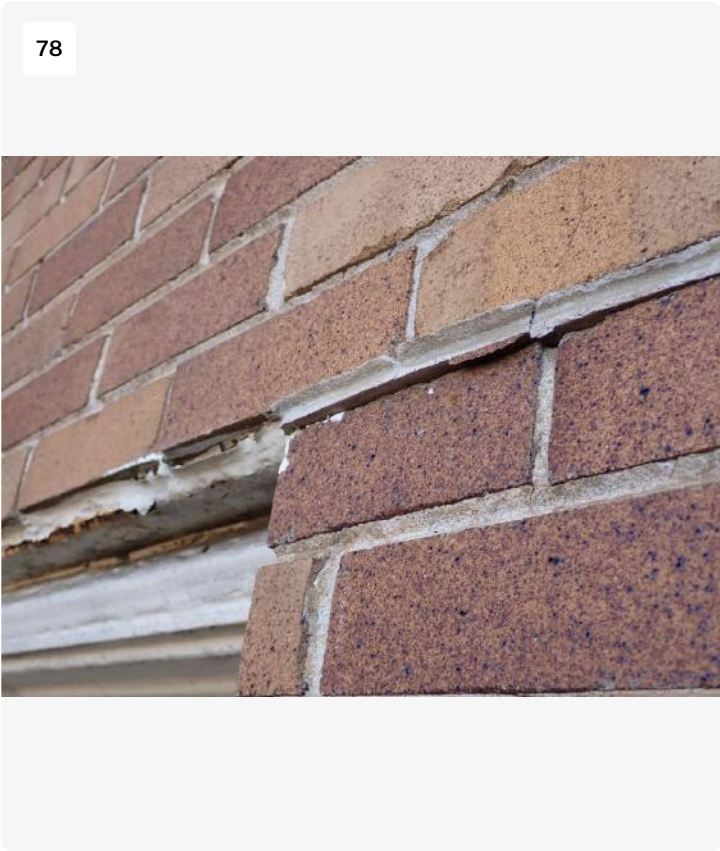
Displaced mortar

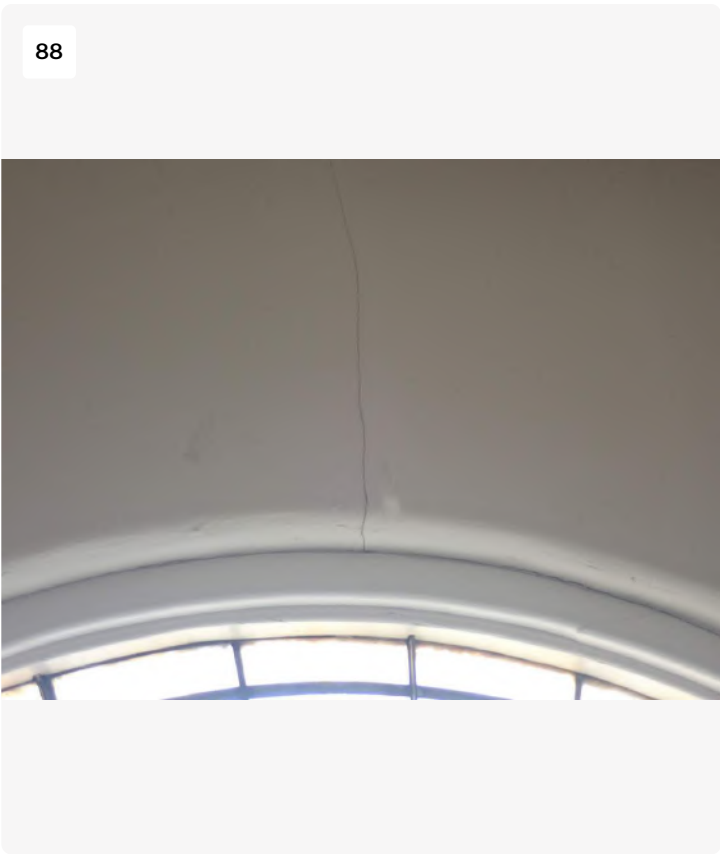
Displacement

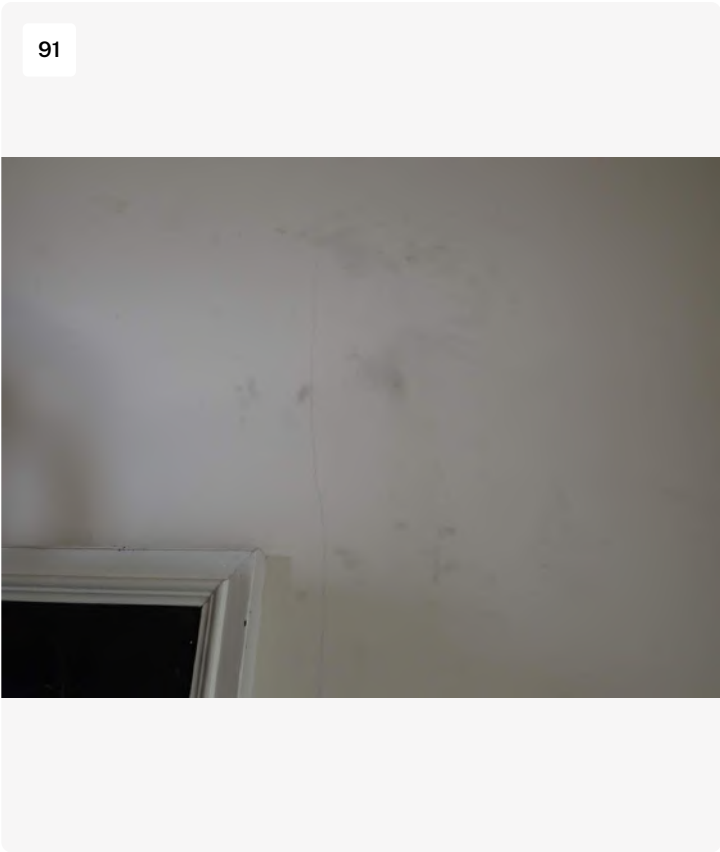
Same

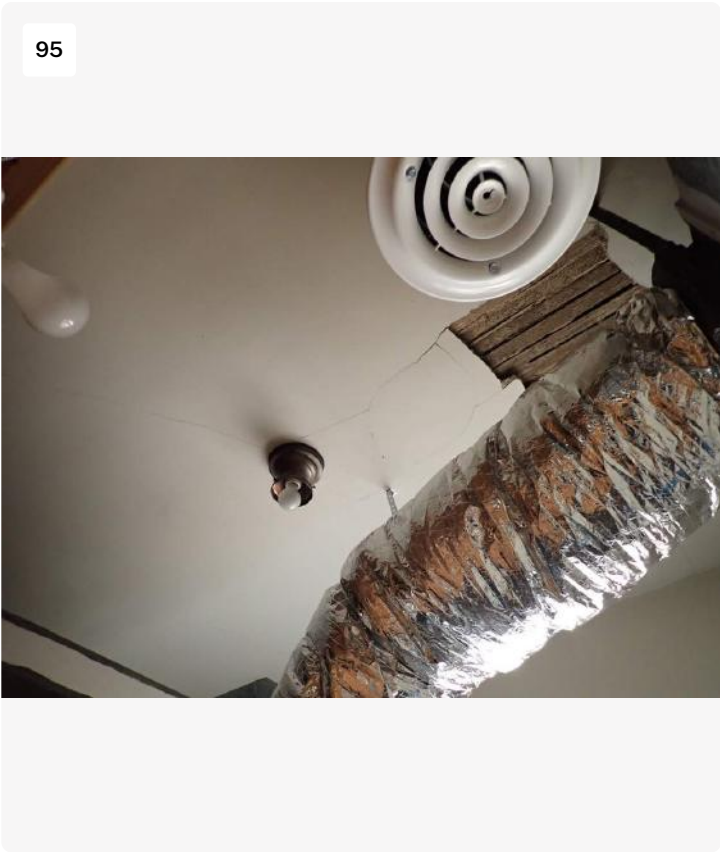
Displacement
