December 7, 2021

**RE: Forensic Engineering Report – Wind Damage  
Newnan Presbyterian Church  
38 Greenville St. S  
Newnan, GA 30263**

Per your request, Shields Engineering Group, Inc. performed a forensic engineering inspection at the Newnan Presbyterian Church at the address above. The Church purportedly sustained damage as a direct result from high winds from a tornado that passed through Newnan on March 26, 2021. This investigation was conducted on November 9<sup>th</sup>, 2021, by Martin Shields, P.E. and Ava Shields of SEG.

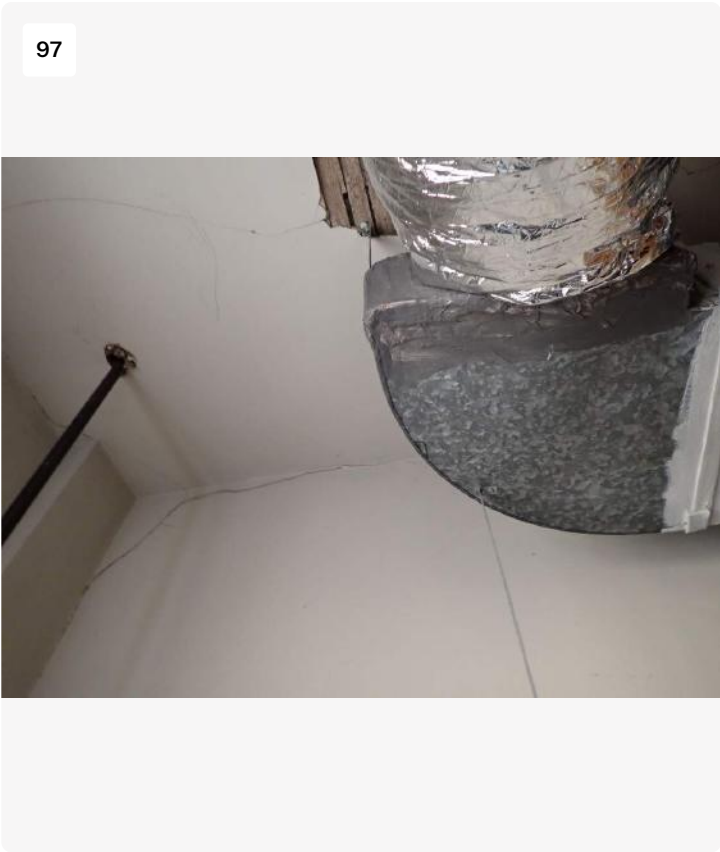
Same

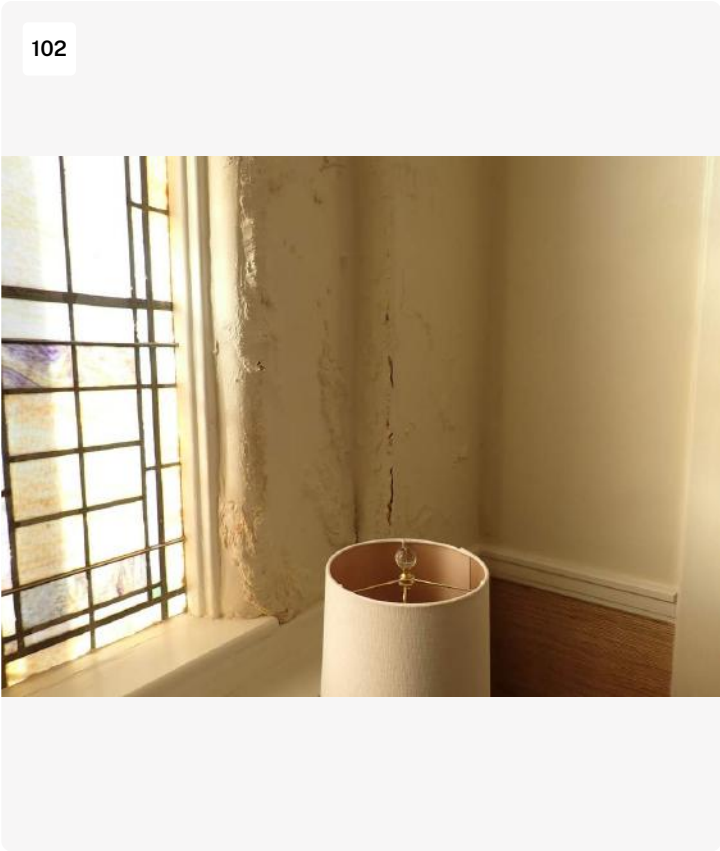
Same

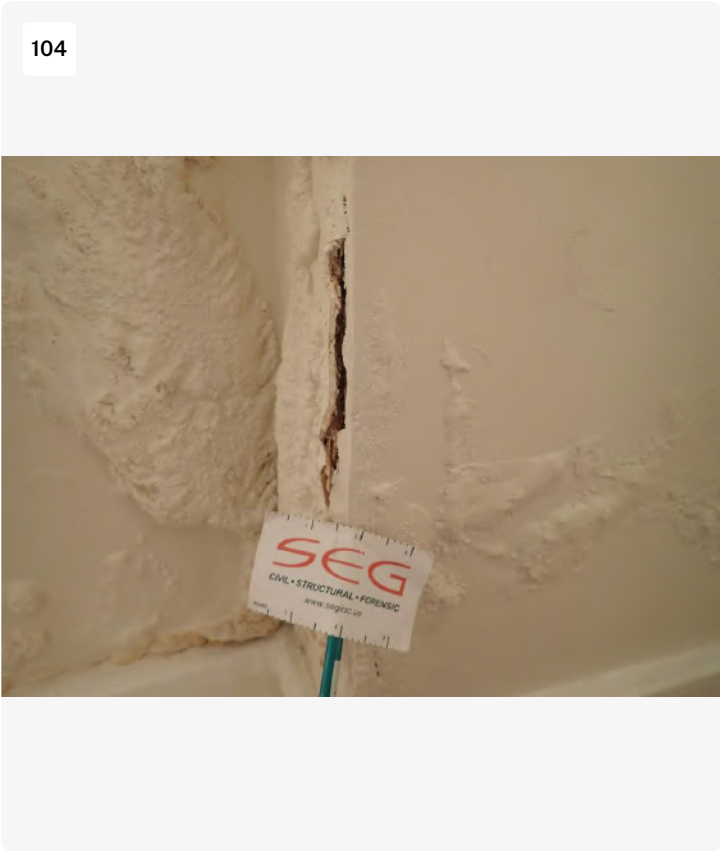
Same

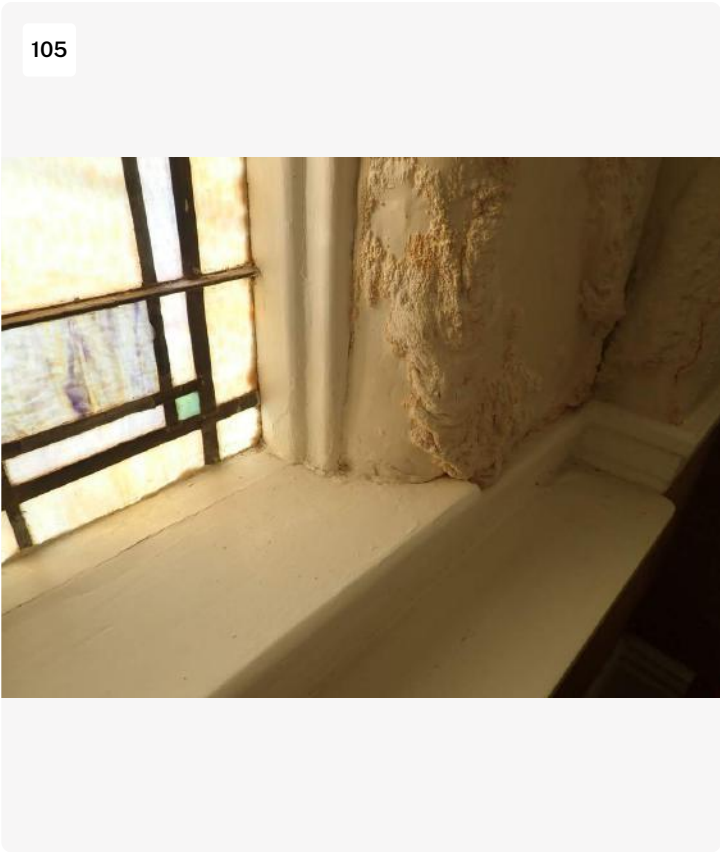
Efflorescence

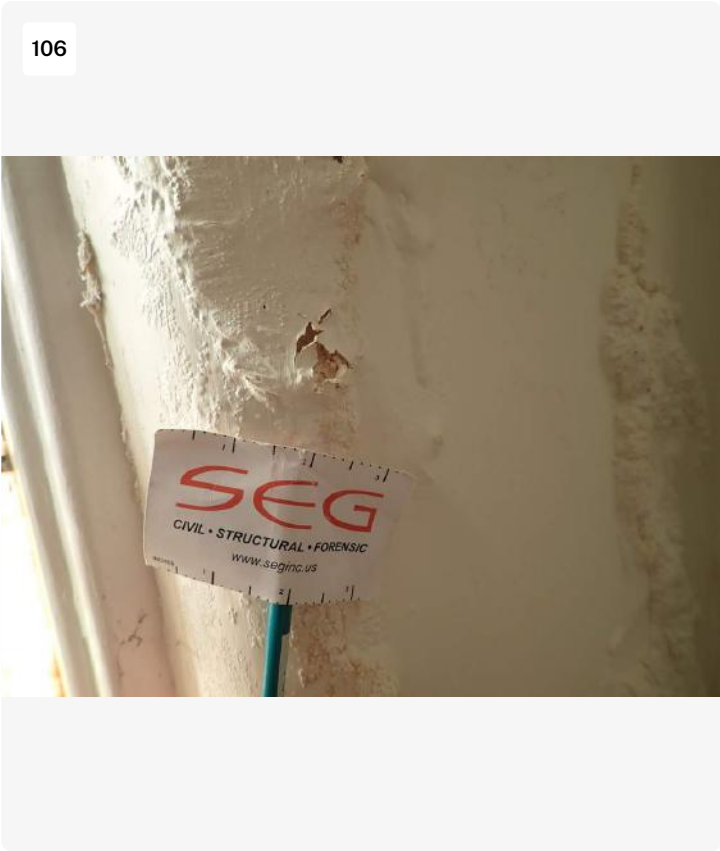
Efflorescence

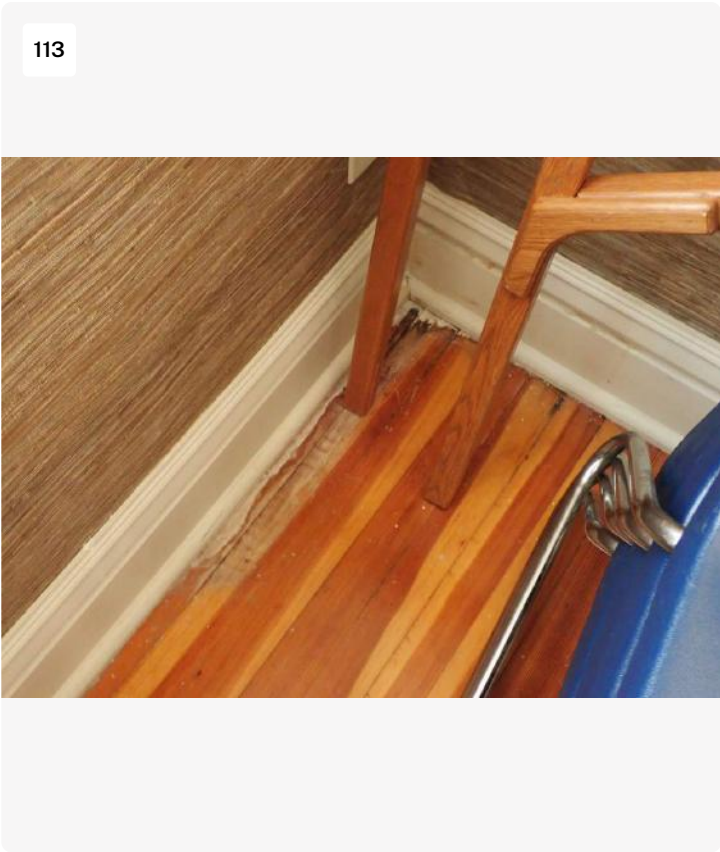
Same

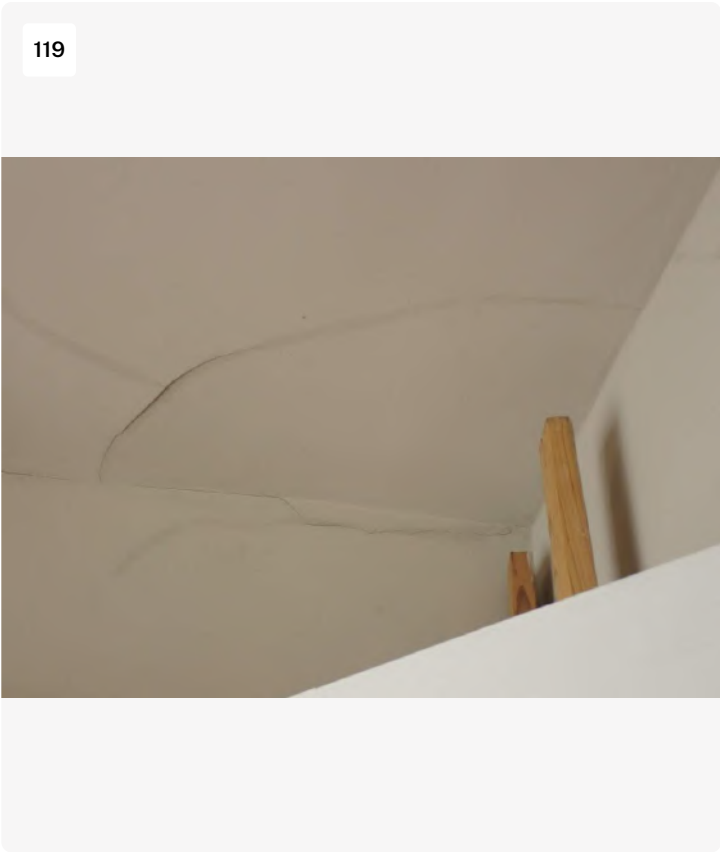
Same

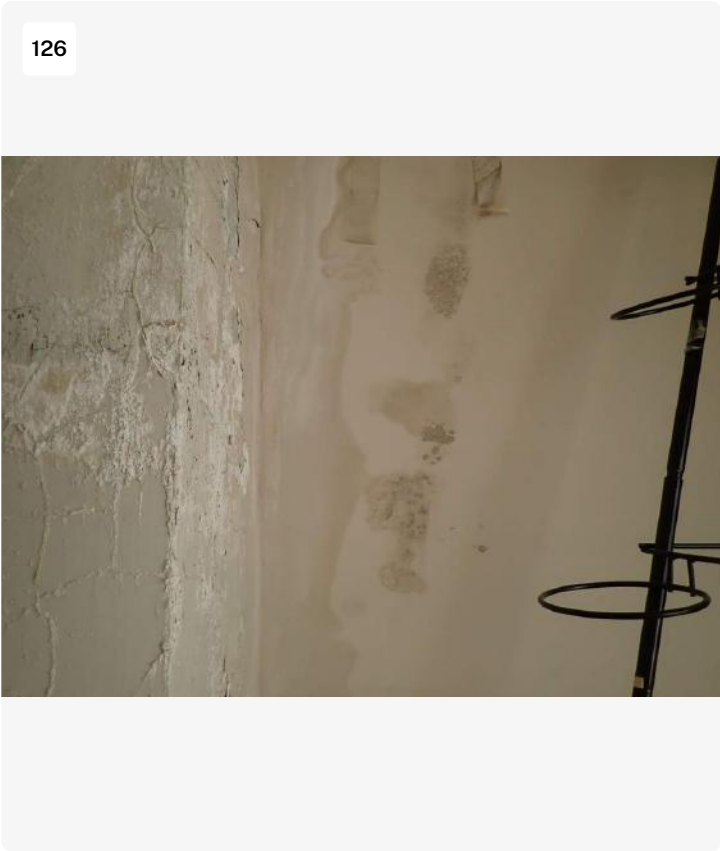
Efflorescence

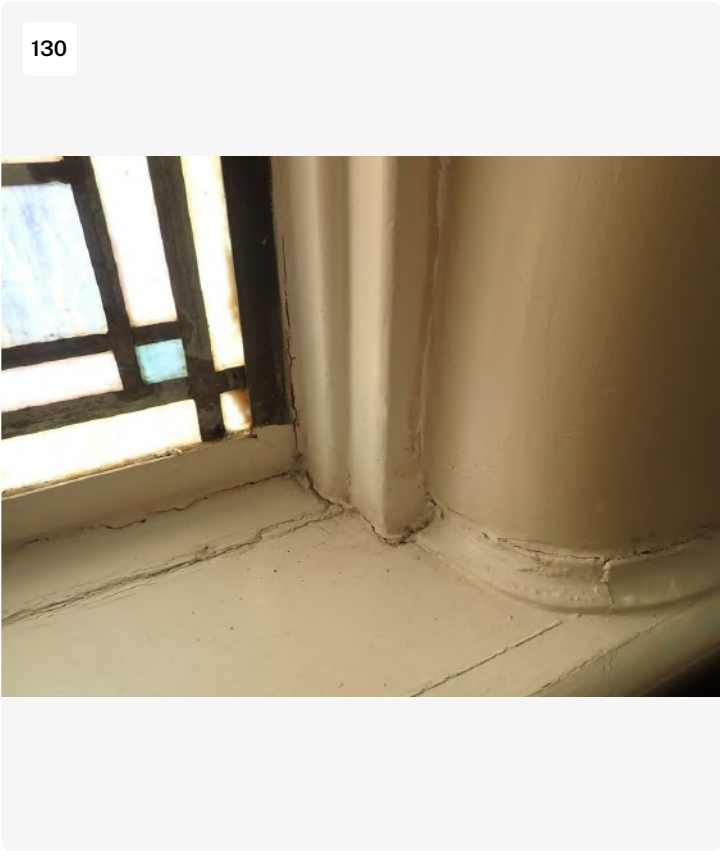
Displacement

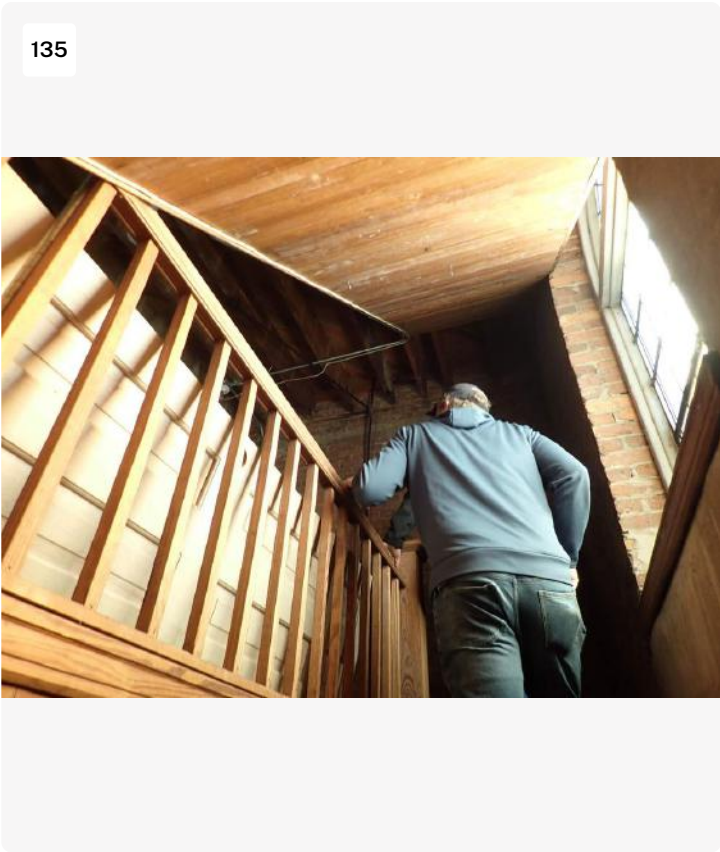
Same

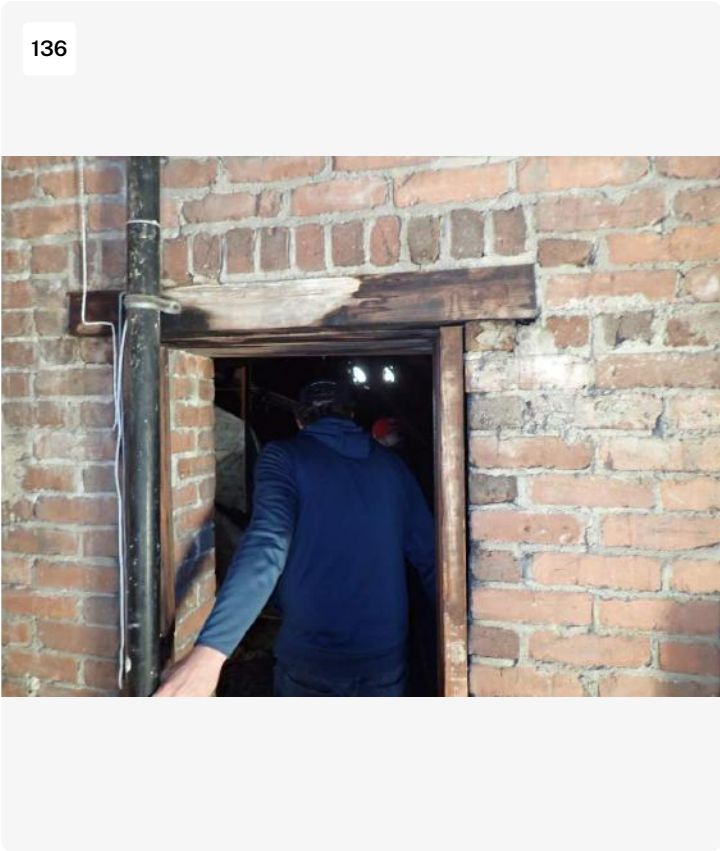
Broken window

4. Remove and replace all plexiglass storm-protection windows on the north and south elevations.
5. Remove and replace all damaged gutters and downspouts.

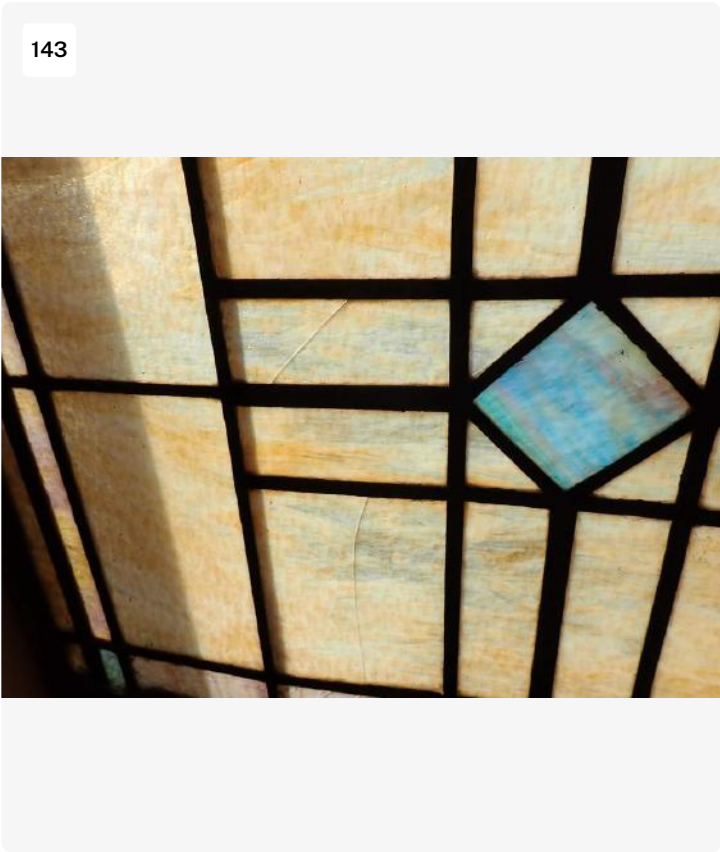
Same

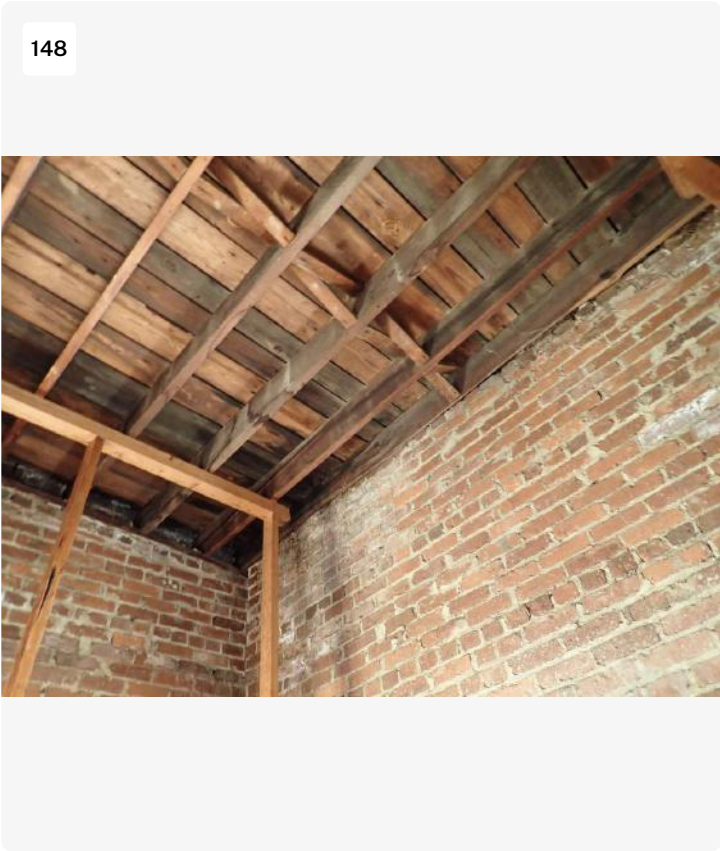
North tower

Water stains around windows

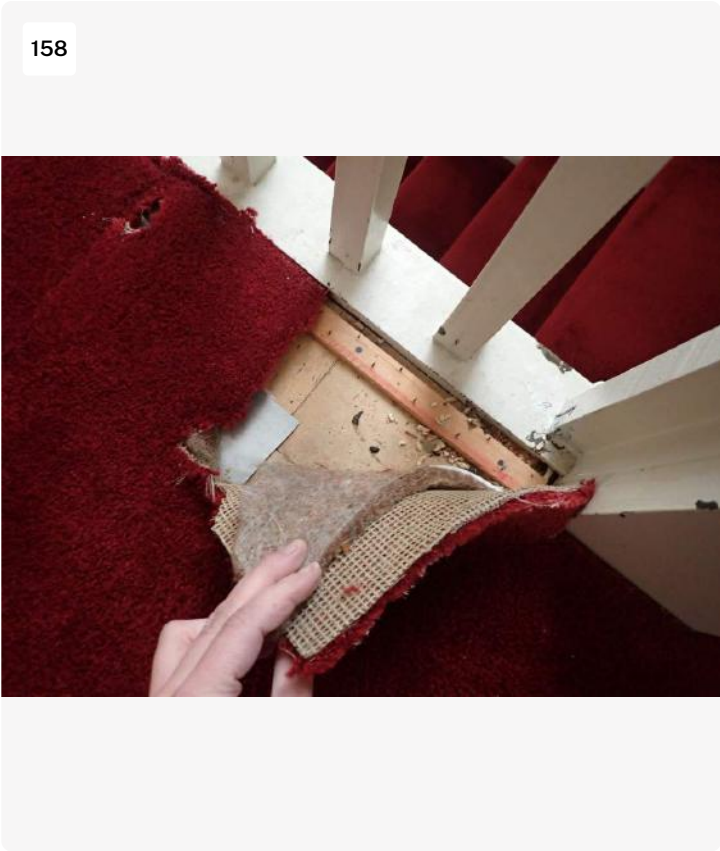
Carpet underlayment

6. According to *The Institute of Inspection Cleaning and Restoration Certification Standard for Professional Water Damage Restoration* (IICRC S500), interior plaster, drywall, insulation and flooring that was impacted by the roof leaks, should all be removed. Hard surfaces should be mitigated using the IICRC S500 Standards, which includes anti-microbial spray and HEPA vacuuming to disinfect affected.

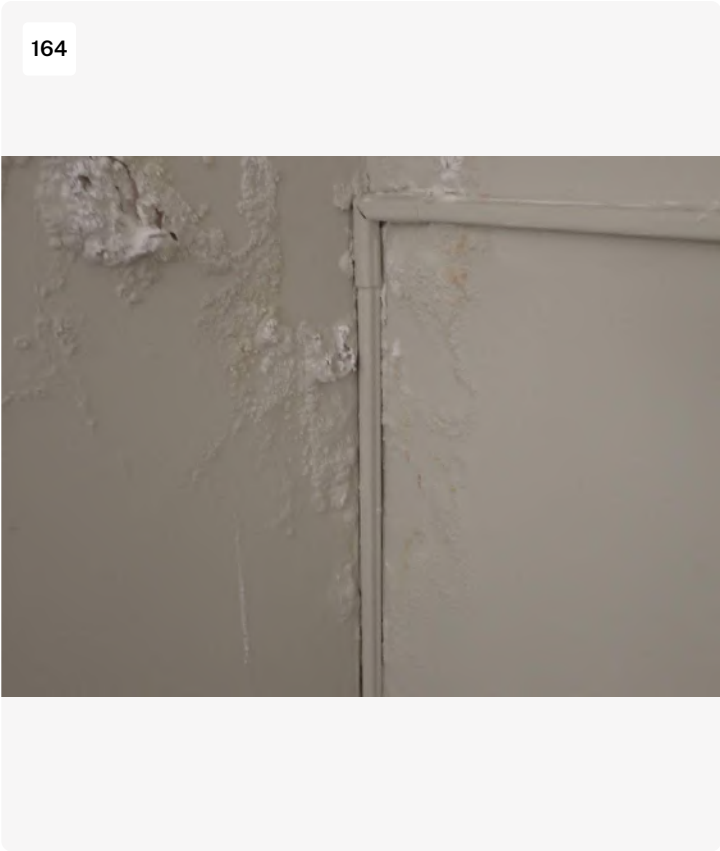
Water damage

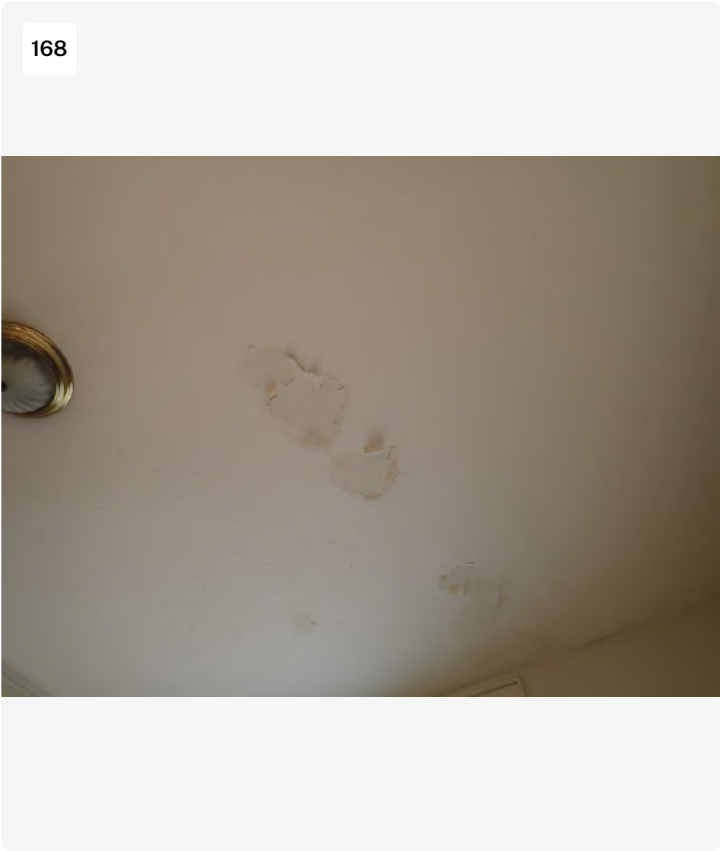
Water damage

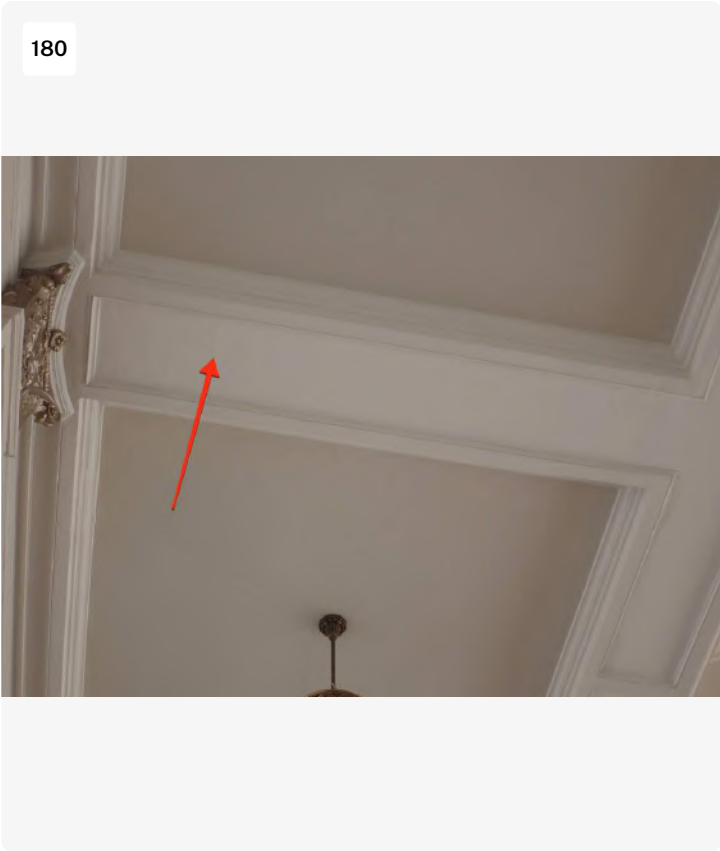
Moisture intrusion

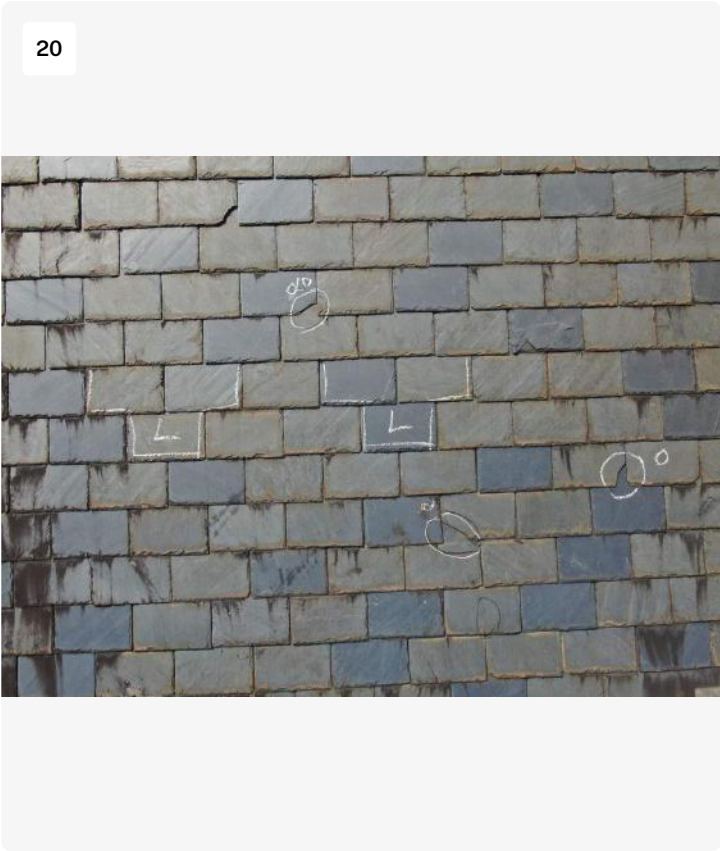
Old cracks were noted along with fresh cracks  
Displaced tiles

1. The slate tiles should be removed and replaced on both the north and south slopes. If economically feasible and if replacement tiles are available to match, the intact tiles can be removed and re-attached, after the replacement of the old/damaged roofing felt. Several items to note if the intact tiles are going to be re-used: 1) A breakage factor must be included as approximately 10 to 15% of the intact tiles will be broken, and 2) many of the intact tiles are currently chipped and have small cracks – these tiles cannot be re-used per IBC codes.

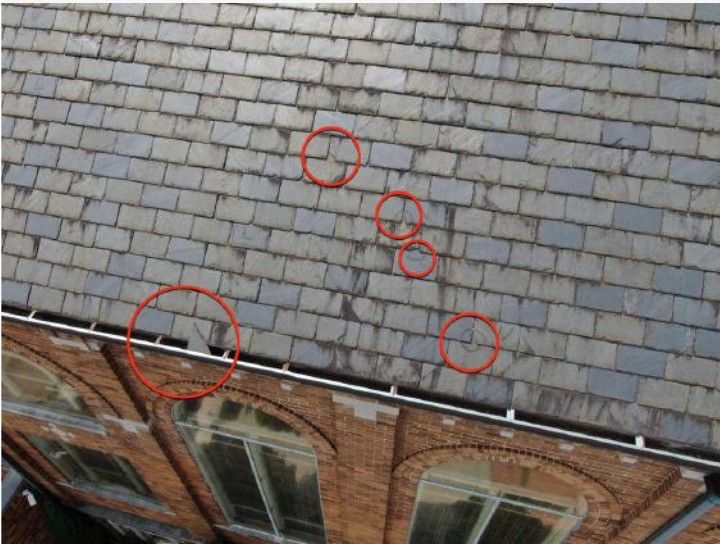
Broken tile in gutter

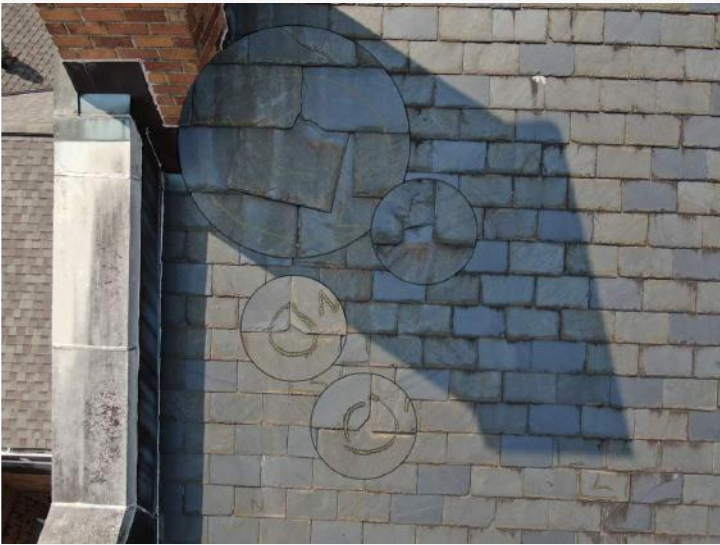
Displaced and broken tiles near chimney

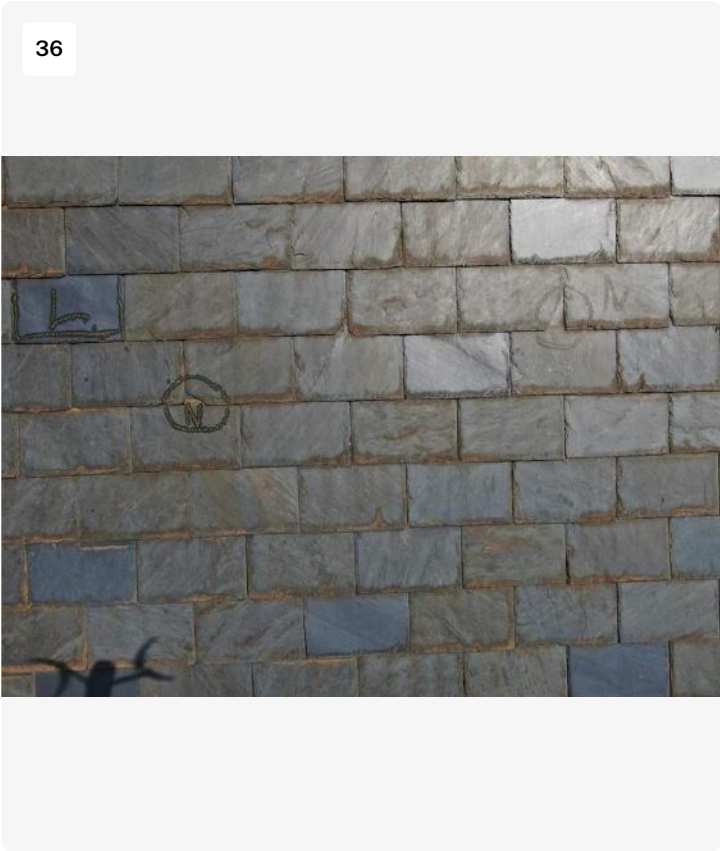
Broken tiles

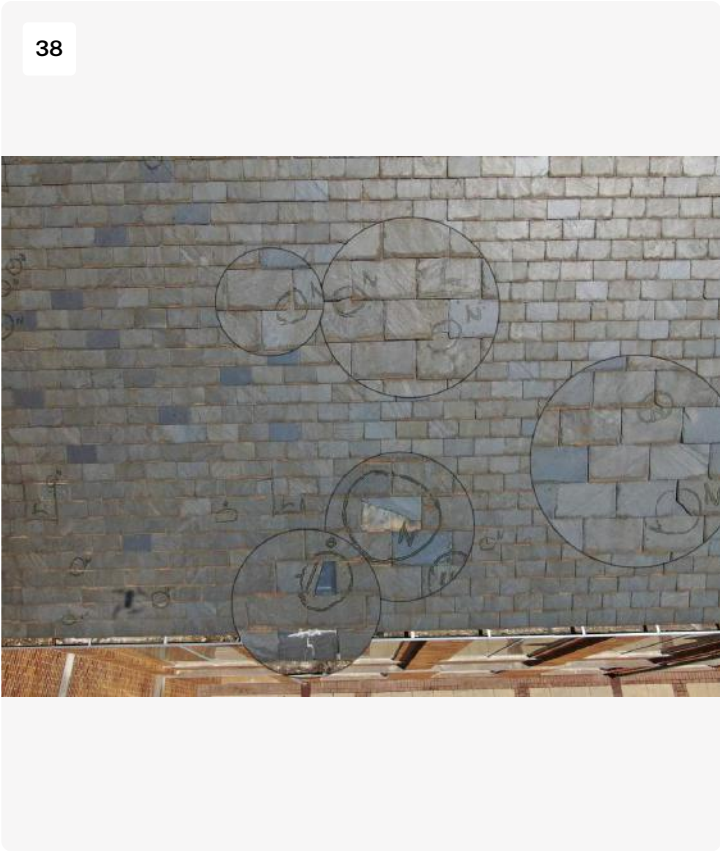
Displaced and broken tiles

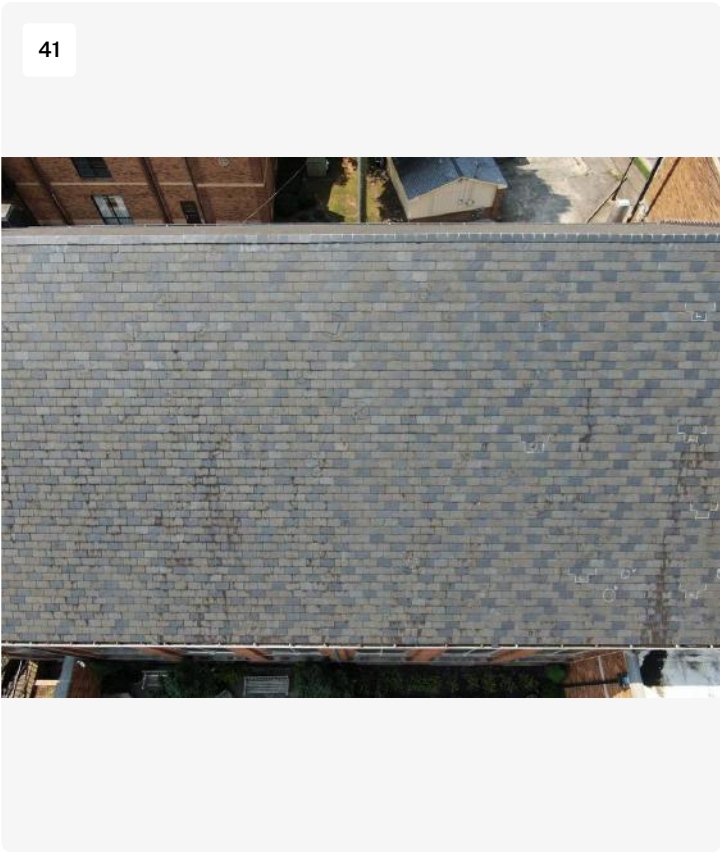
Same

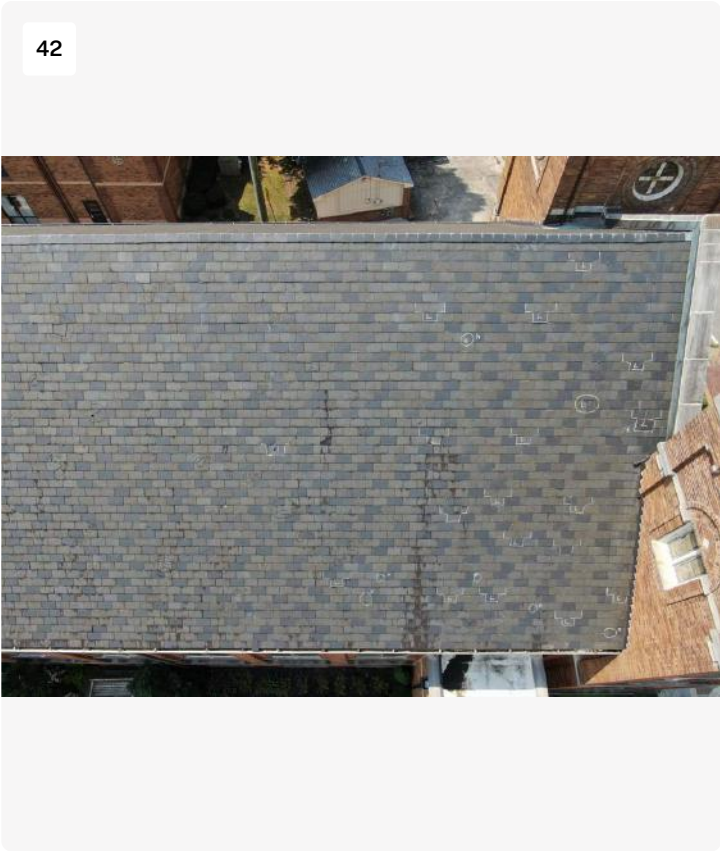
Same

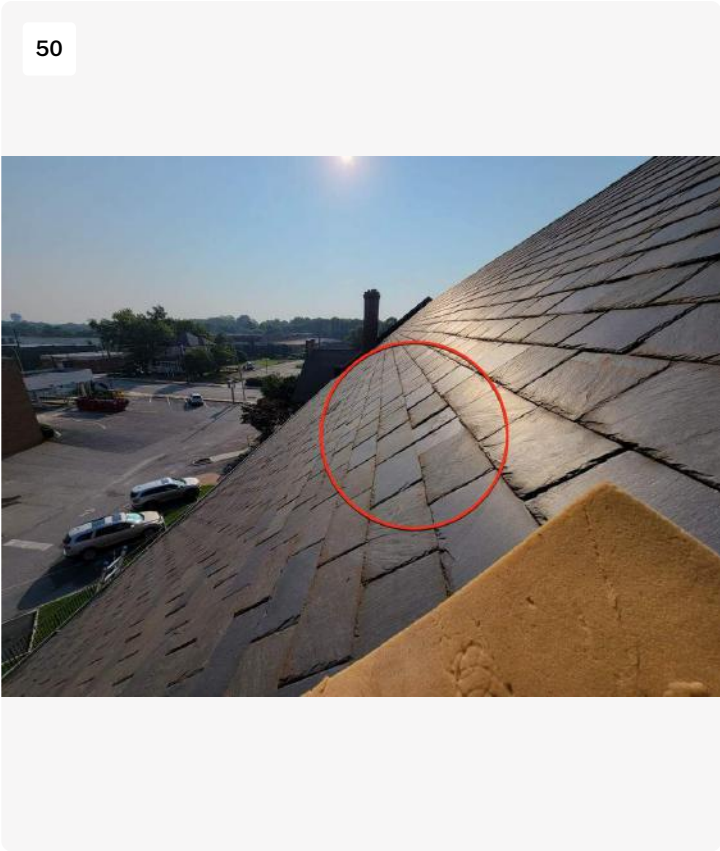
Missing tile

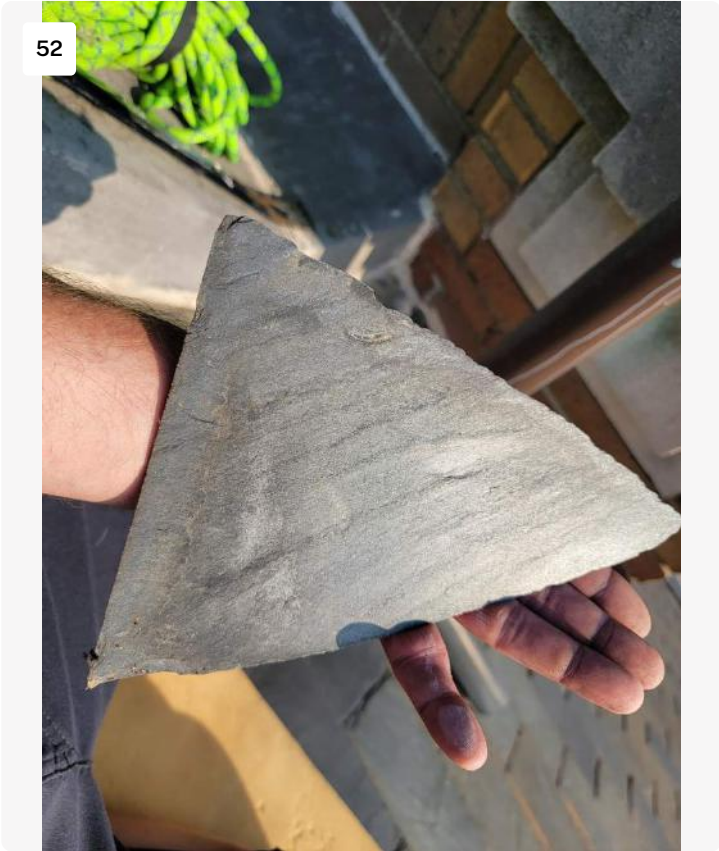
Same

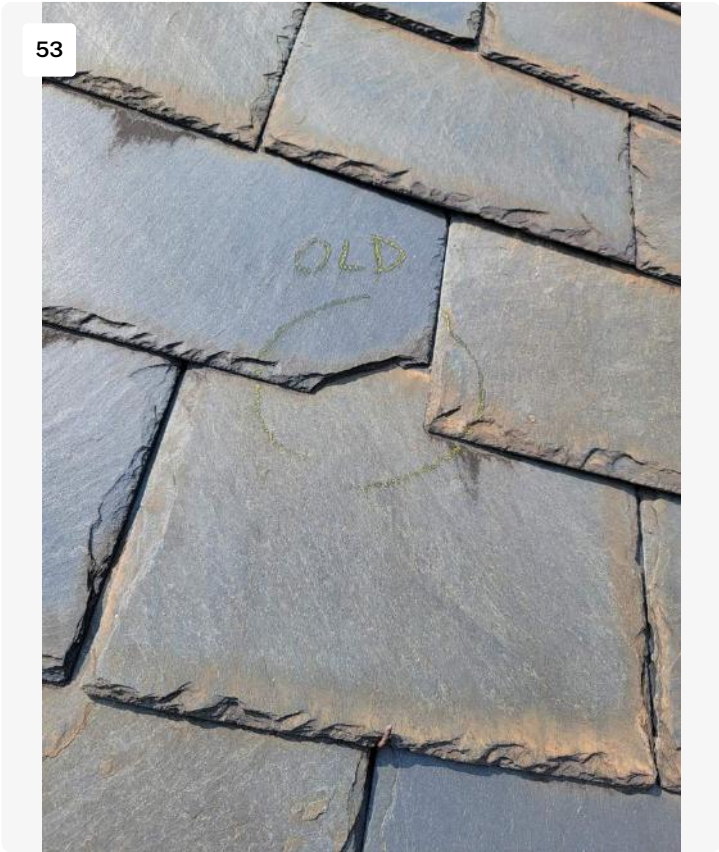
Old crack

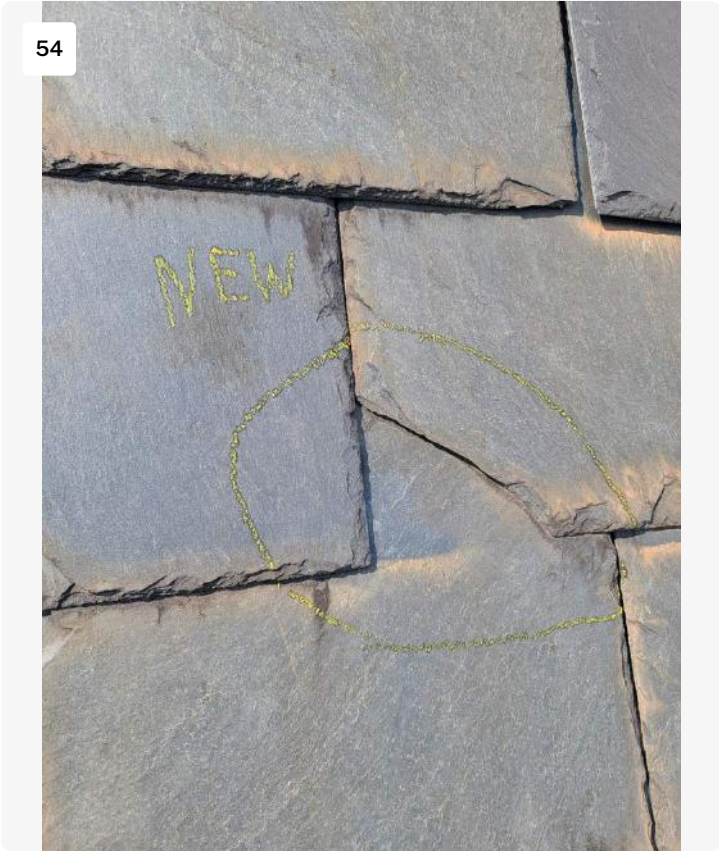
New crack
